Nissan/Jatco CVT Internal

RE0F10D

Presented by:
Mike Souza
ATRA Senior
Research Technician

Nissan CVT Internal Webinar ©2016 ATRA. All Rights Reserved.

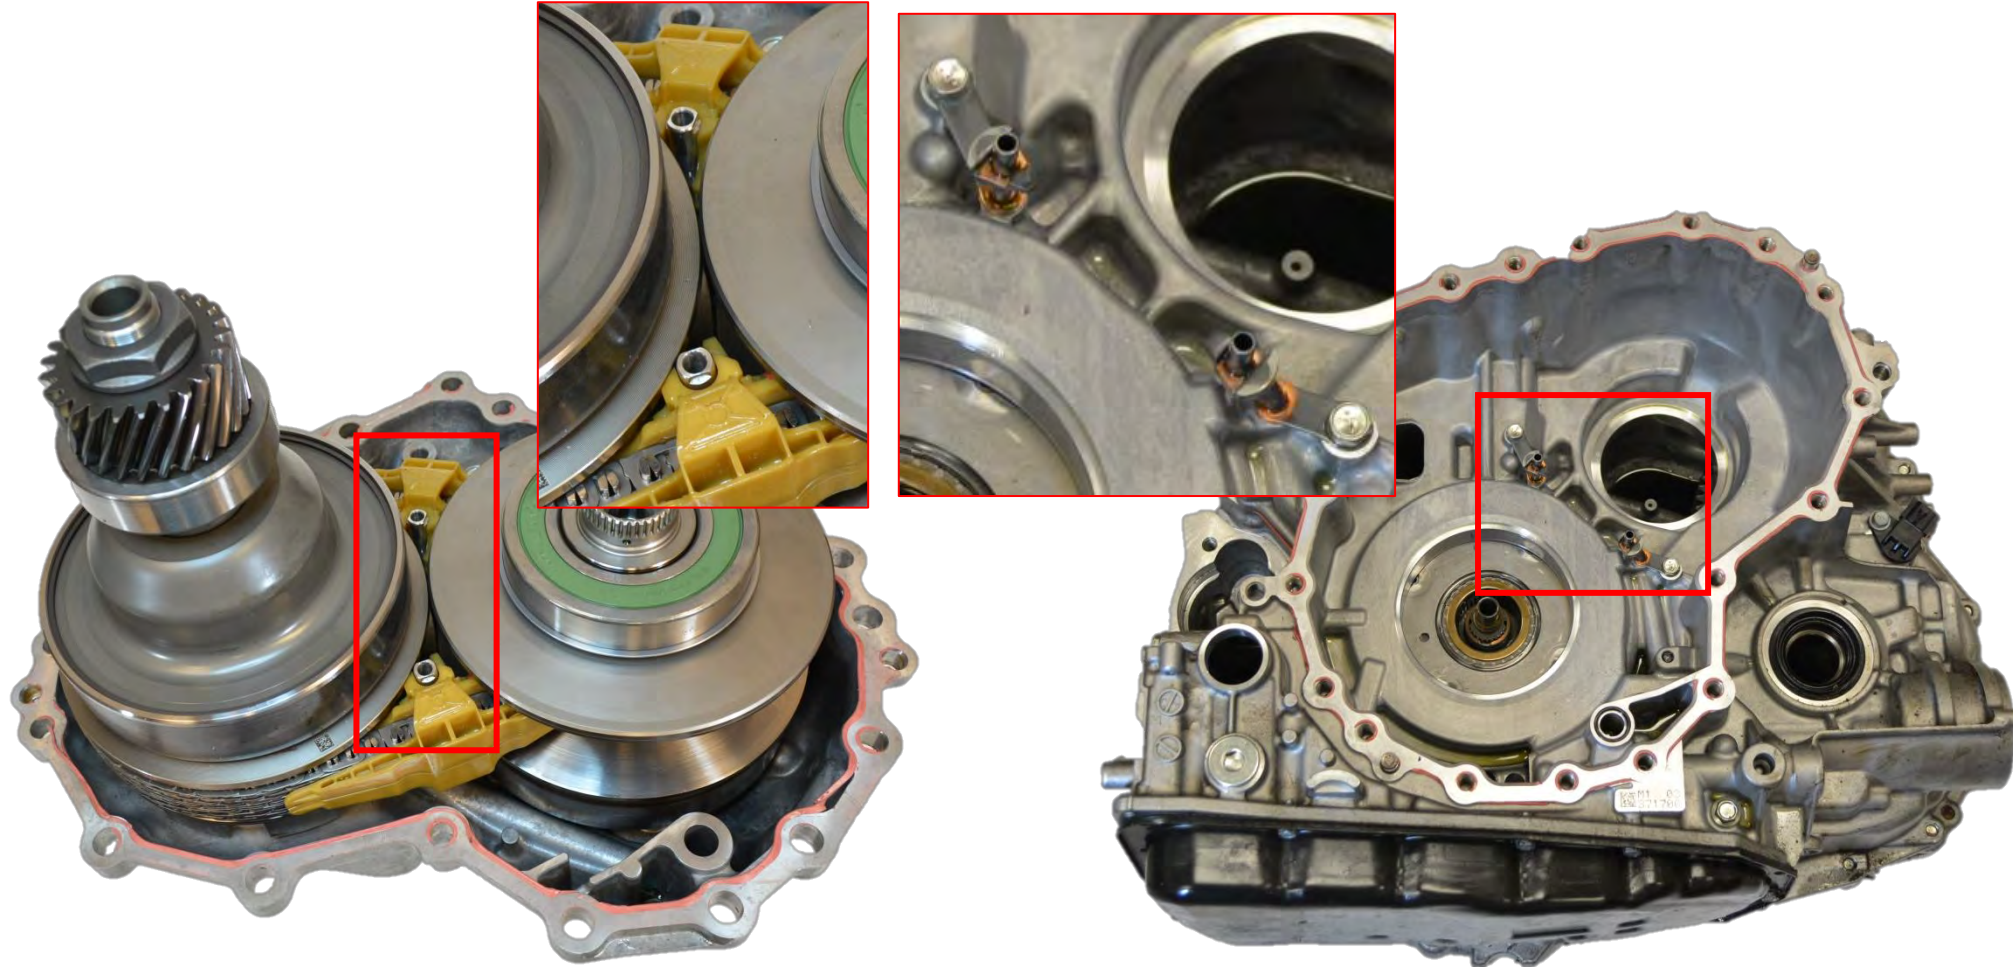
A closer look shows there are two aluminum lube chain guide pins/tubes sitting in the chain guides that fit onto two steel feed tubes inside the case.

Installing these pulleys into the cover first will not work.

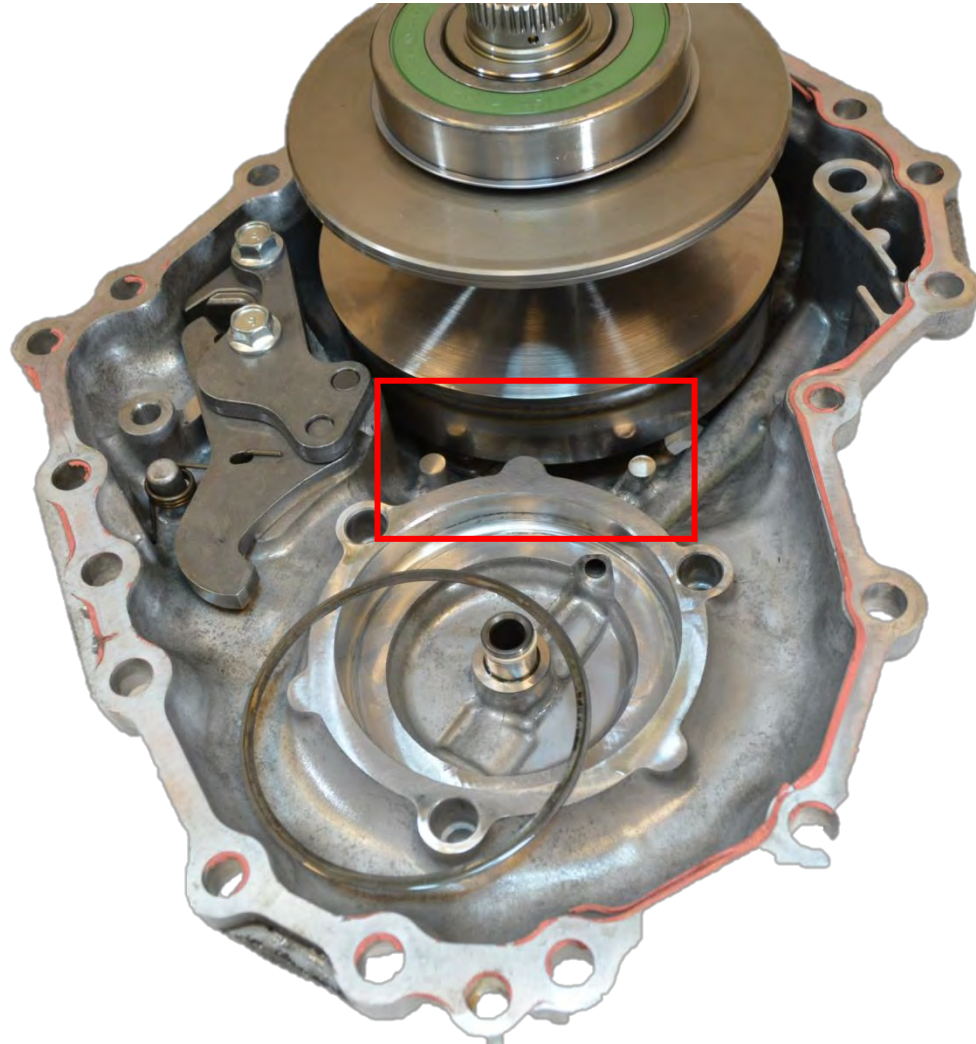
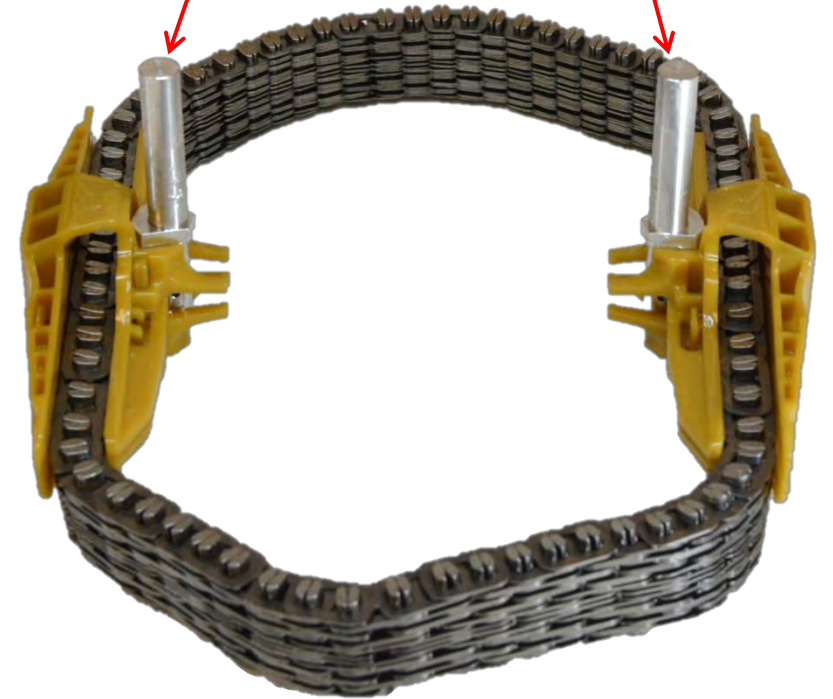
The closed side of the aluminum lube tubes are held down in place by two embossed tabs in the back cover.

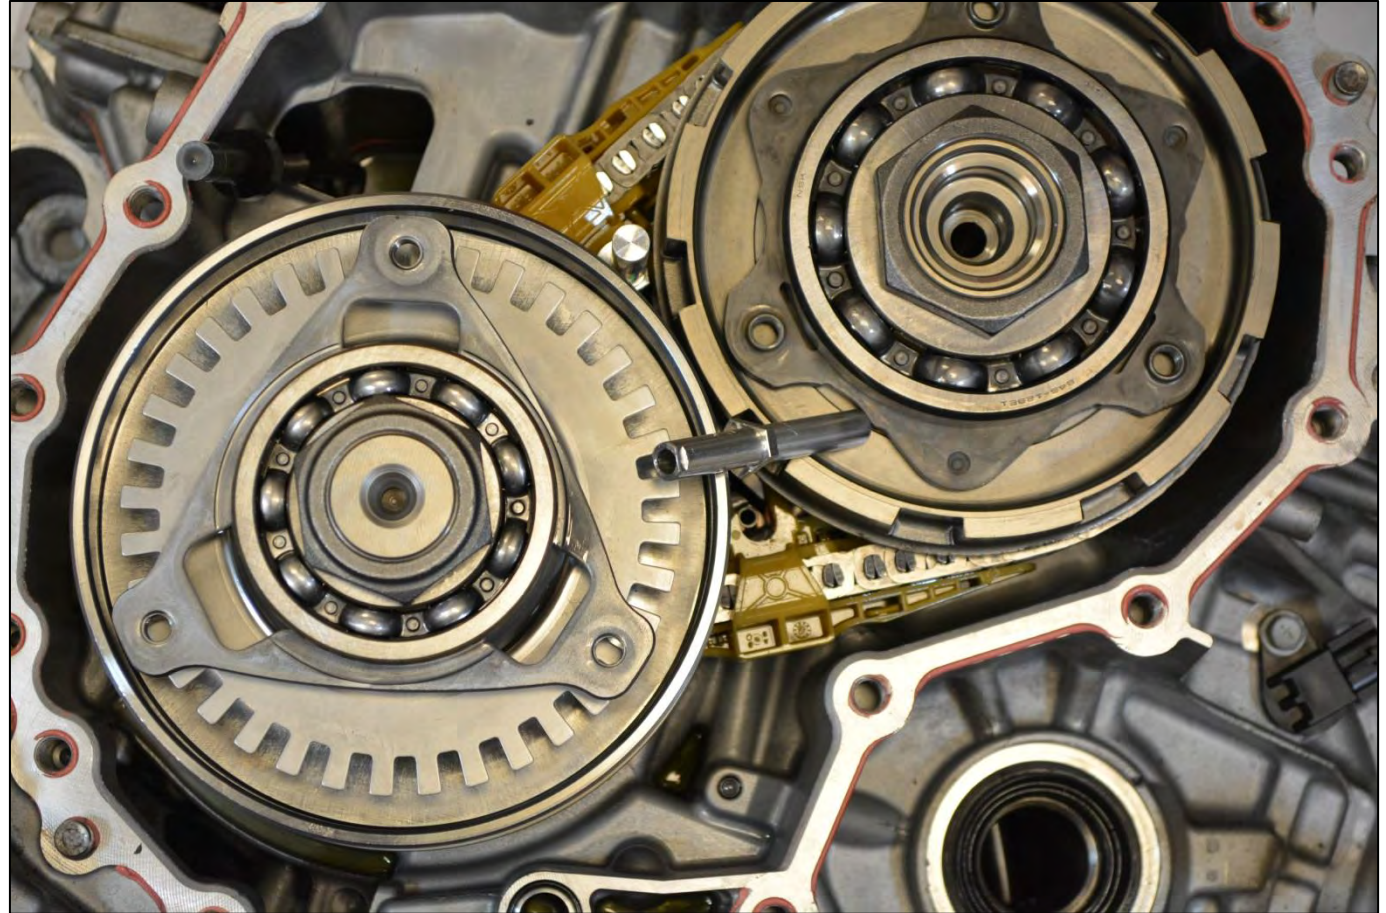
The RE0F10E/H/J pulleys with the chain are installed into the case first instead of the cover.

Now the lube chain guide pins/tubes can be installed onto the feed tubes in main case one at a time making sure the flat area aligns with tab.

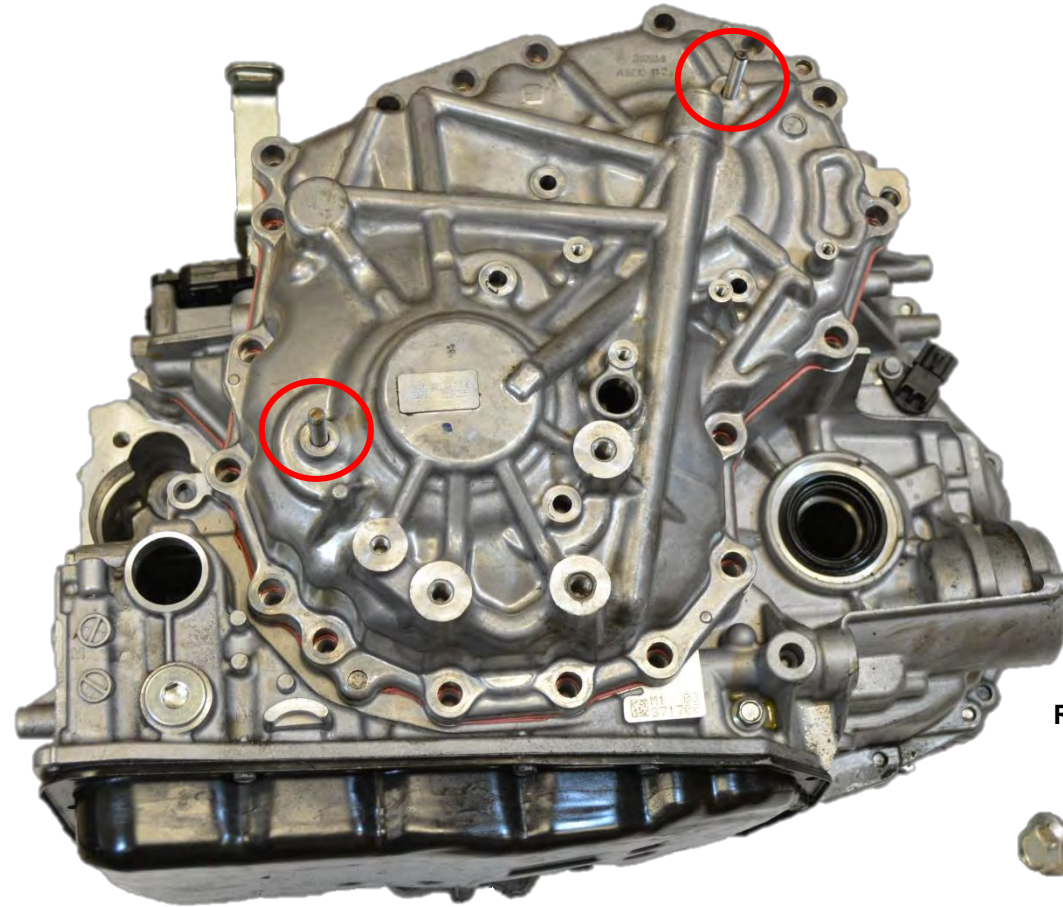
RE0F10E/H/J

Now with a couple of alignment bolts on the pulley retainers we can slide the cover onto the pulleys and install the six (6) retainer bolts with seals.

Retainer Bolts & Seals

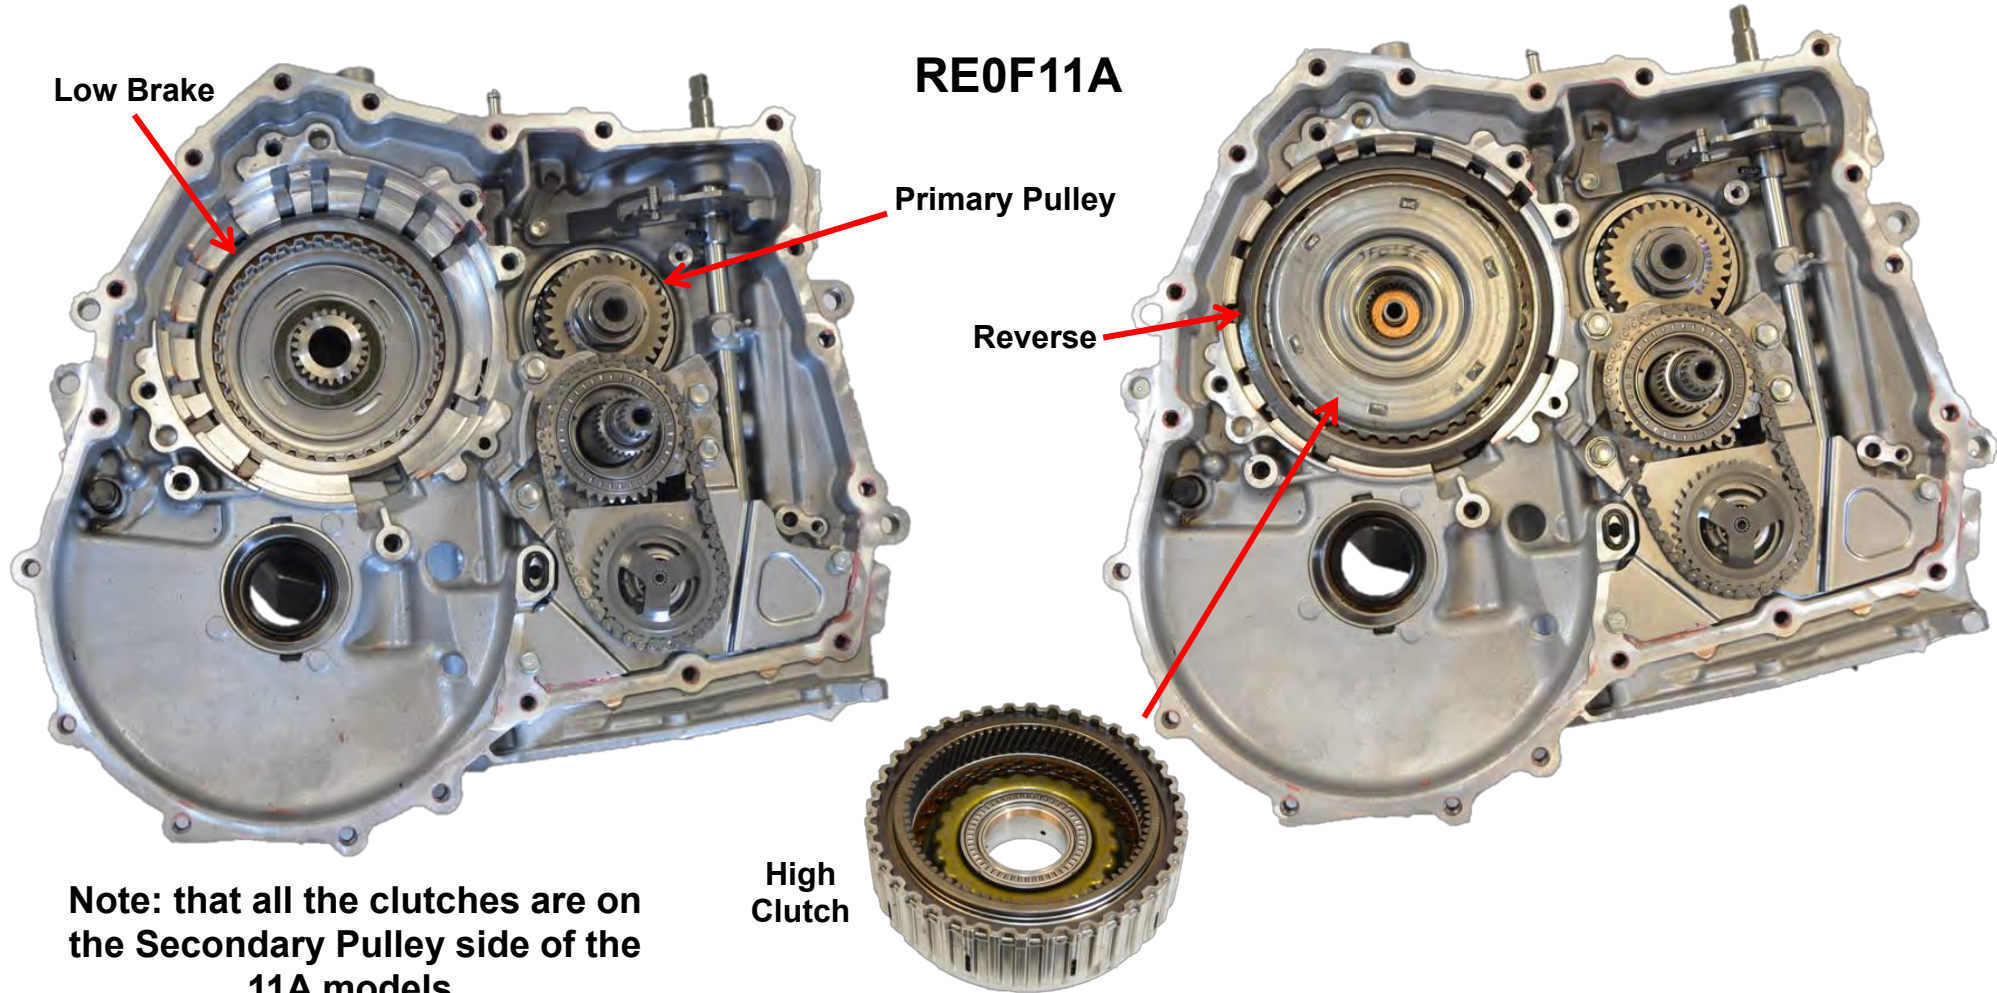
The RE0F11A (JF015/16E) models use a Low Brake and High Forward and Reverse Brake clutch (2 speed). Other models use only a Forward and Reverse Clutch.

Note: that all the clutches are on the Secondary Pulley side of the 11A models.

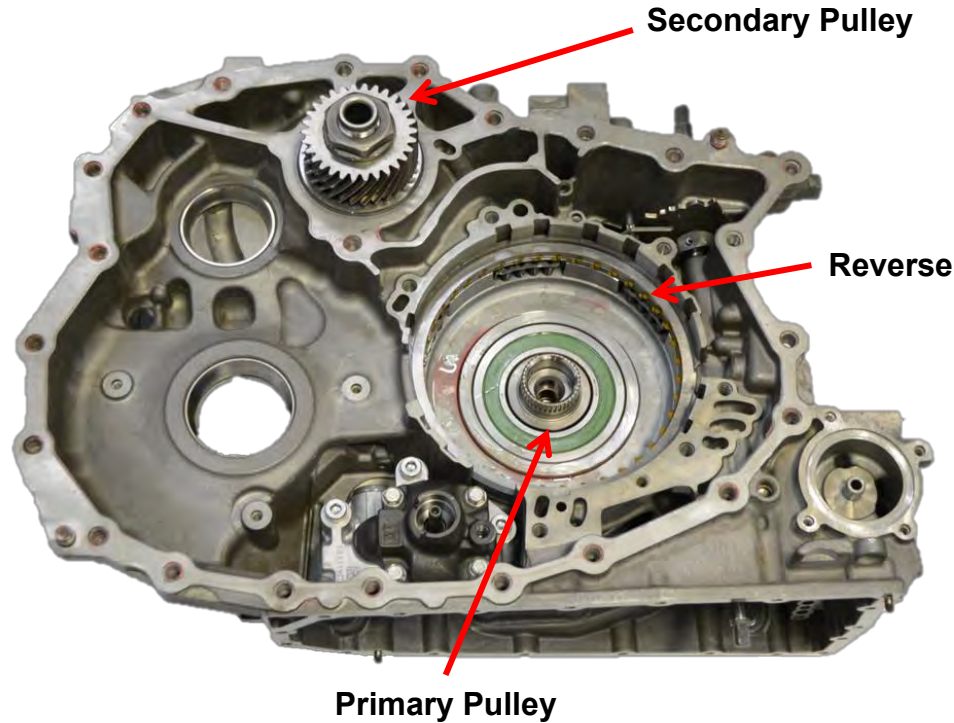
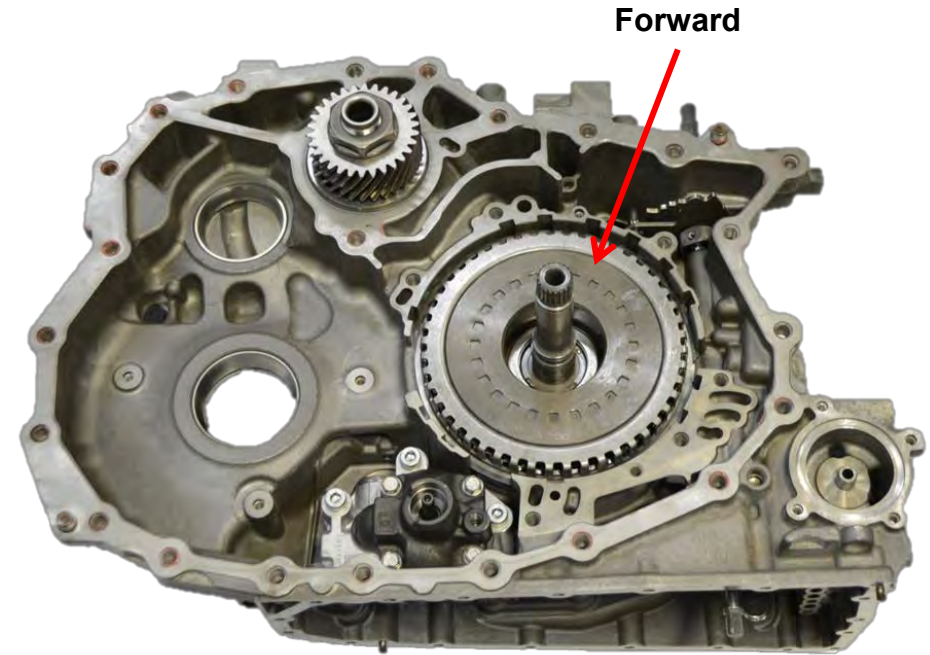
RE0F10D

Other Nissan/Jatco CVT's use only a Forward and Reverse Clutch (RE0F10D example).
The clutches are found on the Primary Pulley side on all other models except RE0F11A.

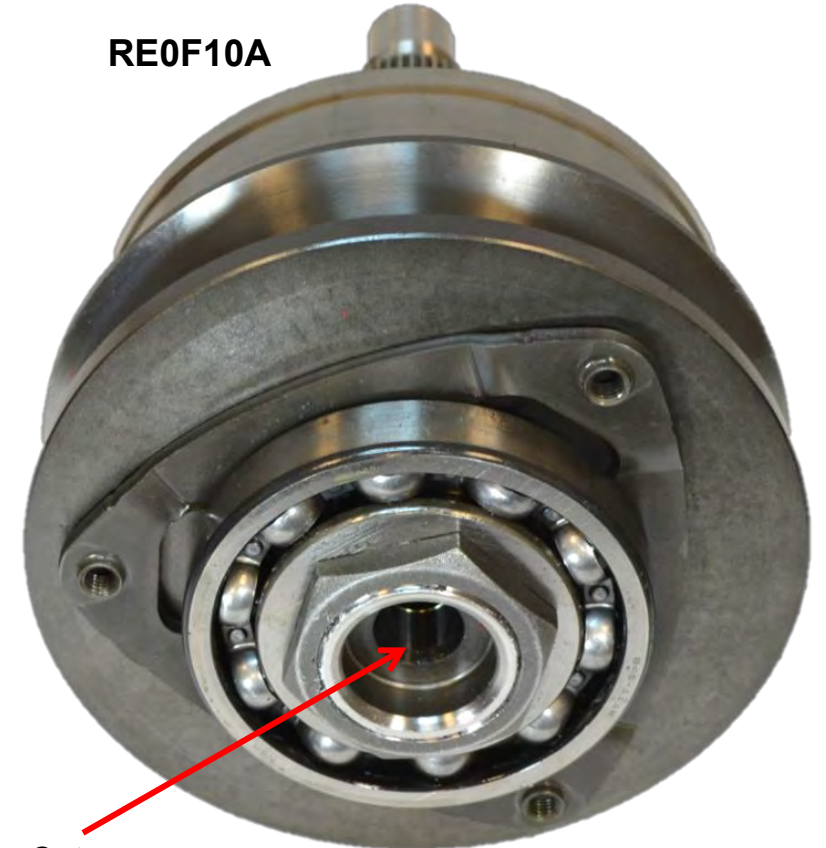
It is not uncommon to find bearing failure on these CVT transmission. If the bearing does not spin extremely smooth by hand with some pressure; check for ring cut inside the pulley shaft.

Ring Cut

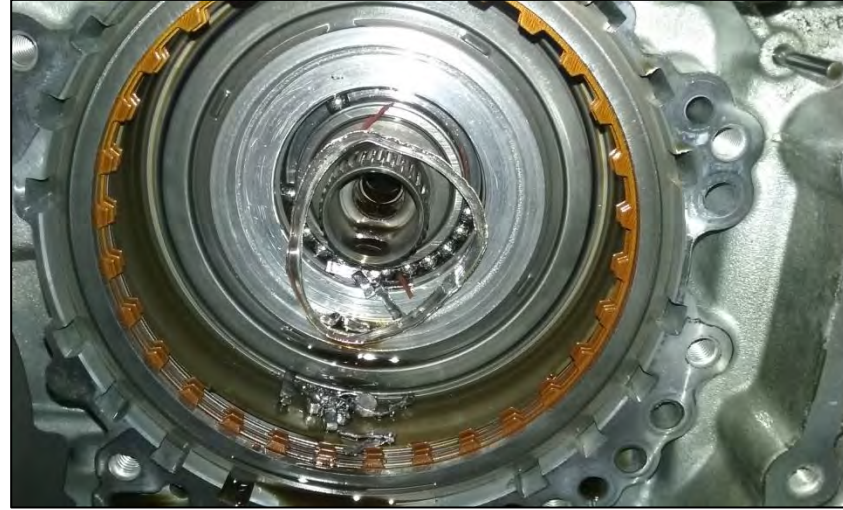
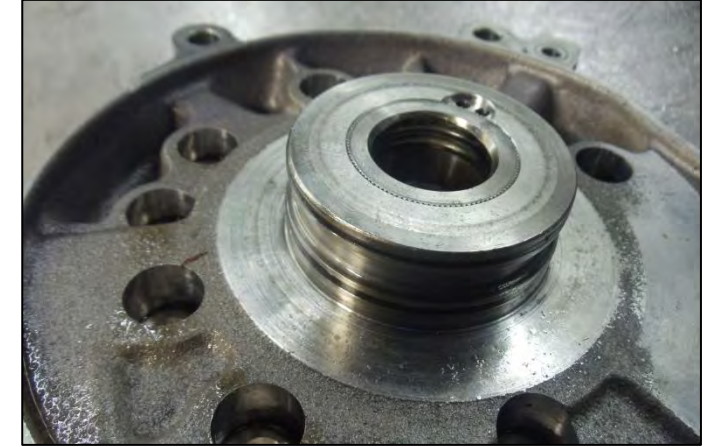
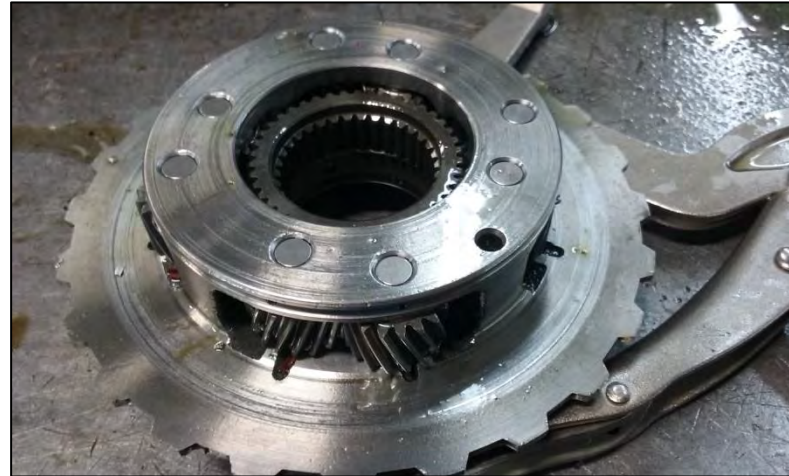
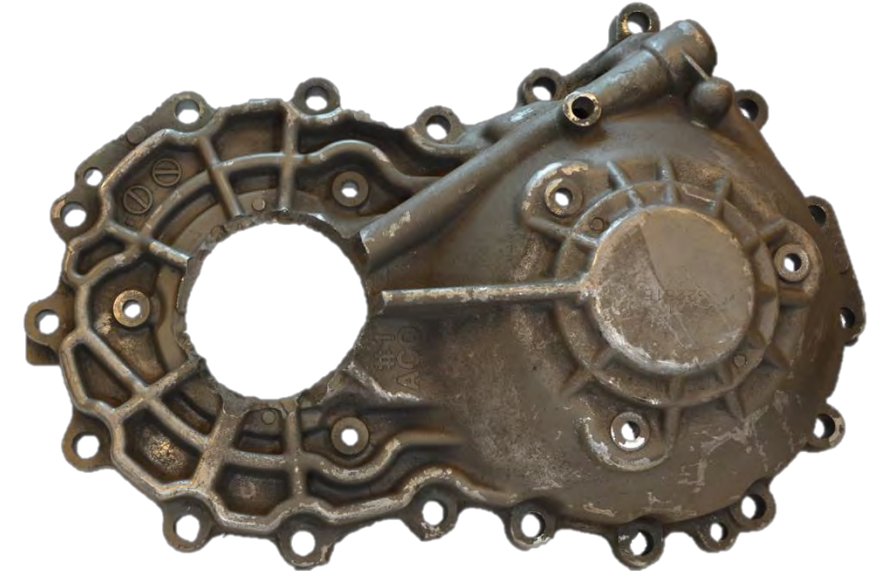
Here are a couple examples of pulley bearing failures. Most often the Secondary Pulley bearing begins to fail first with the exception of this RE0F08A shown below.

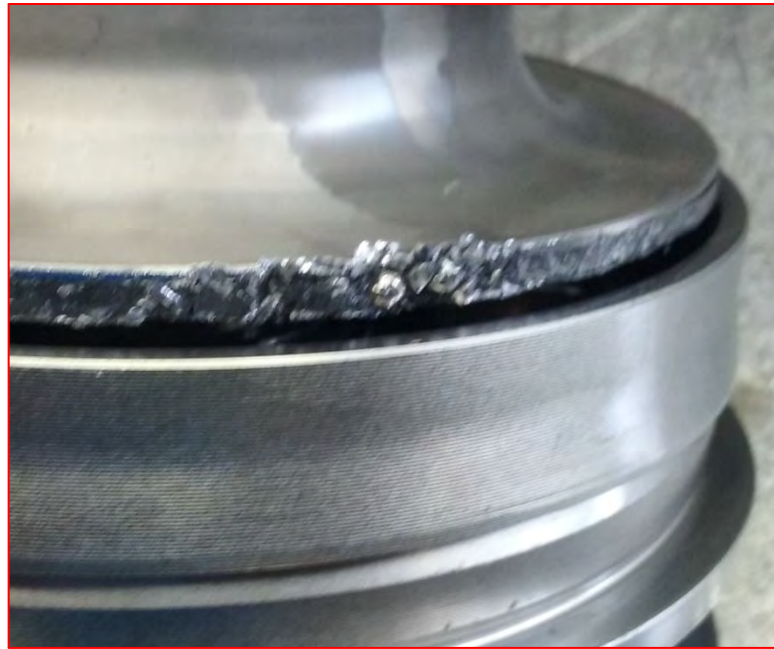
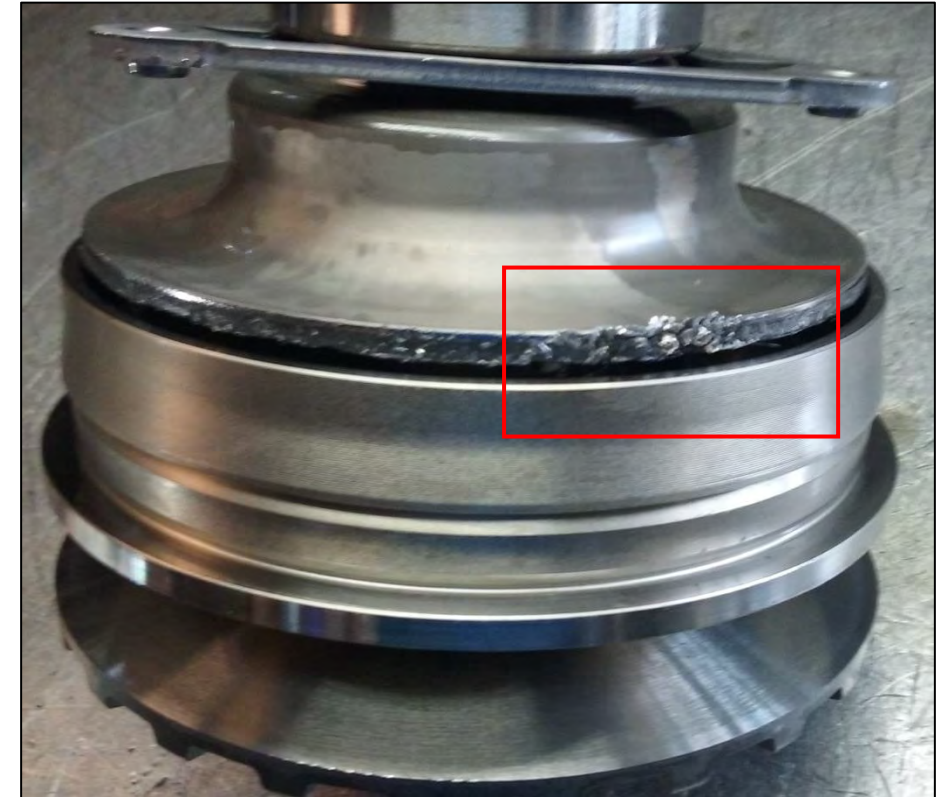
RE0F09B

Not only is there an issue with the bearings on the pulleys going bad completely there are times they will cause noise complaints.

There also times when the check balls on the pulley shafts go bad.

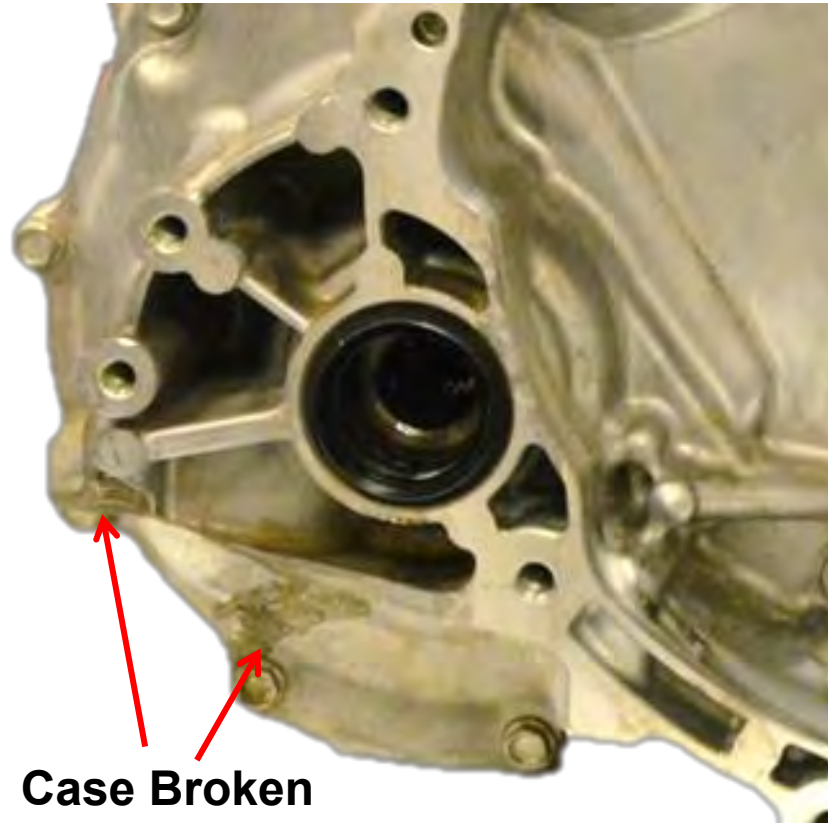
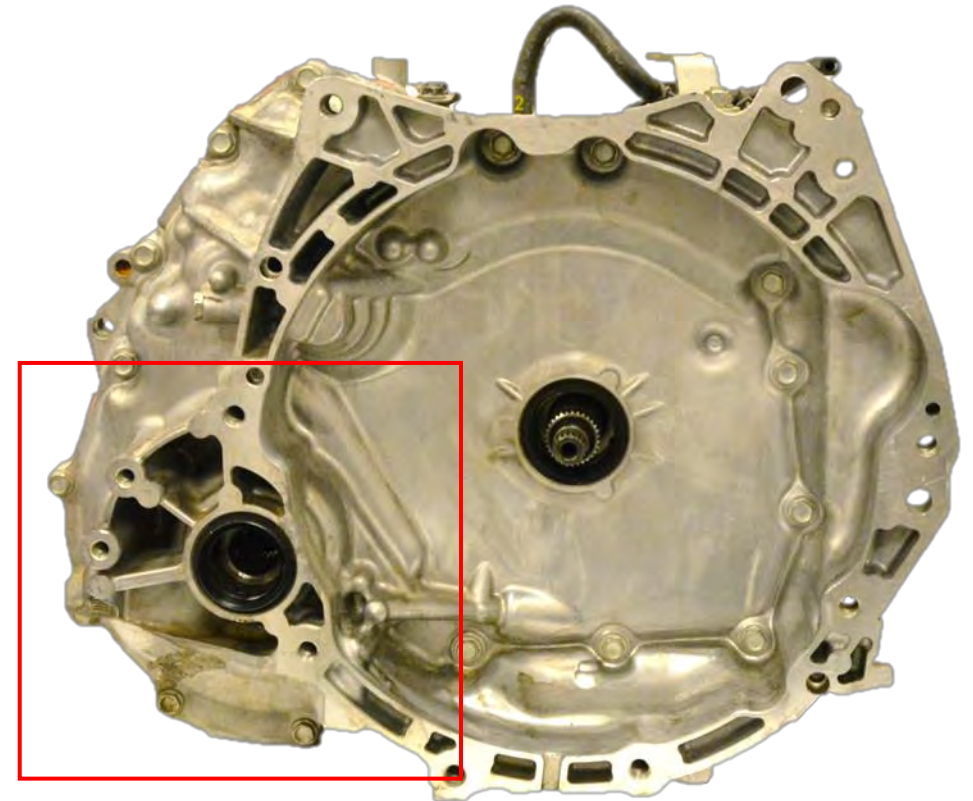
It is not unusual for a later model RE0F11A (JF015E) to arrive at your shop with the section of the case that mounts up to the vehicle to be broken.

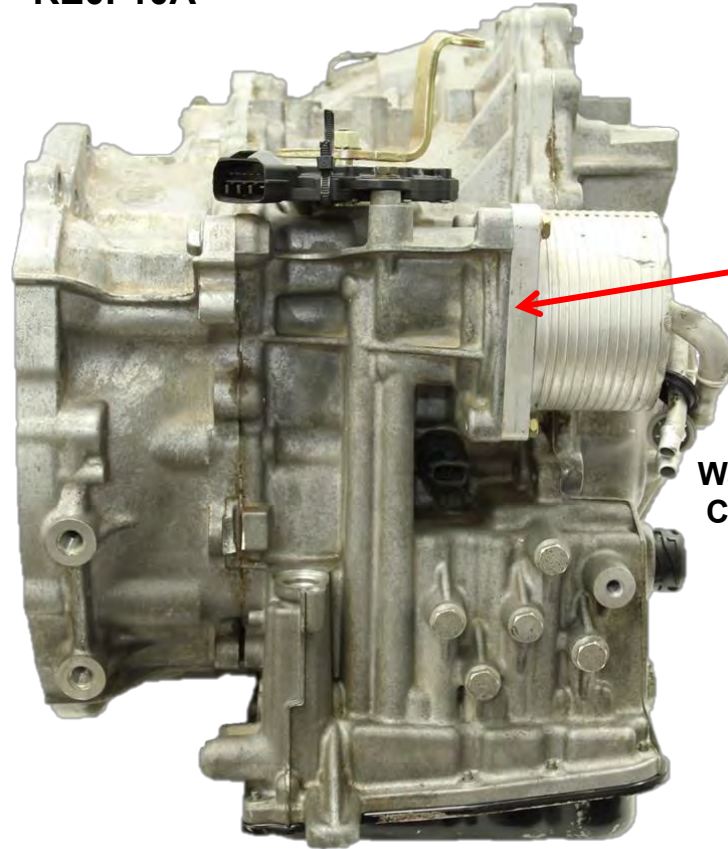
RE0F10A

P0218 Transmission Overheat is the most common complaint on the tech line. Caused by a restricted High Pressure Filter. Even if the filter looks new change it.

External Filter

Located Behind The Warmer/Cooler

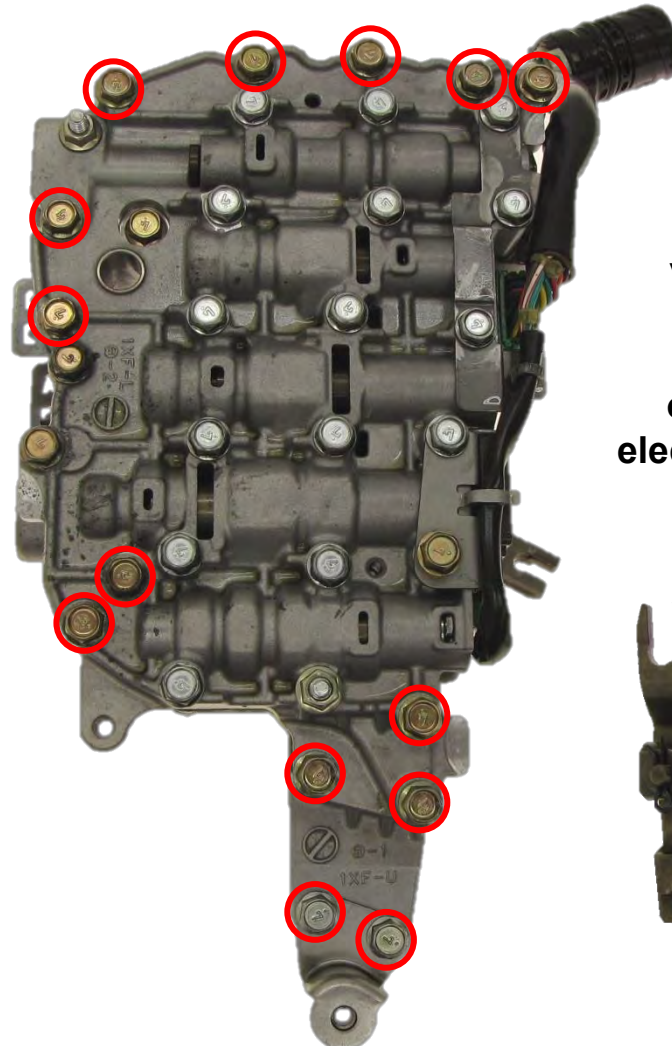
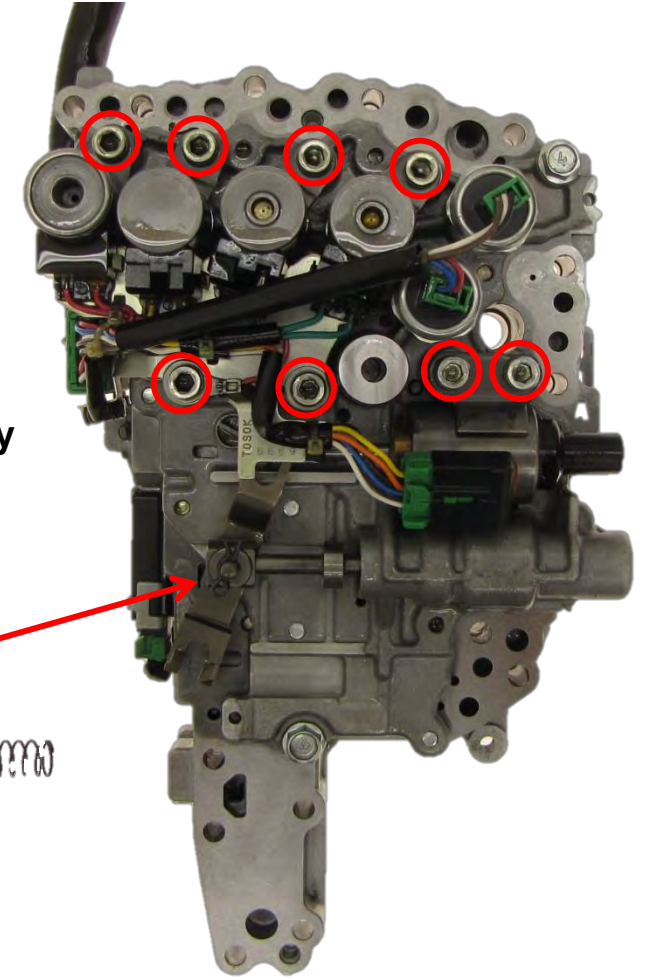
Remove the bolts circled on the left to remove the valve body from the case.

Remove the bolts circled on the right to remove the electronics from the valve body

Ratio Control Valve

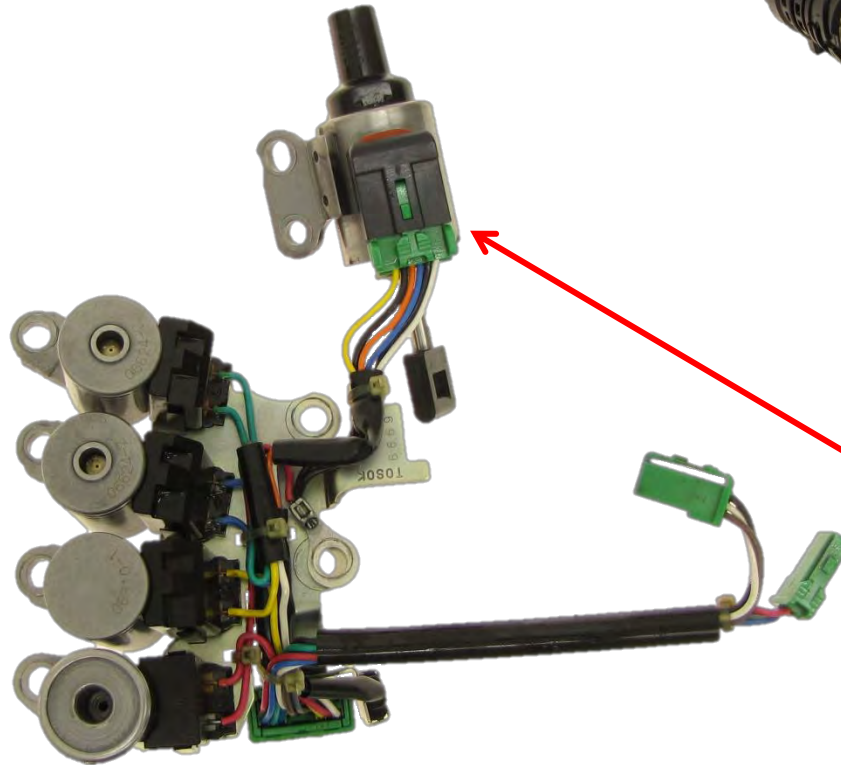
RE0F10A/B Valve Body Electronics

ROM

Solenoids

Ratio Control Motor

Internal Harness

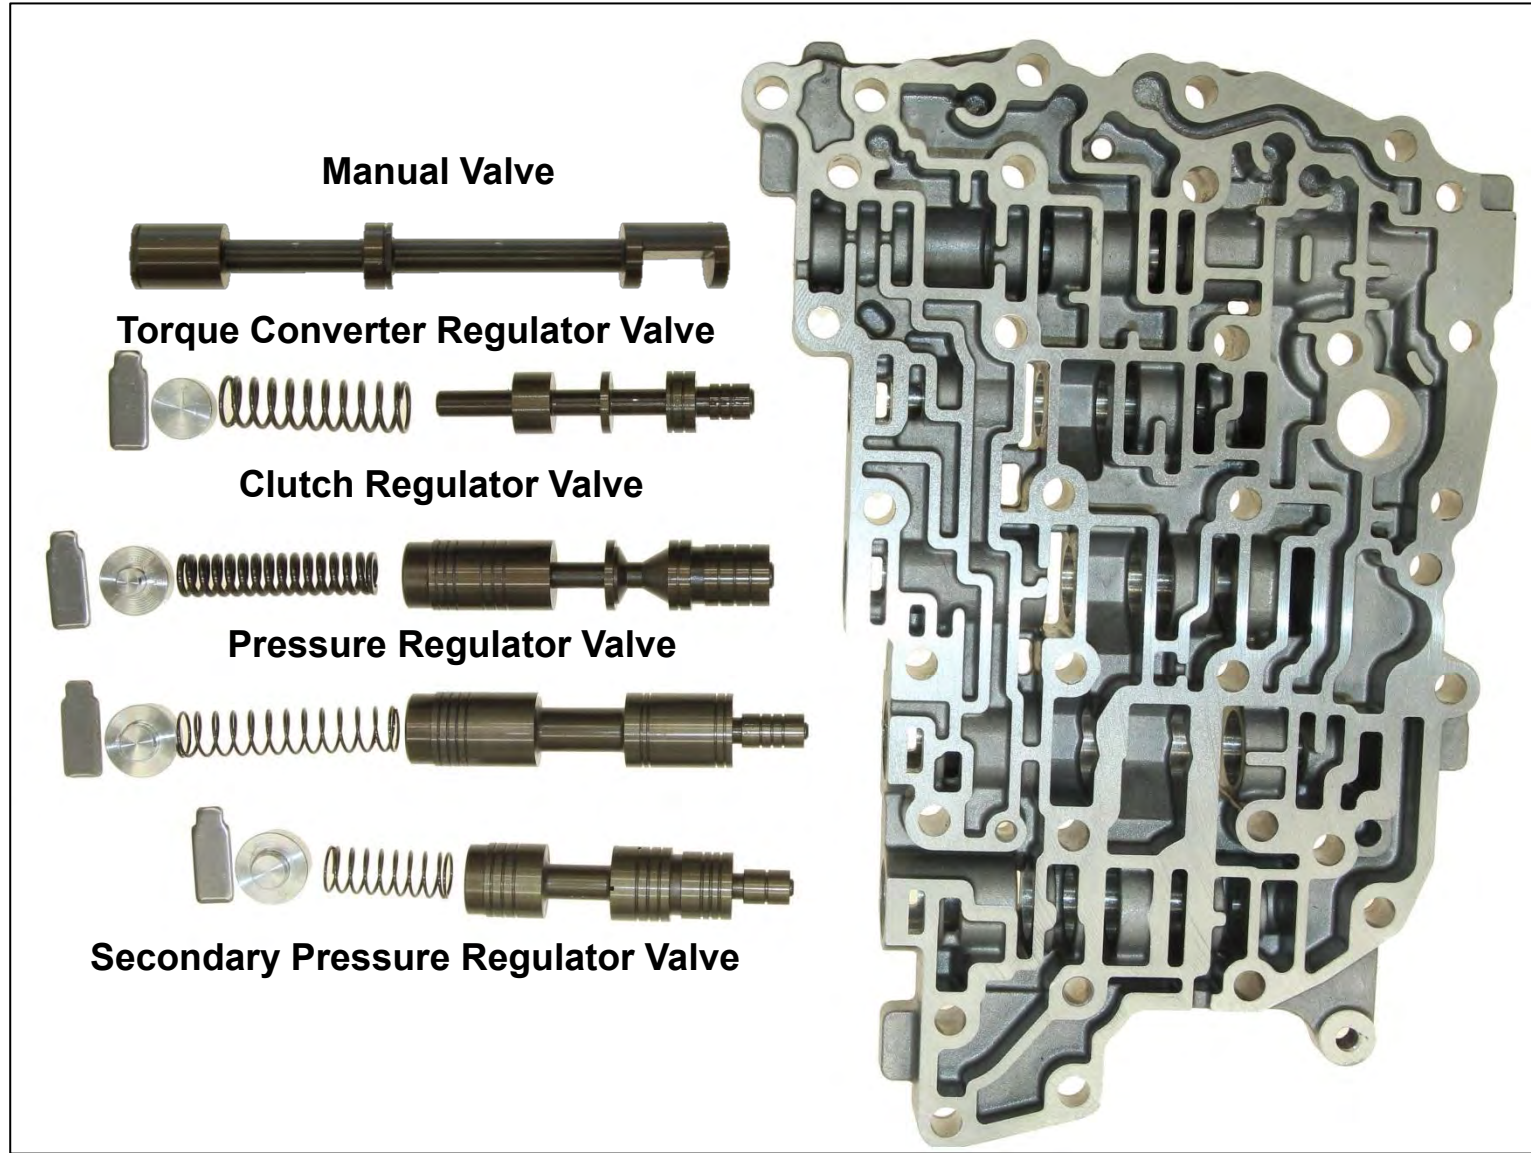
RE0F10A/B Upper Valve Body

Manual Valve

Torque Converter Regulator Valve

Clutch Regulator Valve

Pressure Regulator Valve

Secondary Pressure Regulator Valve

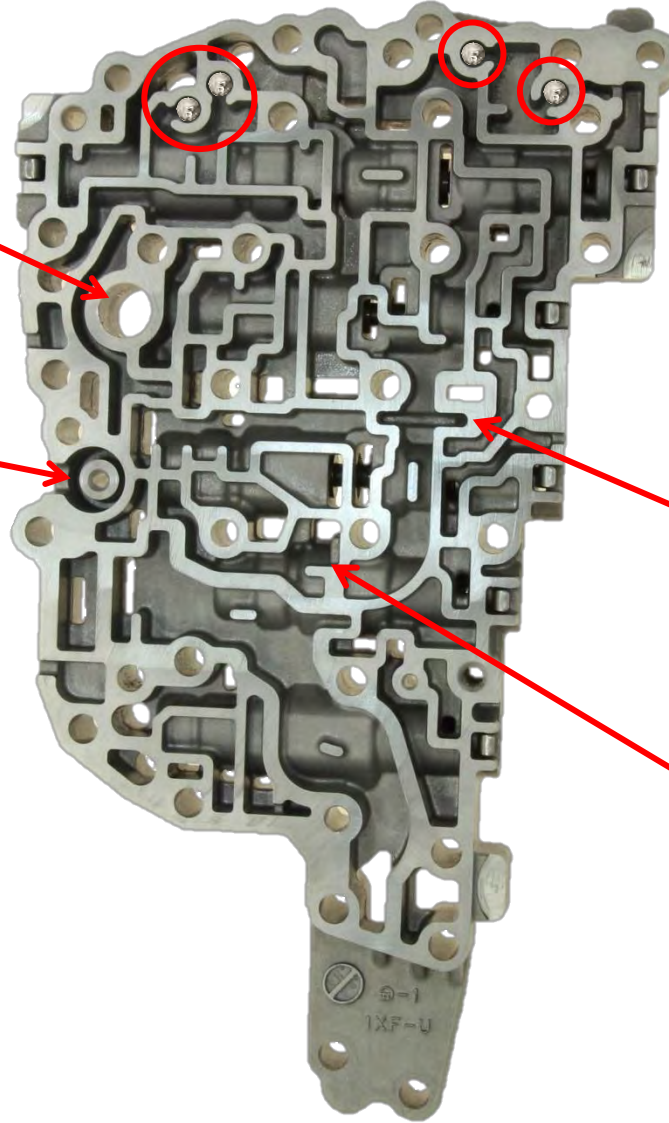
RE0F10A/B Lower Valve Body Small Parts

Lube Relief Valve

Spring First

Separator Plate Alignment Dowel

Check Balls (4)

Screen

Install As Shown

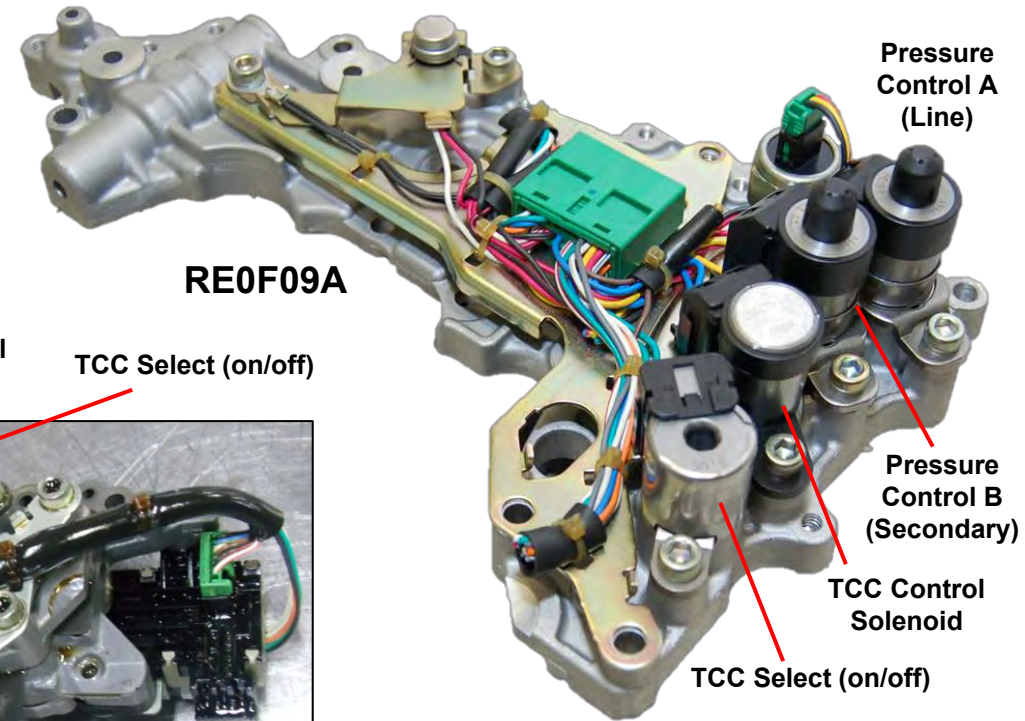
RE0F08A

The only major difference between these two valve bodies and solenoids is the Line Pressure Control A and B solenoids. The Flow rate is different on the solenoids and the valve body separator plate is designed for the difference in flow rate.

The TCC Select and the 2007 08A TCC the only On/Off type solenoids the others are Pulse Width Modulated.

Pressure Control A (Line) Pressure Control B (Secondary) TCC Control Solenoid TCC Select (on/off)

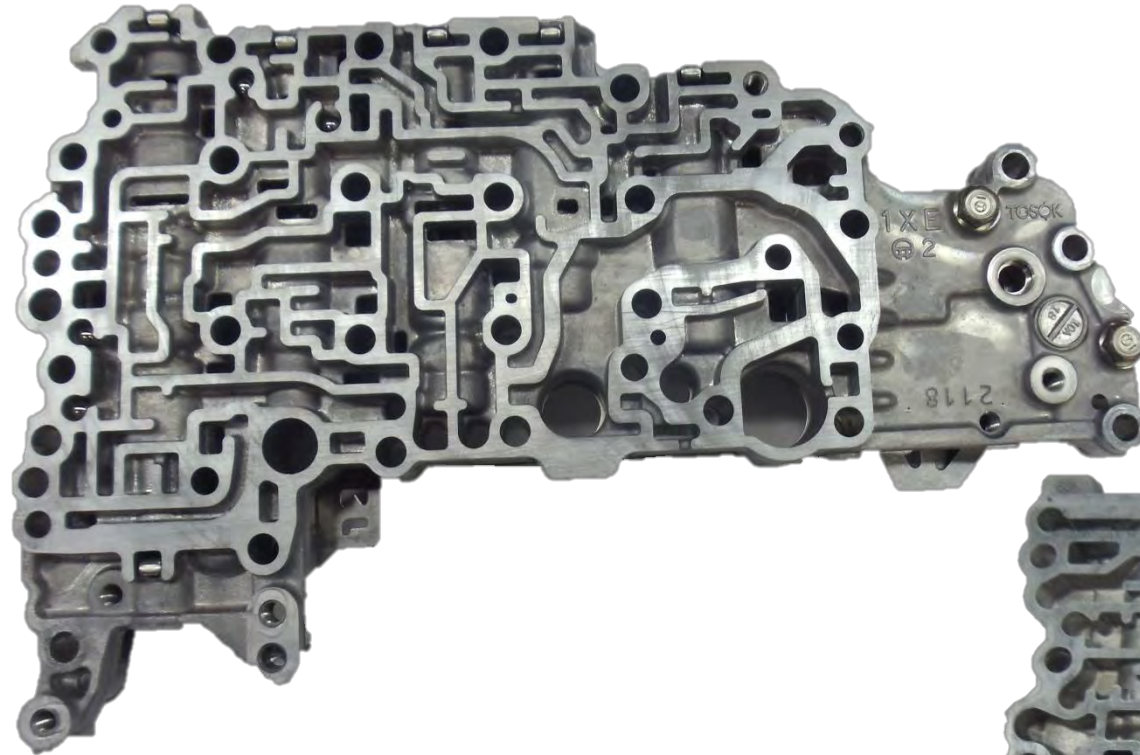
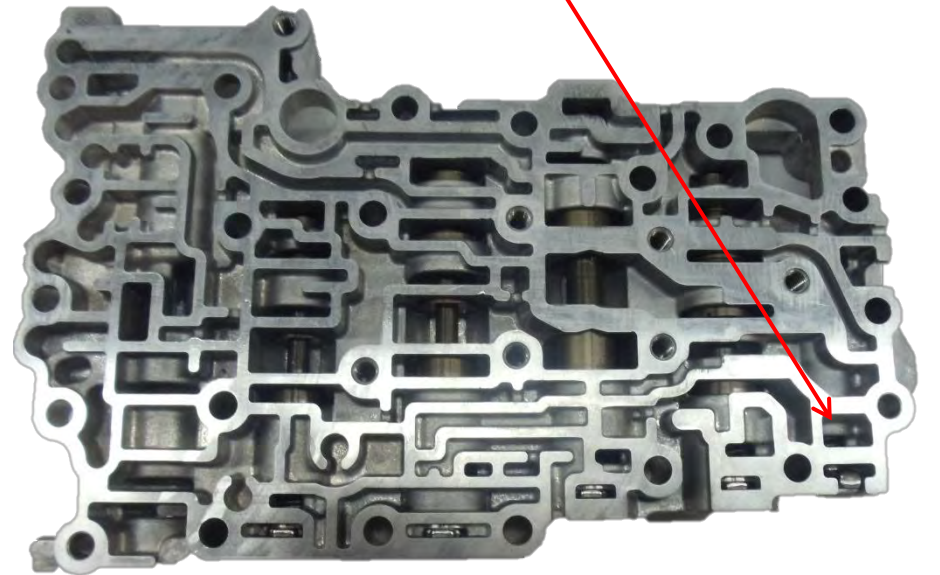
Although the configuration looks quite different the valve layout is almost the same as the RE0F10A/B series with the exception of one extra plug valve.

Plug Valve
