Nissan/Jatco CVT Internal

RE0F10D

Presented by:
Mike Souza
ATRA Senior
Research Technician

Nissan CVT Internal Webinar ©2016 ATRA. All Rights Reserved.

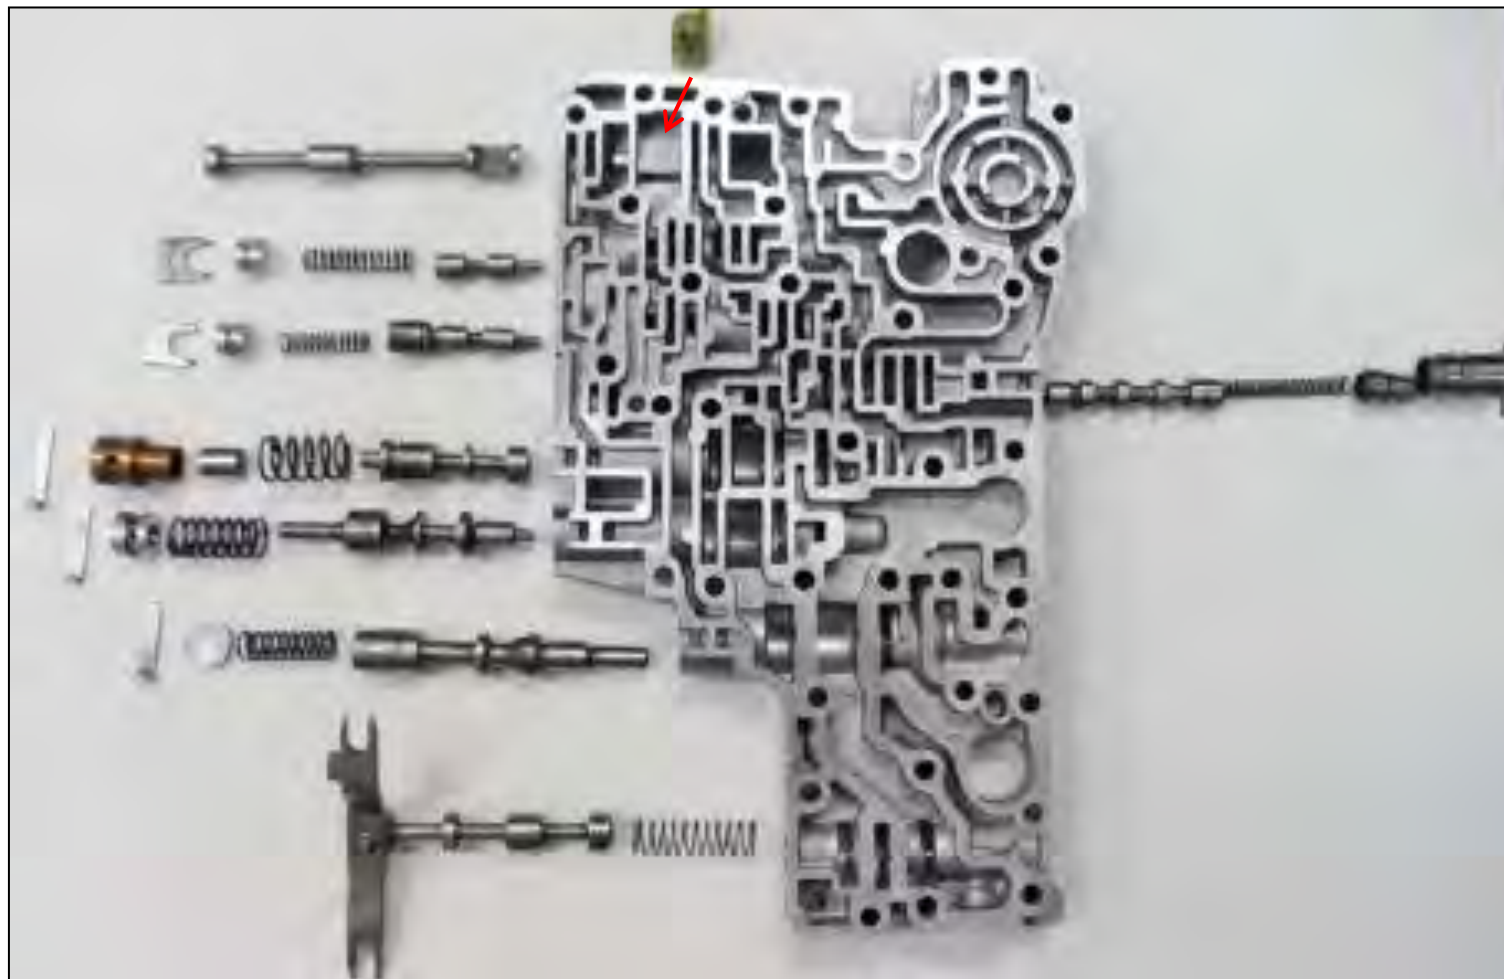
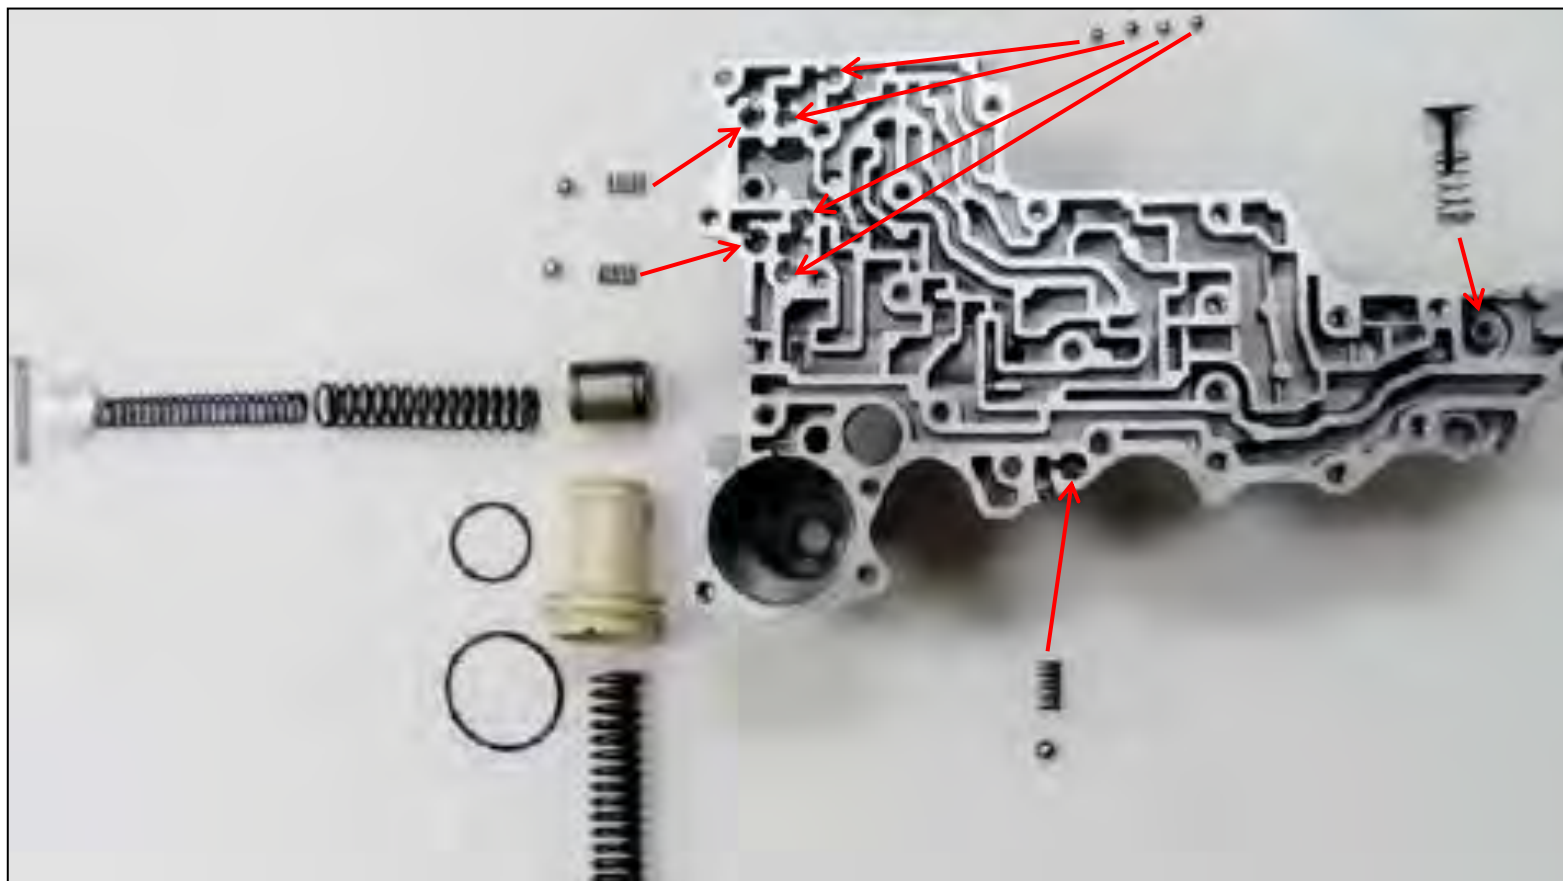
RE0F06A Valve Body

Earlier model RE0F06A units were not found in the U.S. market.

As you can see it's completely different than any of the others.

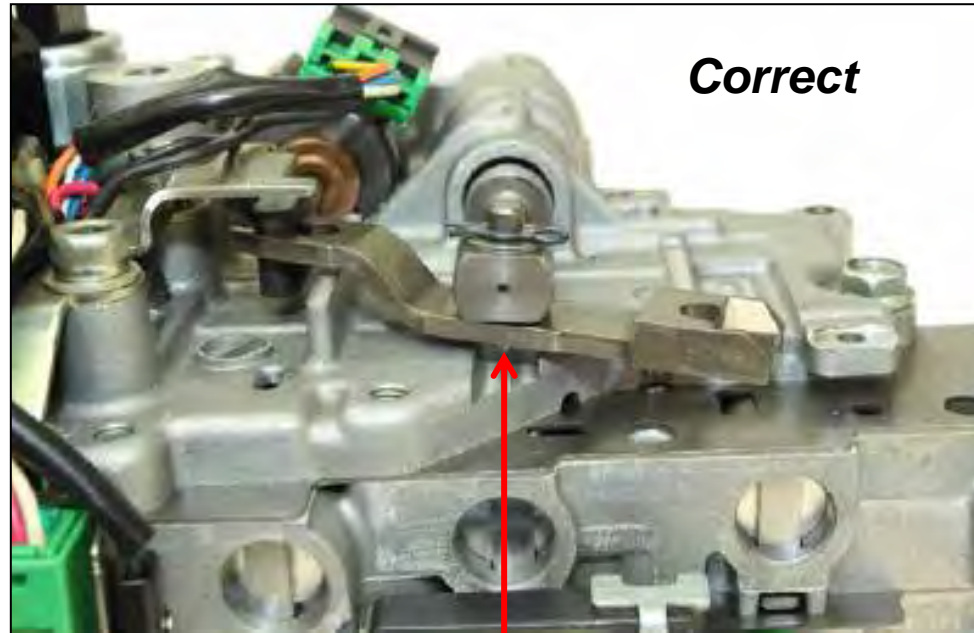
Installing a valve body with a ratio control motor onto the transmission. If not done correctly will cause a no ratio change (shifts) it may stay at a 1:1 ratio only.

First make sure the control arm is facing the correct way (left photo).

Correct

Arm Below The Shaft

Wrong

Arm Above The Shaft

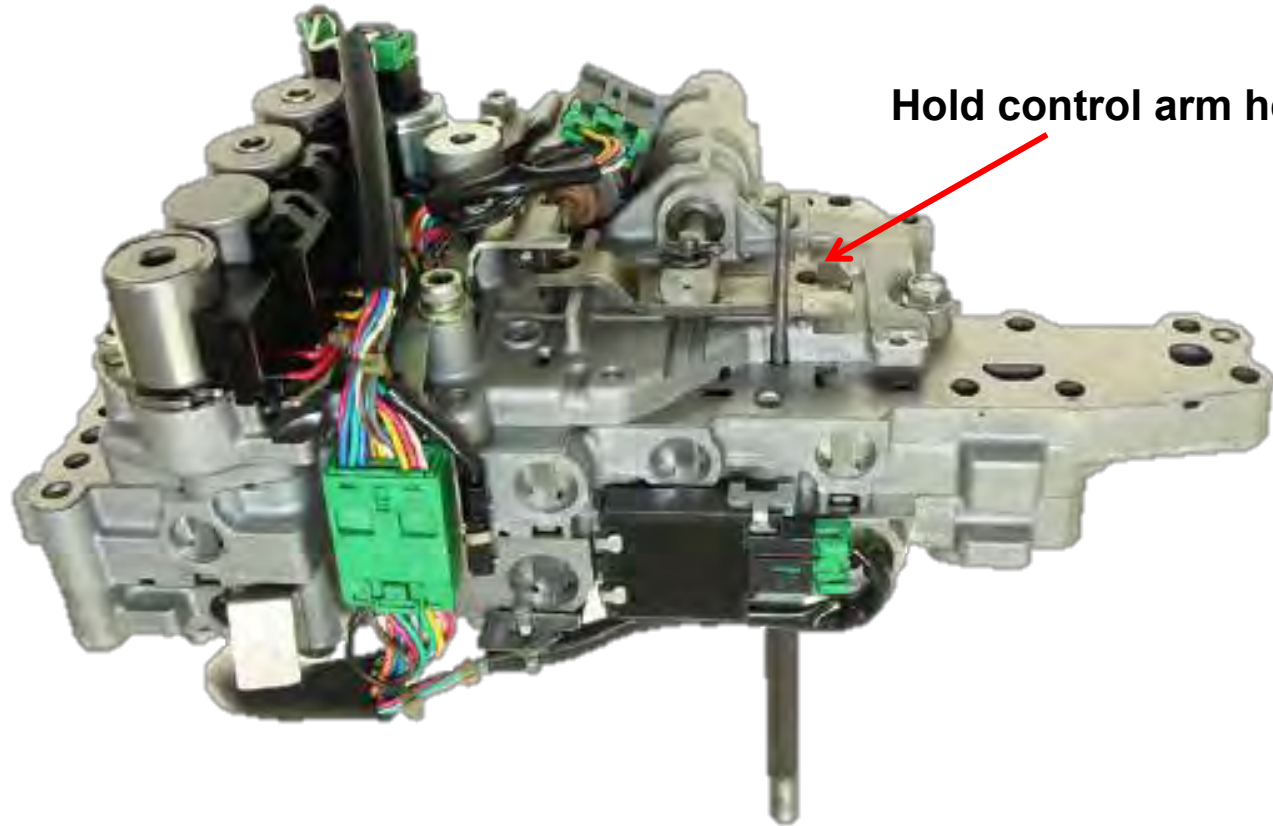
Then install a thin punch through the valve body to hold the control arm back against the valve body.

Hold control arm here

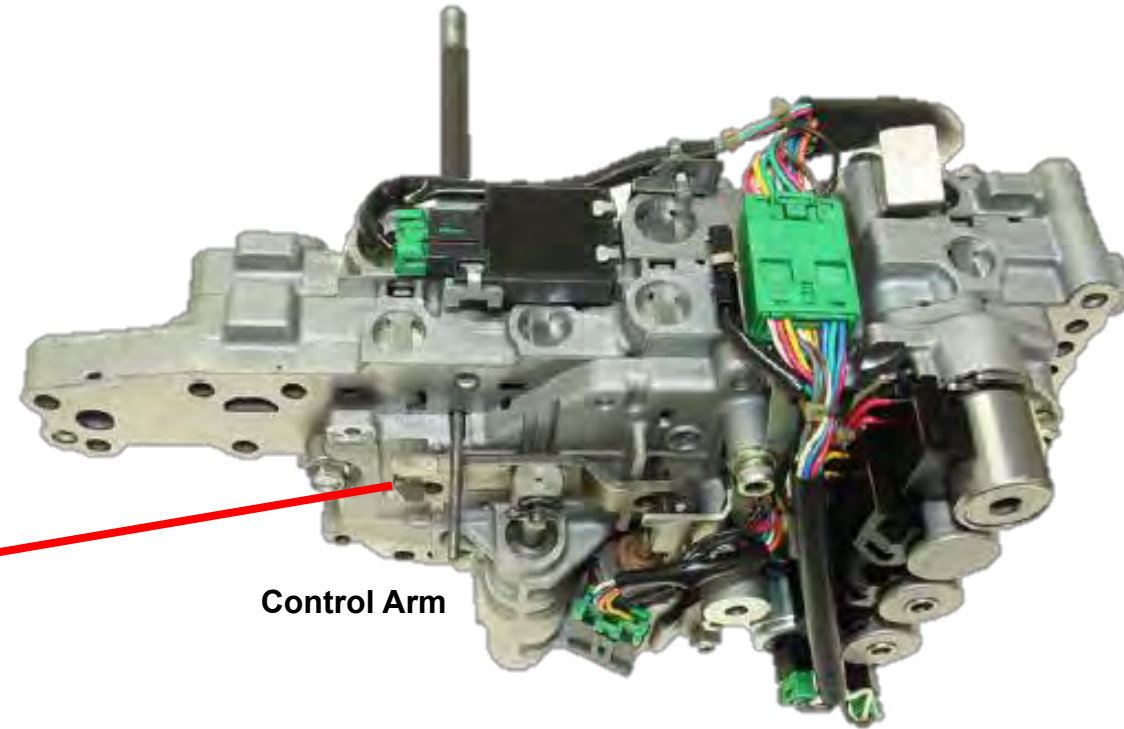
Now turn the valve body over and make sure the control arm aligns onto the pivot pin located in the case.

The pulley has to be turned until the pivot pin is moved all the way to the location shown below.

Turn Pulley Until Pivot Pin Is In This Location
