Transmission: 4L60-E

Subject: Code 72 diagnostics (1993-95 applications with a PCM)

Application: GM

Code 72 Diagnostics (1993-95 Applications with a PCM)

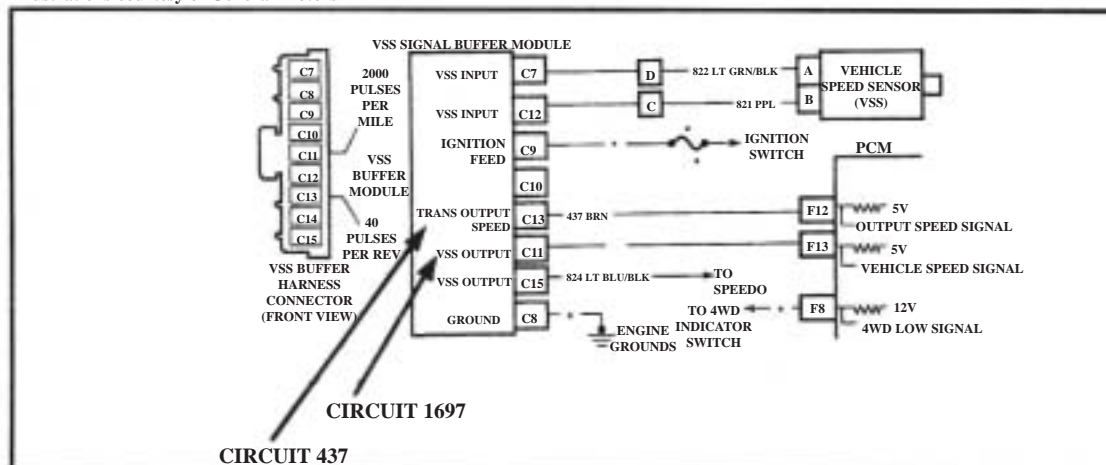
To perform these functions, the buffer is given a five volt signal from the vehicle's PCB on two circuits, 437 and 1697. Circuit 437 is used by the transmission shift points. Circuit 1697 is used by the PCB to determine road speed for uses such as vehicle overspeed fuel cutoff and idle air control valve position (Figure 1).

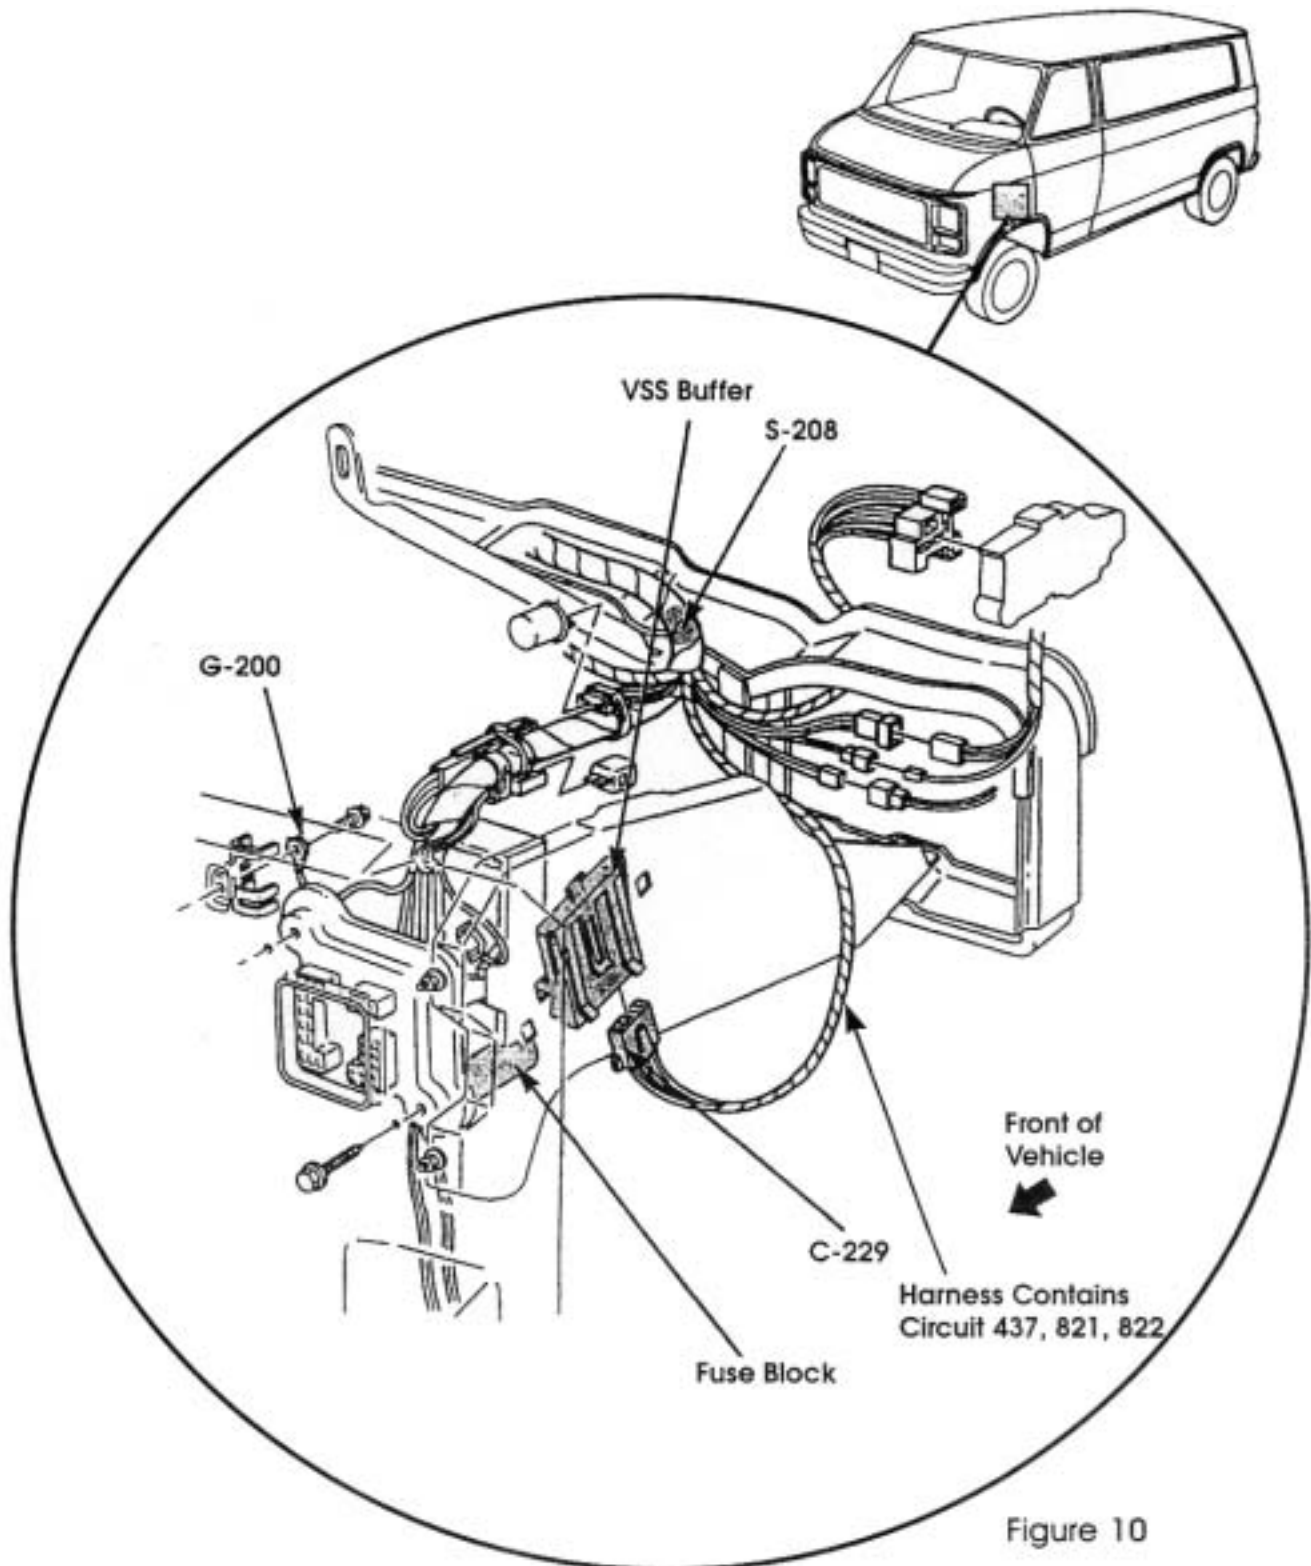
- Ground G-200 loose, not installed or corroded. G-200 is mounted under the driver's side of the instrument cluster next to the fuse block. It may be necessary to add an extra ground for this location. *Note: A poor ground for this circuit may also cause intermittent operation of other systems which rely on this ground for proper operation, such as the dome light and brake system circuits.*
