# ***ATRA Diagnostic Procedures***

## Technical Bulletin # 1150

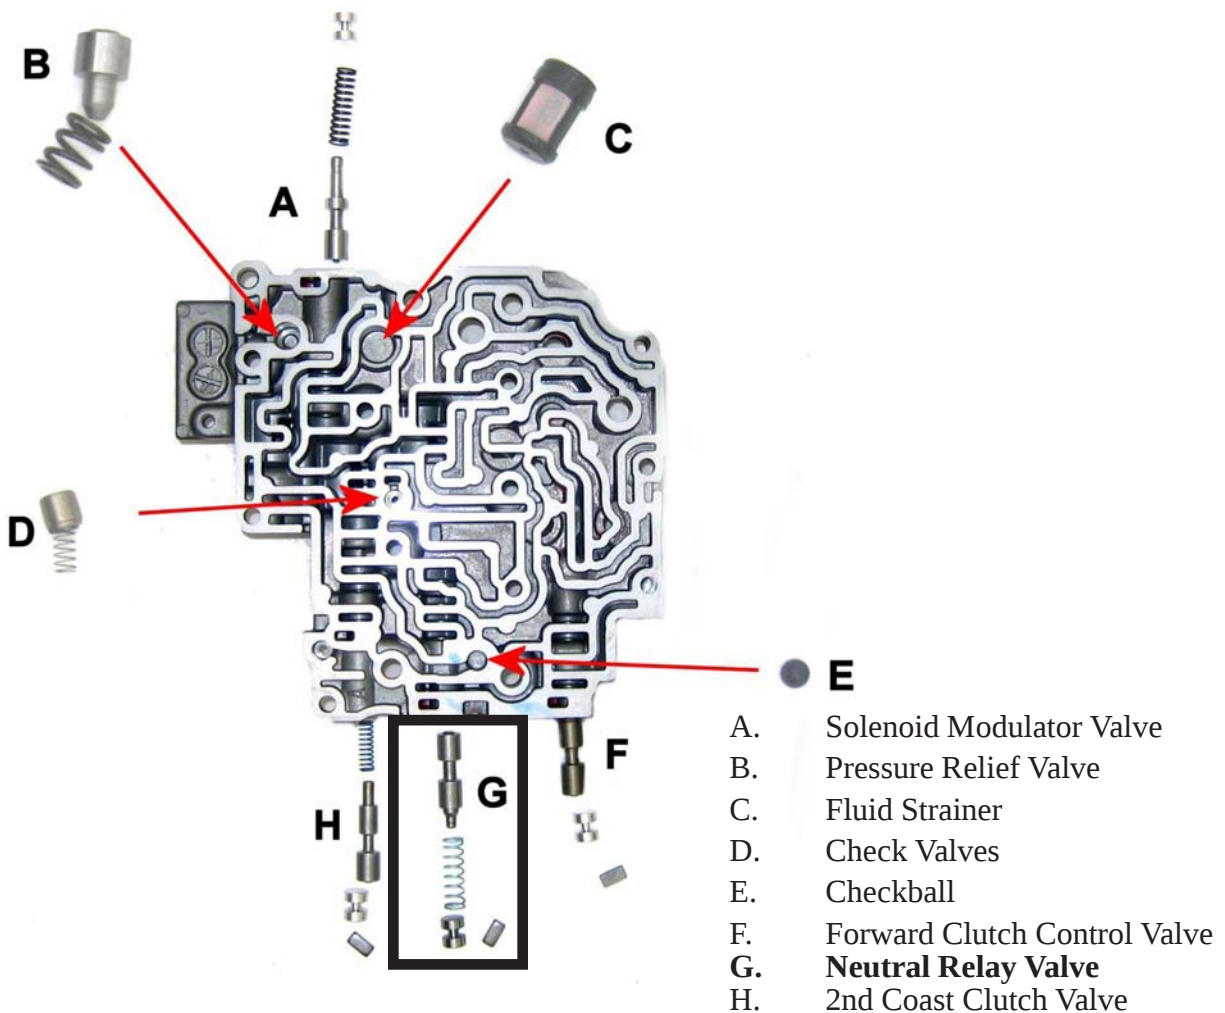
Some Saturn and Volvo models with the AW55-50 or AF23/33-5 transmission may have a delay when engaging forward. Make sure there are no internal problems and the computer has had the latest software update (if available). If no other problems are found, install a 50 % stronger spring in the Neutral Relay Valve. Use the exploded view of the valve body to identify the spring.

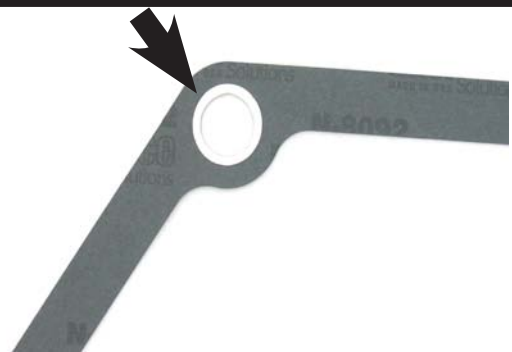
Codes relating to mode switch circuit problems or encoder/motor circuit problems are the most common codes to be set. If the transfer case has been previously removed, this condition may be caused by “not” replacing the transfer case to transmission case gasket. Ford is using a special gasket with a metal ring built into the gasket.

The purpose of this metal ring is to allow the transfer case housing to ground through the transmission case.

The purpose of this metal ring is to allow the transfer case housing to ground through the transmission case. The bolts that attach the transfer case to the transmission are coated with a special anti-corroding coating and do not allow for a good ground. Installing an early paper gasket or adding silicone to the mating surfaces will interfere with the transfer case grounding through the transmission case. Ford recommends replacing this gasket every time the transfer case is removed. The Ford part # is 4L2Z-7086-AA

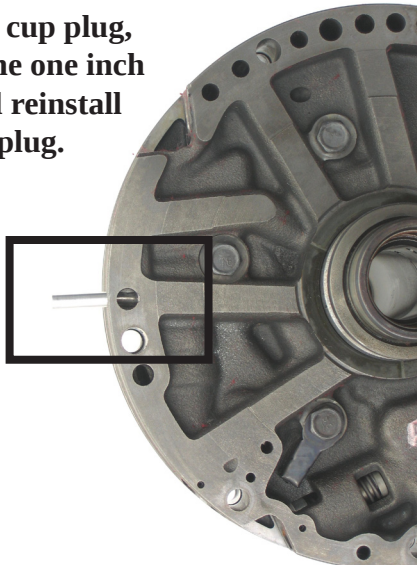
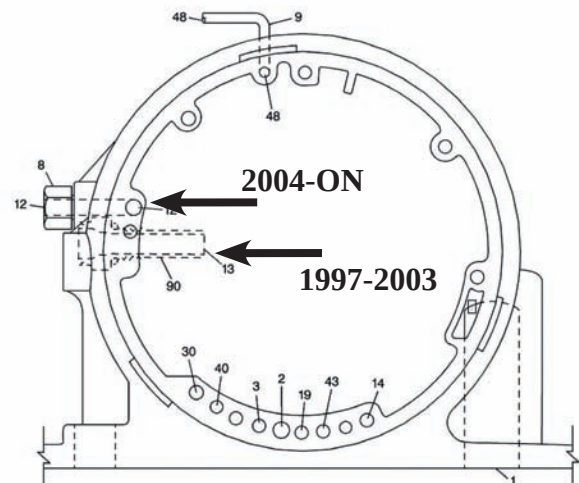
This is a simple plug kit. Remove cup plug, install the one inch slug and reinstall the cup plug. If a kit is not available from your parts supplier you can make your own. The size of this slug is one inch long and .247" in diameter, (1 x .247)

**Remove cup plug,  
install the one inch  
slug and reinstall  
the cup plug.**

**1997-2003 pumps are  
interchangeable if  
you use GM Plug Kit  
#24232339**

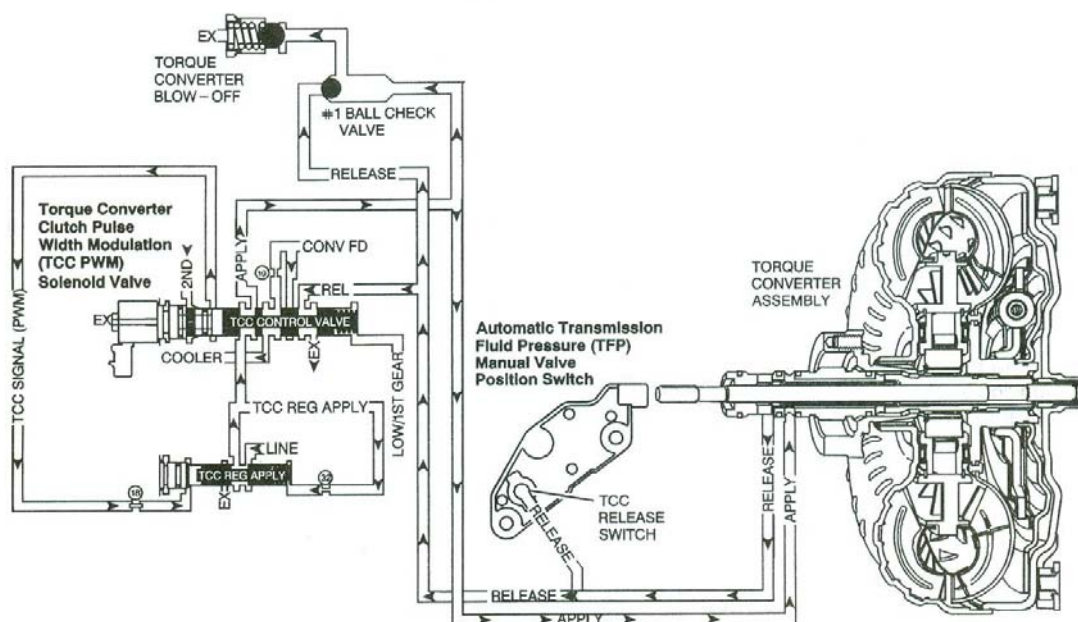
Anytime lock up is disengaged, the switch will be in the open position and “TCC release” PID on your scanner will display “on” with the release oil against the switch contact. When the TCC release oil is exhausted, (Lock Up) the switch moves to the closed position as the release oil is exhausted and “TCC release” on your scanner will display “off”. It is common for a switch to fail in the closed position and trick the computer into thinking that the release oil is exhausted and that lock up is stuck on. The PCM strategy for this code is to ground the TCC solenoid which results in lock up on top of second gear and freeze the adaptive strategies.

1. When the code is set and TCC is engaged in second gear, clear the codes with your scanner. If TCC releases and works again until the code sets, the PSM is faulty.
2. Find the functional test section in your scanner. While driving engage and disengage lock up with the scanner. If TCC responds correctly to the scanner commands, you have tested the entire electrical and mechanical parts of lock up. Replace PSM.
3. Unplug the transmission. Run the engine and put the shifter in drive. If the engine stalls replace the solenoid.

**Always check for damage  
at the pressure switch**

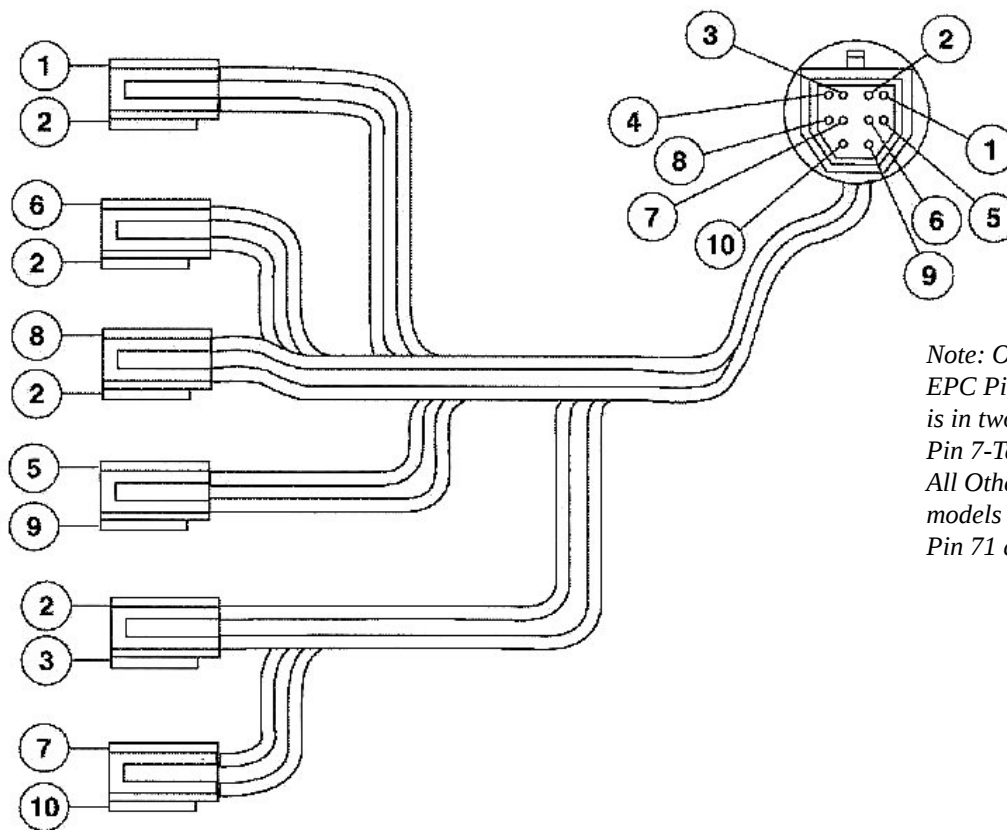
# Technical Bulletin # 1196

It is important to note that the power pins for the TCC solenoid is in two different locations depending on the year of the vehicle being worked on. Improper hookup can cause issues like TCC cycling on when in drive.

The EPC and the TCC share a Power Source Pin# 7

*Note: On 2004-on vehicles, the EPC Pin at the EEC-V module is in two different locations: Pin 7-Taurus/Sable and Pin 71- All Other Models! On earlier models (2000-2003 all) it is at Pin 71 at the EEC-V module.*

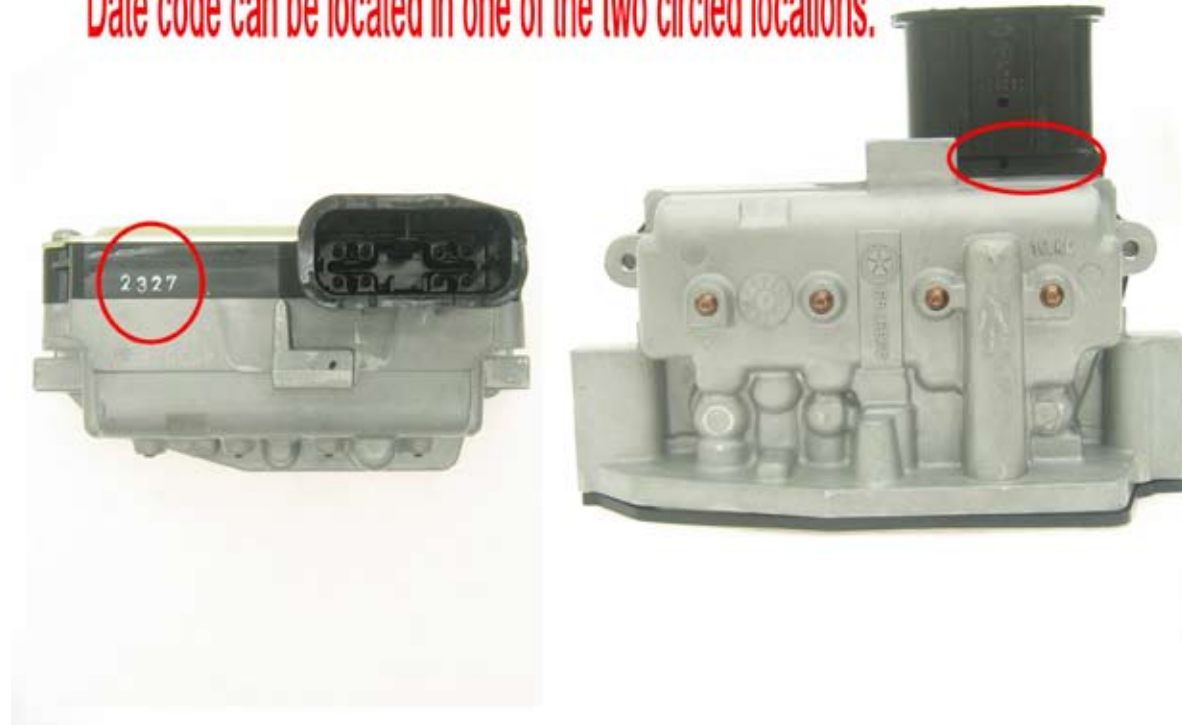
If you're working with 42LE transaxle with this code, look at the four digit manufacturing code on the solenoid pack. (Figure 3) The first three digits are the day of the year and the fourth digit is the year. (3001 would be the 300th day of 2001) If the code falls between 3001 and 0603, replace the solenoid pack before the valve body to repair code. Even if the year vehicle does not fall within these dates, the solenoid pack could have been replaced with the effected years previously.

Date code can be located in one of the two circled locations.

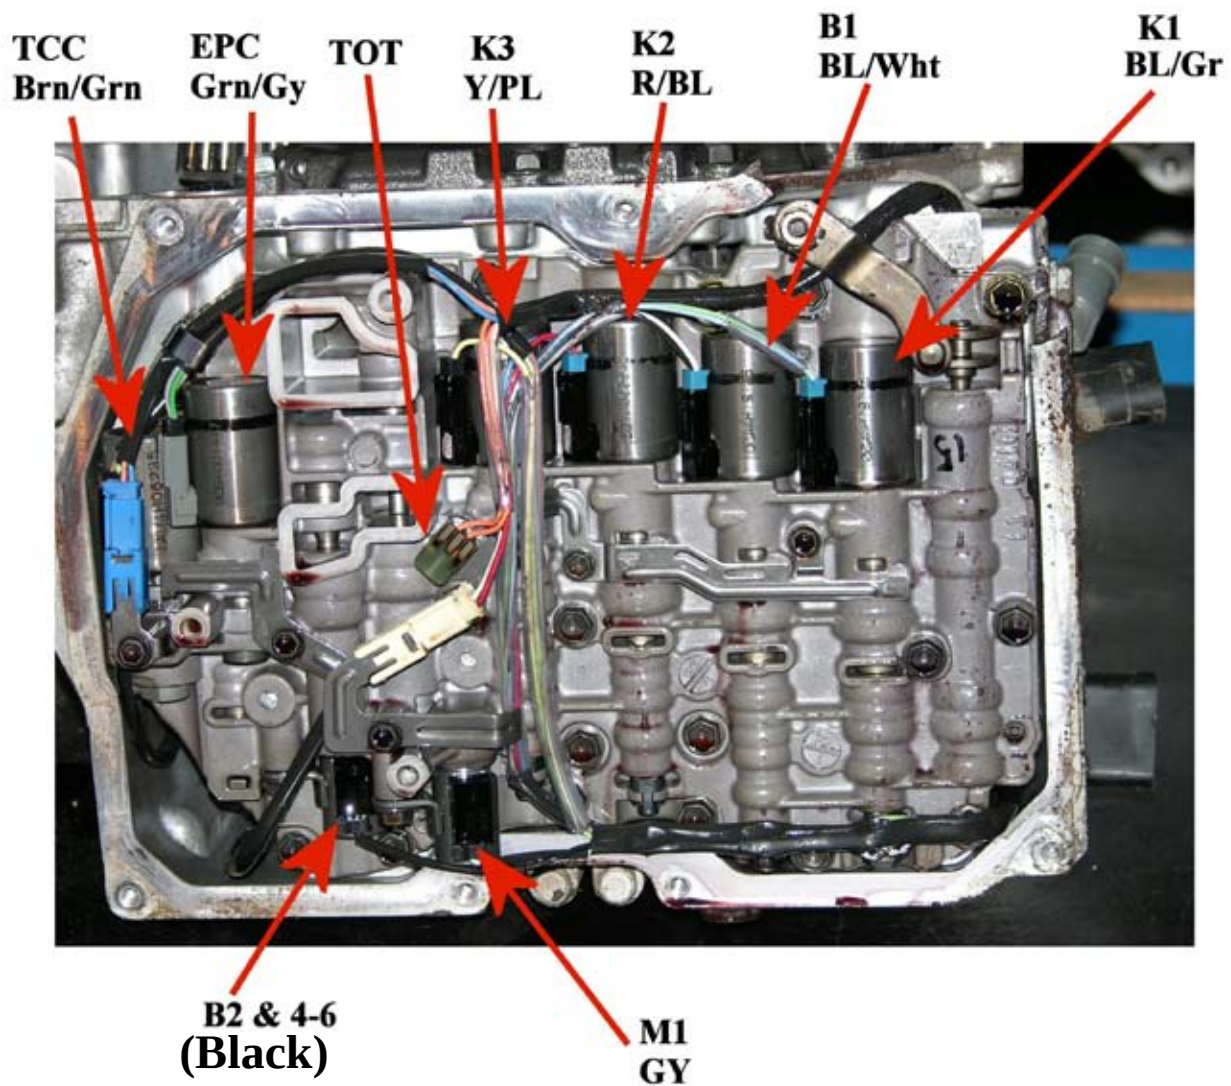
Some 2004 and later VW models with the 09G 6-speed transmission may Neutral during a 3-4 upshift. This problem may occur after rebuild or solenoid service. The reason for this is that the M1 (N88) and B2/4-6 (N89) solenoid wires are reversed. The Light Gray wire goes to the M1 and the BLACK wire goes to the B2/4-6 solenoid. Always mark the solenoids harness or take a picture to insure the harnesses go to the correct solenoid connectors.

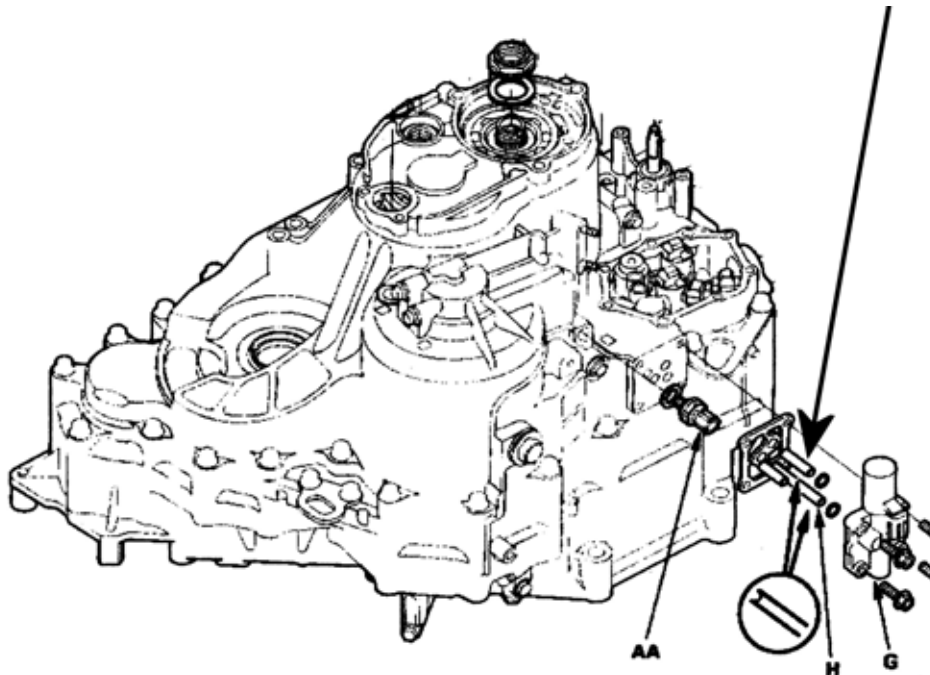
**Always remove these 3 pipes before splitting the case halves**

Remove CPC C feed tubes prior to case separation to prevent feed tube damage. These tubes fit into the valve body inside the case. If the pipes are damaged they are available from the Acura dealer.

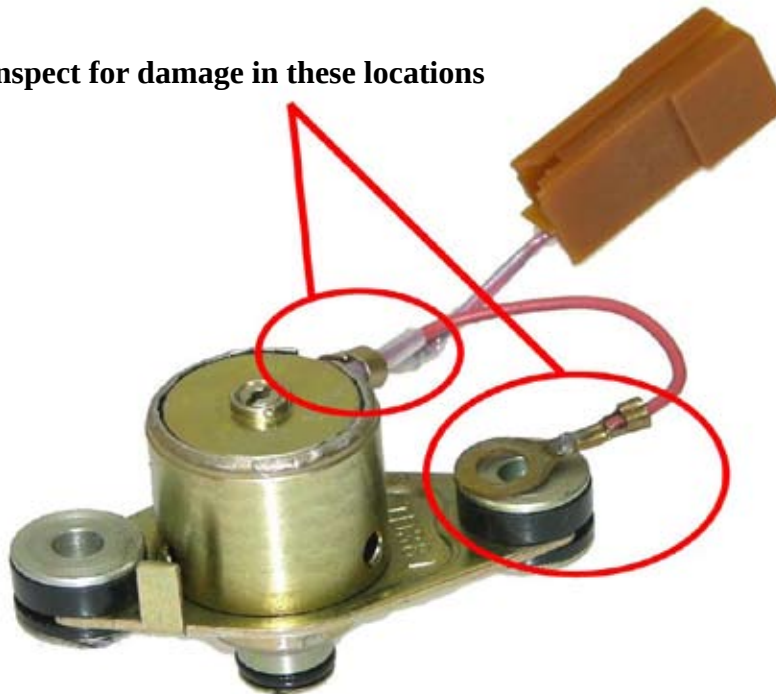
**Inspect for damage in these locations**

This usually causes high pressure and may have a harsh engagement and or harsh shifts. If either concern is present, remove the transmission oil pan. Inspect the line pressure control solenoid for loose wiring, faulty solenoid ground or replace the line pressure control solenoid (Nissan universal part no. 31940-41X01).

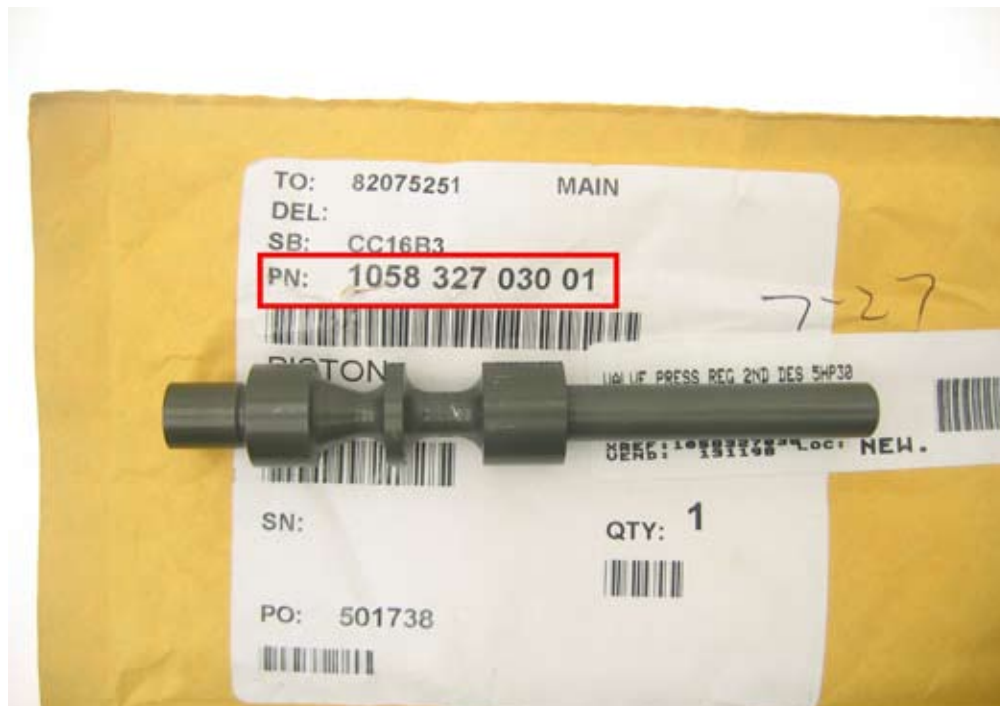
Some vehicles equipped with the ZF5HP24 transmission may have a condition of low or high pressure operation. A revised pressure regulator valve is available to correct this.

This valve should also be updated to the new design pressure regulator valve during an overhaul or any valve body repair. The revised pressure regulator valve part is available under Transtar part no. 55976T. This part no. is the same as the original design. The revised valve is the only one that is available.

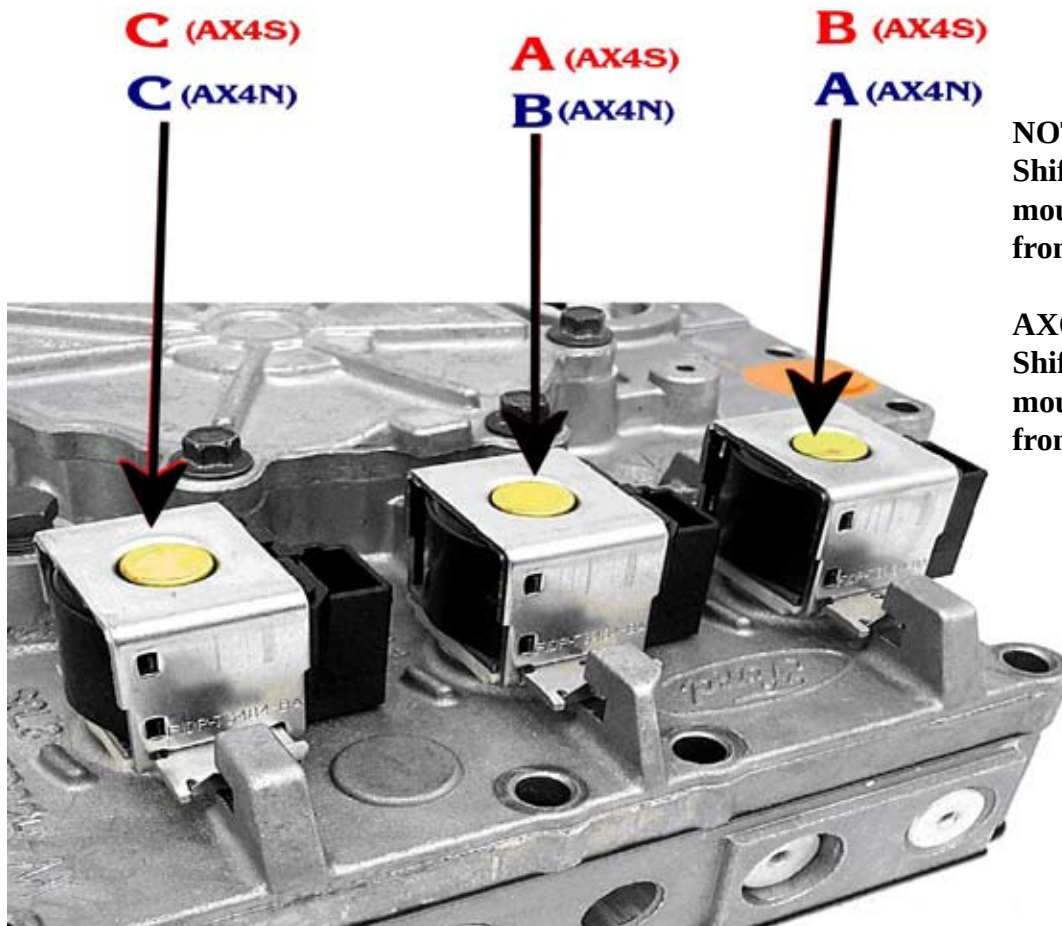
After overhaul some FWD Ford vehicles with the 4-speed A/T may develop erratic shifts, some of these concerns include, Neutrals during upshifts, binds, and shift cycling. There may be no codes present. If a shifter box is available, see if the transmission still has a shifting concern. If not, suspect inputs signals to the PCM, such as TR, VSS, TPS, MAF or ground problems affecting the PCM commands.

If the shift concern is still present, an incorrect internal harness may be the cause. Please note the following information to ensure the solenoids are connected to the correct harness.

**NOTE: AX4N/4F50N**  
Shift Solenoids are mounted A, B, C from top to bottom

**AXODE/AX4S**  
Shift Solenoids are mounted B, A, C from top to bottom

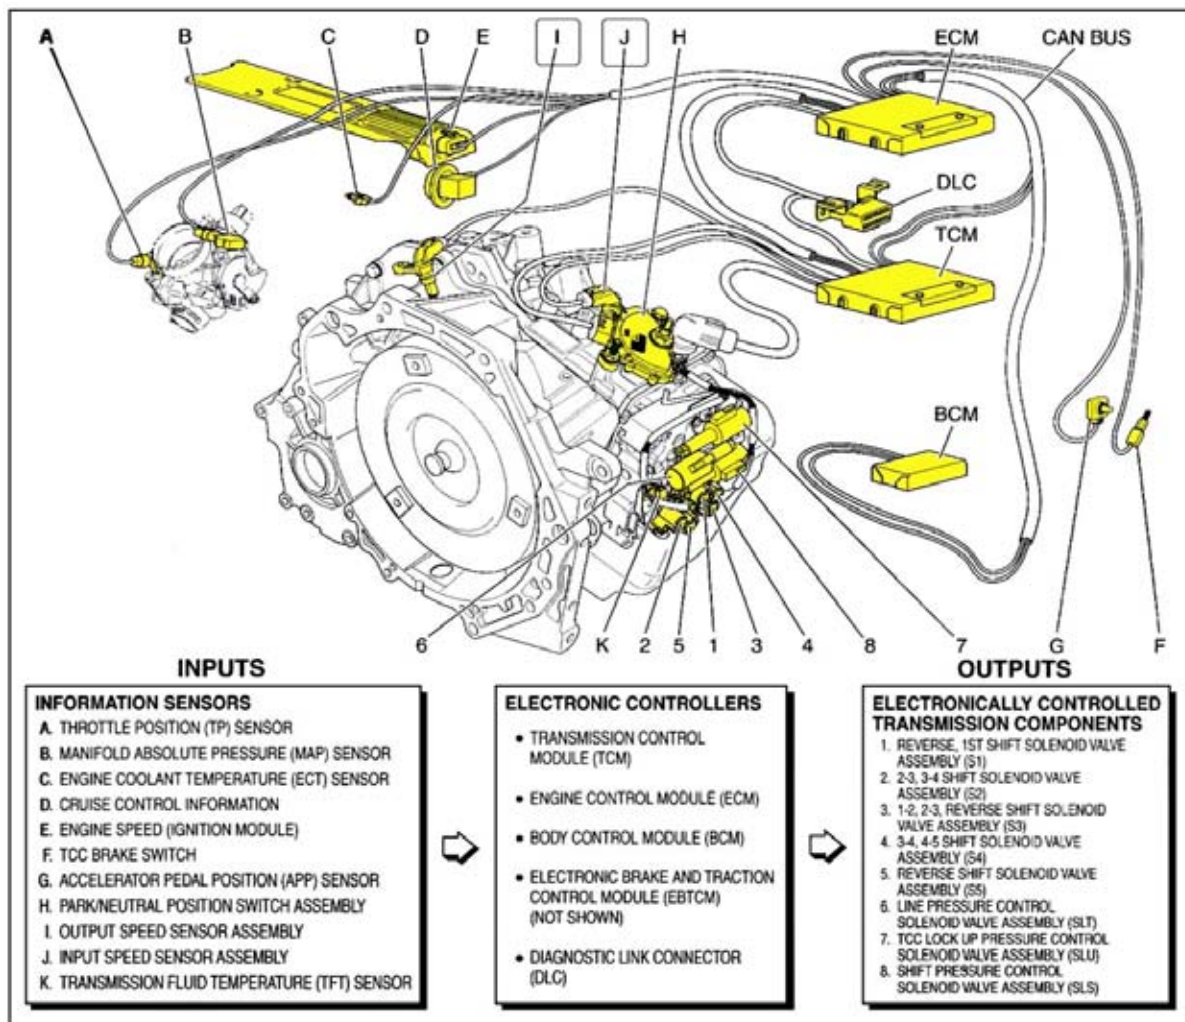
It is important to note that the speed sensor wires “can be installed incorrectly” after any repair when the transaxle has been removed. If the wires are crossed the complaint will be: Shifting to Reverse from Park there is no engagement (neutral) - shifting from Drive to Reverse, the reverse engagement will be fine. When using a scan tool you will also note that while standing still in park that the output speed sensor will be producing a signal. The wire harness plug ends are identical.

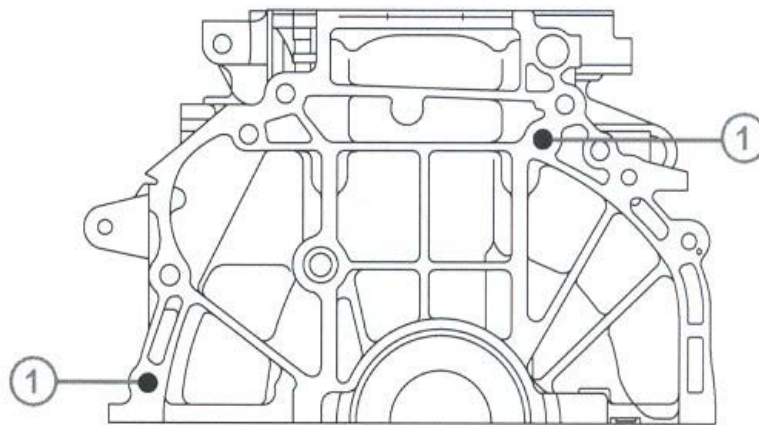
## Broken Case, Transmission Failure

Missing, Damaged, or Worn alignment pins may result in incorrect alignment and failure of the Transmission/transaxle assembly.

Toyota Part Numbers:  
90250-10113

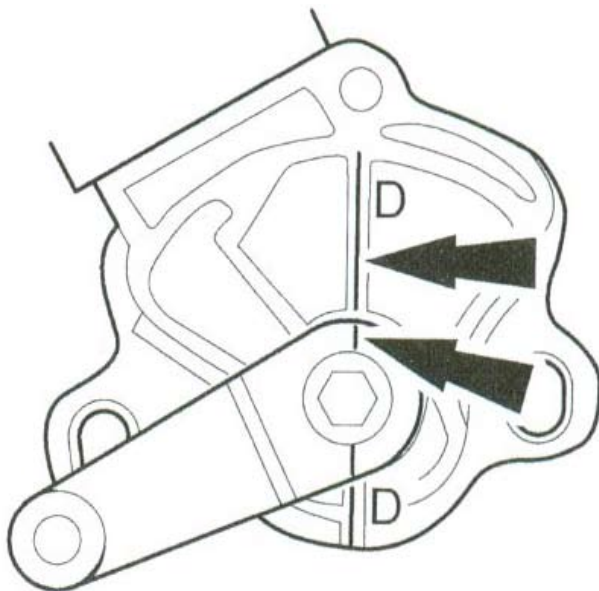
Some Ford and Mazda vehicles with the 4F27E transaxle may not shift correctly after overhaul or service. This may be caused by a miss adjusted shifter cable. Use the following information to locate the shift cable in the correct location.

1. Make sure the transaxle shift lever and park/neutral switch are aligned in the Drive range.

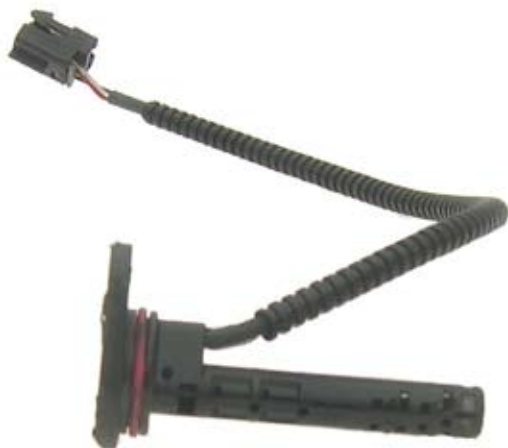
**OSS is located  
on the end cover**

1. If any DTCs related to OSS or TSS are present, check the transaxle build date
  - a. If the build date is before 10/21/2007 go to Step 2.
  - b. If vehicle transaxle is built on or after 10/21/2007 follow normal Diagnosis and Testing.
2. The TSS sensor is located in the end cover assembly. The OSS sensor is located inside the transaxle under the valve body. Both sensor connectors are plugged into the solenoid body. Both sensor connectors look the same but are wired differently.

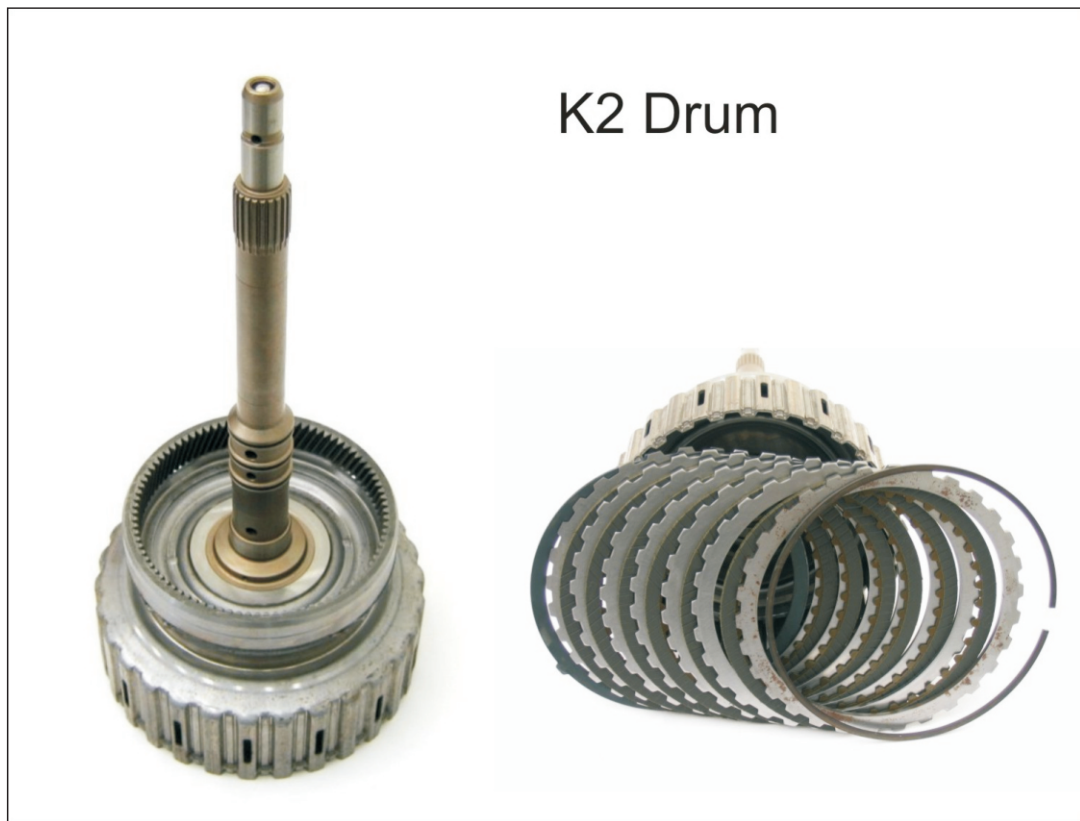
Figure 1

A drag or bind during a 2-3 shift or no 2-3 and then failsafe after rebuild. Upon disassembly of the transmission it is discovered that the K2 clutch shown in figure 1 has cut through the rear planet hub in figure 2 (shown on page 2).

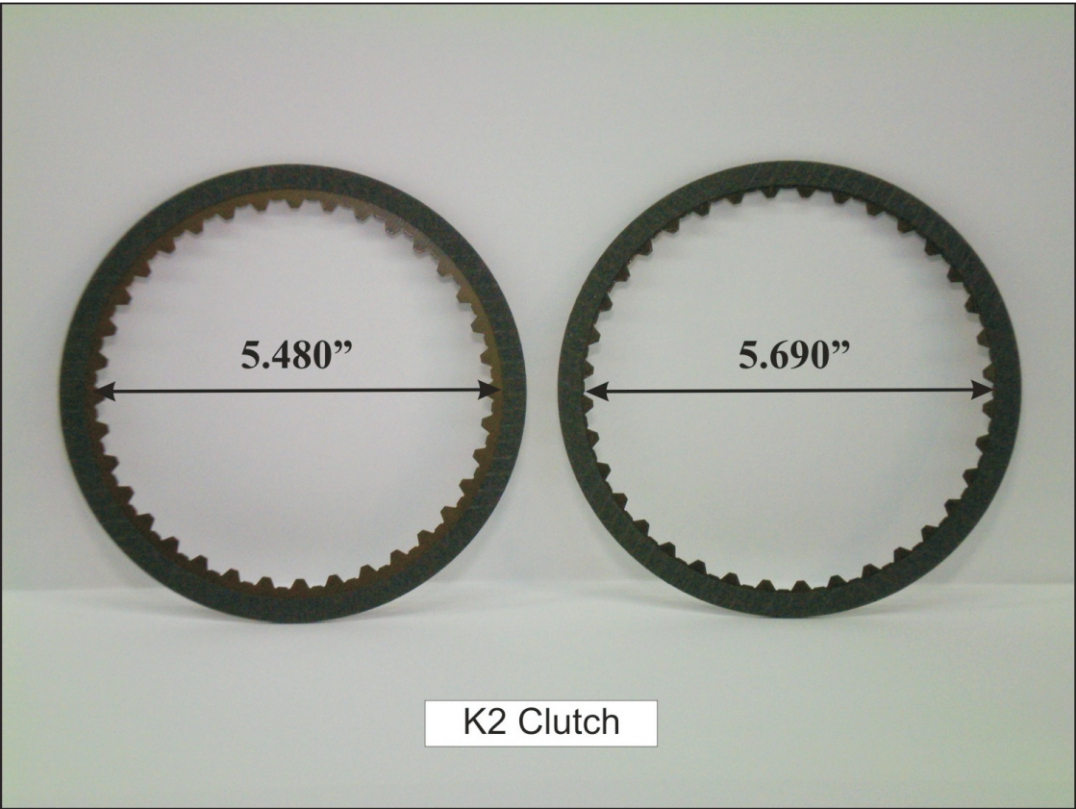
Figure 3

This is caused by installing the incorrect K2 clutch during the transmission rebuild. There are two different internal tooth diameters shown in figure 3 on page 3, one measuring 5.480" and the other 5.690. This difference in diameter was designed for a 3 pinion rear planet with a K2 clutch hub size of 5.455" for smaller engine vehicles along with a larger 4 pinion hub size of 5.670" for larger engine vehicles seen in figure 4 on page 3. The outside diameter along with friction thickness is the same for both K2 clutches. Always check the for internal diameter fit of the K2 clutch over the rear planetary hub as shown in figures 5 and 6 on page 4 during every rebuild to prevent a mistake.

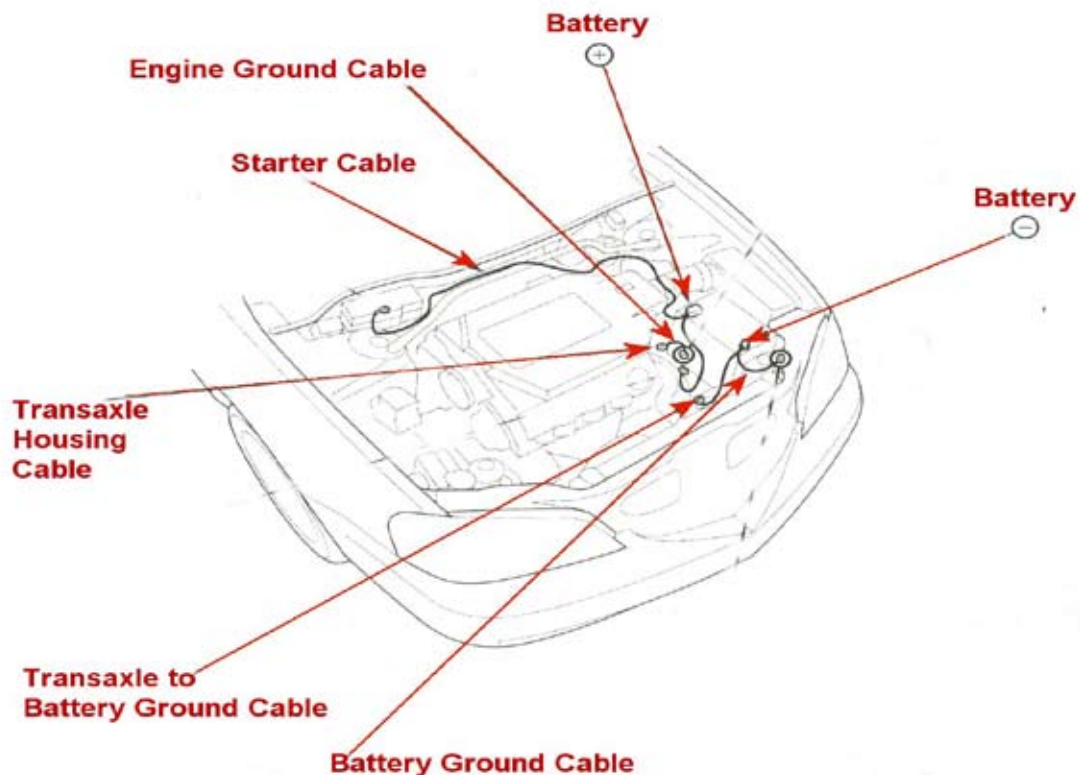
Some 2001-03 Acura TL with 3.2L and B7WA transmission may exhibit a DTC 743/P01753 for a fault in the TCC solenoid circuit. This may be caused by a problem in the TCC solenoid circuit or ground. Make sure the solenoid has a resistance of 15-25 ohms. Check for a missing or loose transaxle ground between the transaxle case and chassis. The transaxle case ground is located under the battery tray. Clear the code and make sure it does not re-appear.
