## Technical Bulletin #831A

**Transmission:** 5L40E

**Subject:** *Fluid Fill Procedure*

**Application:** 2000-2007 BMW, 2003-2009 Cadillac

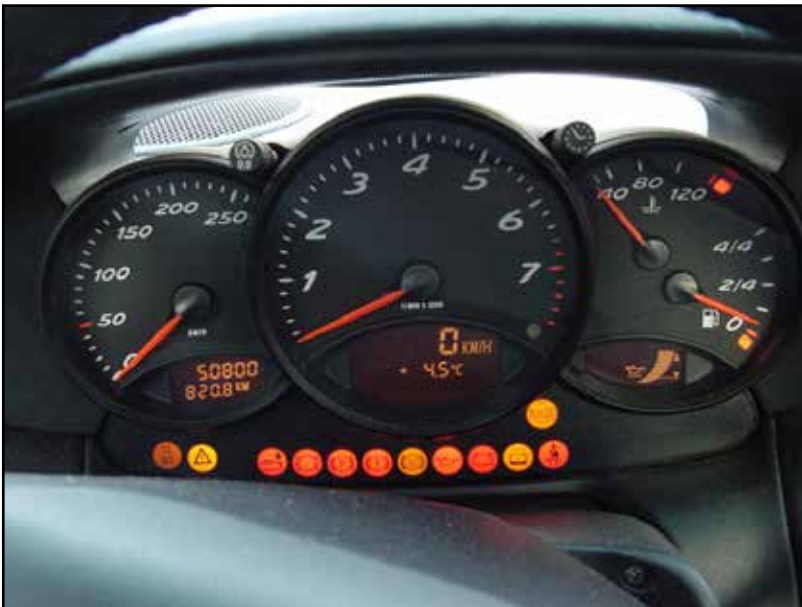
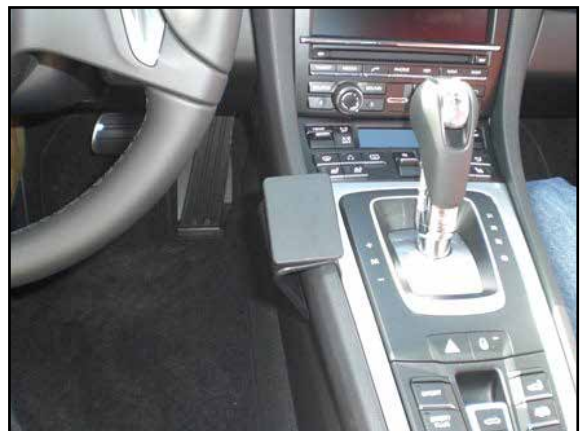
## Cold Operating Strategy, 2nd Gear Starts, Erratic Downshift

Cold operating strategy is below 102° F (39° C). At this temp and below the transmission will start off in 1st gear. After 3 minutes of operation the transmission will take off in 2nd gear. This is normal, it's an emission based strategy. The range indicator on the dash will display which gear the transmission is starting off in. If the vehicle is equipped with a power sport mode button, the transmission will take off in 1st gear when activated. The power sport mode provides an overall performance shift strategy. Full throttle take off from a stop will also shift the transmission down to 1st gear.

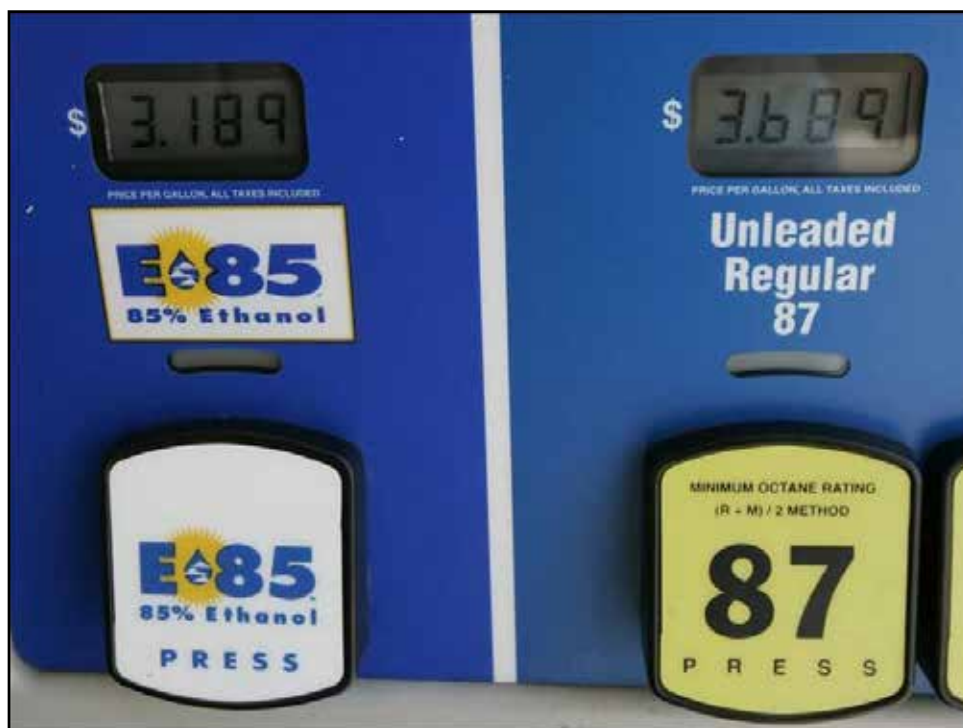
## Harsh Shifts, Misfire Codes, Wrong Fuel, Fuel Trim Codes

All Flex Fuel vehicles are designed to run on gasoline and E85 fuel. E85 type fuel is blend of 85% Ethanol and 15% gasoline. If E85 fuel is run in a NON Flex Fuel compatible vehicle the engine will run lean. This will set cylinder misfire and fuel trim DTC's and Various O2 sensor DTC's may also be set along with disabling the traction control system which illuminates the TCS lamp.

Harsh shifts will also occur when the PCM recognizes the lean condition after start up, it will cut the EPC command signal to the transmission resulting in high line pressure.

You should check with your customer when misfire codes are found after fuel fill.

**NOTE:** Do not attempt to fix the transmission shifting complaints if the engine is not performing correctly or has DTC's stored.

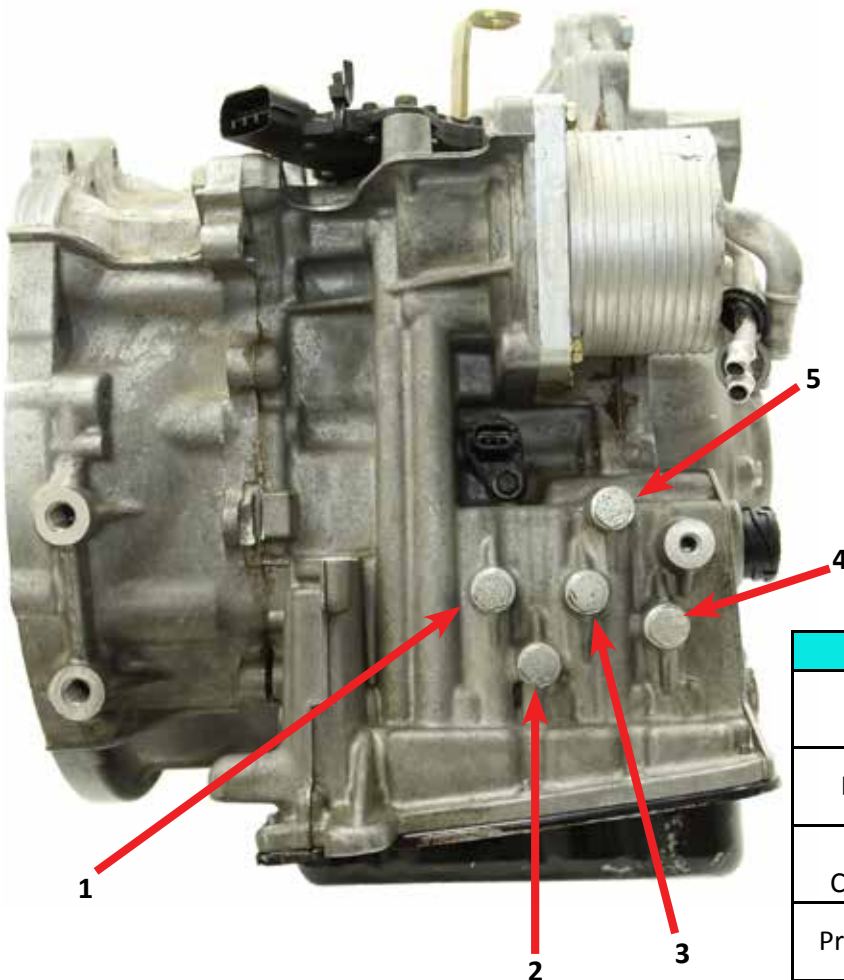
| Pressure Tap I.D. | |
| 1 | Line Pressure |
| 2 | Forward Clutch Pressure |
| 3 | Primary Pressure |
| 4 | Torque Converter Apply Pressure |
| 5 | Torque Converter Release Pressure |

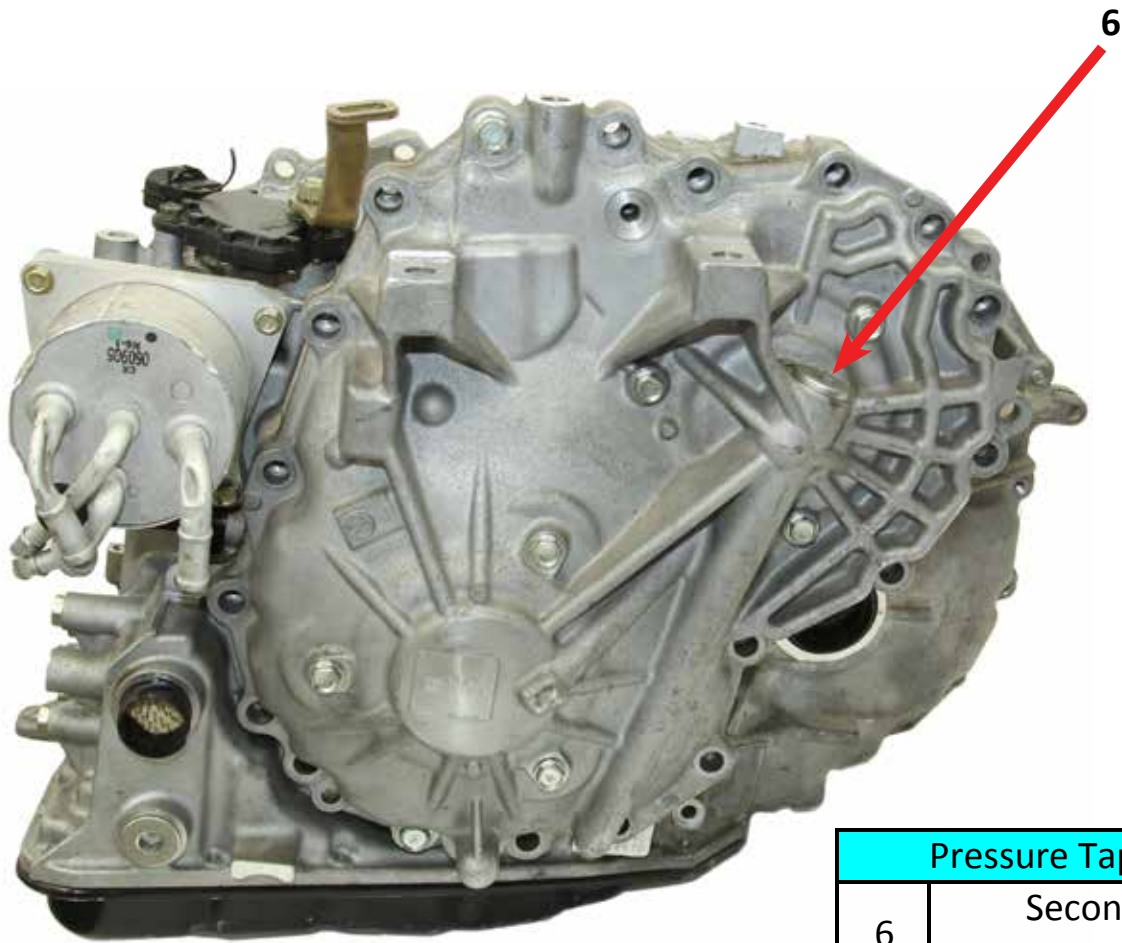
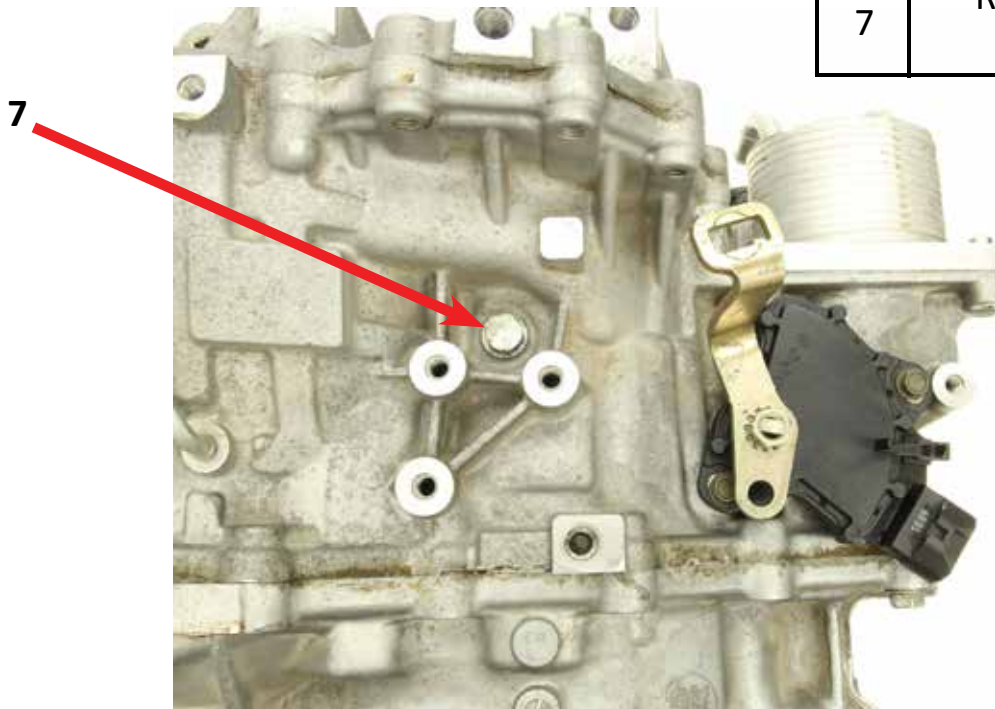
| Pressure Tap I.D. | |
| 6 | Secondary Pressure |
| 7 | Reverse Brake Pressure |
