## Technical Bulletin #1660

**Transmission:** U660E, U660F, U760E & U760F

**Subject:** Erratic Shift Concerns, Solenoid Performance Codes and Erratic TCC Operation

**Application:** Toyota

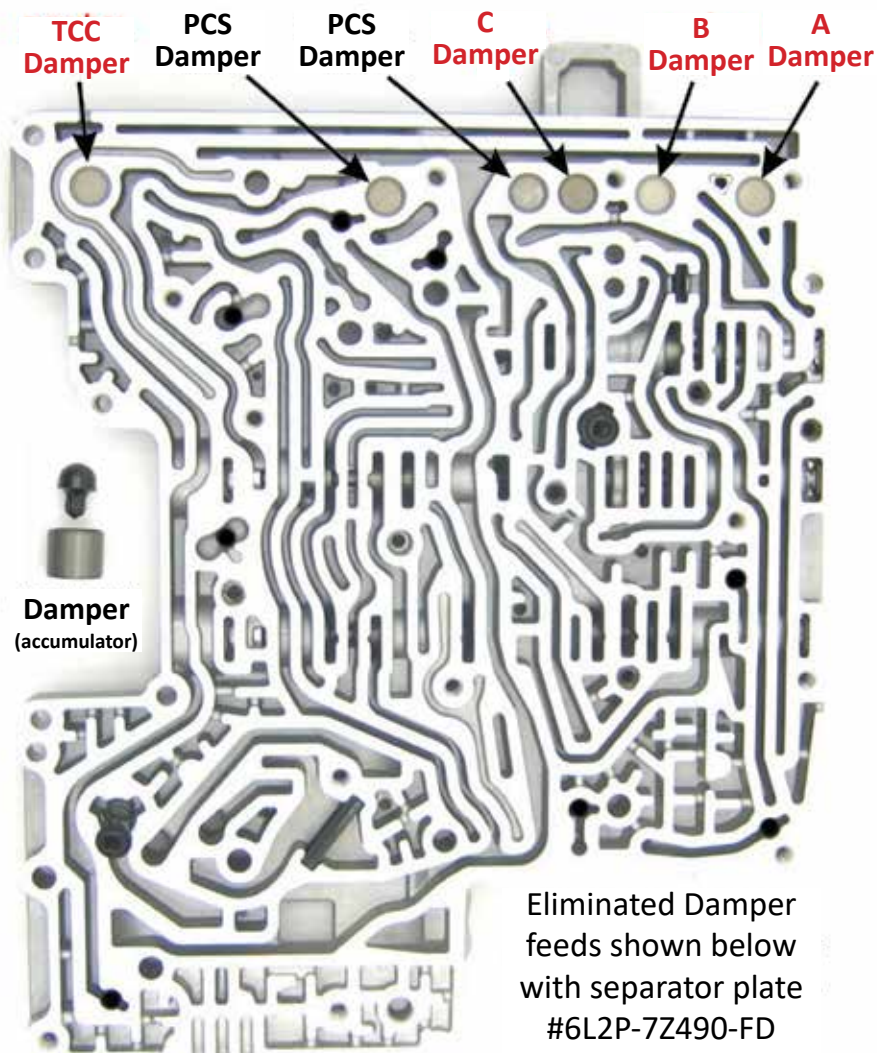
**Figure 1**

The 6R60, 6R75 and 6R80 are referred to as TCM Driven units, initially released with Bosch solenoids and six dampers (accumulators) for the 6R60 and 6R75 transmissions until 2008 ½ or J1 units. In 2008 ½ (11/16/09 J2 units) during testing Ford learned that only two were required so they eliminated four dampers; A,B,C and TCC (figure 1) along with the feed holes in the separator plate part #6L2P-7Z490-FD (figure 2). The D1 regulator spring bore 201 was removed and added a bleed circuit to the “D” clutch these vehicle required using MERCON SP oil. The ID number on the 2006 to 2008 separator plate is 6L2P-7Z490-FB (figure 3).
