# Problems with the MP Transfer Case

by Steve Garrett members.atra.com www.atra.com

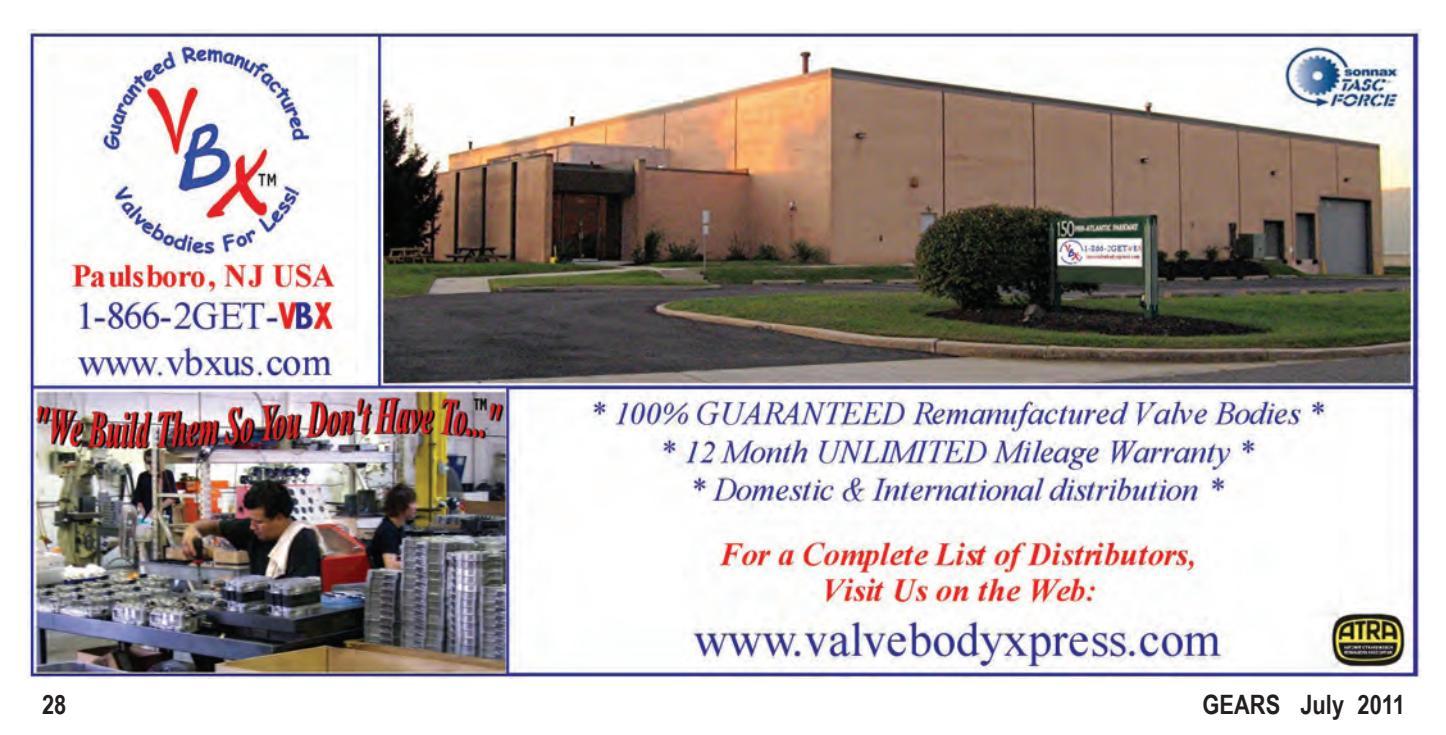
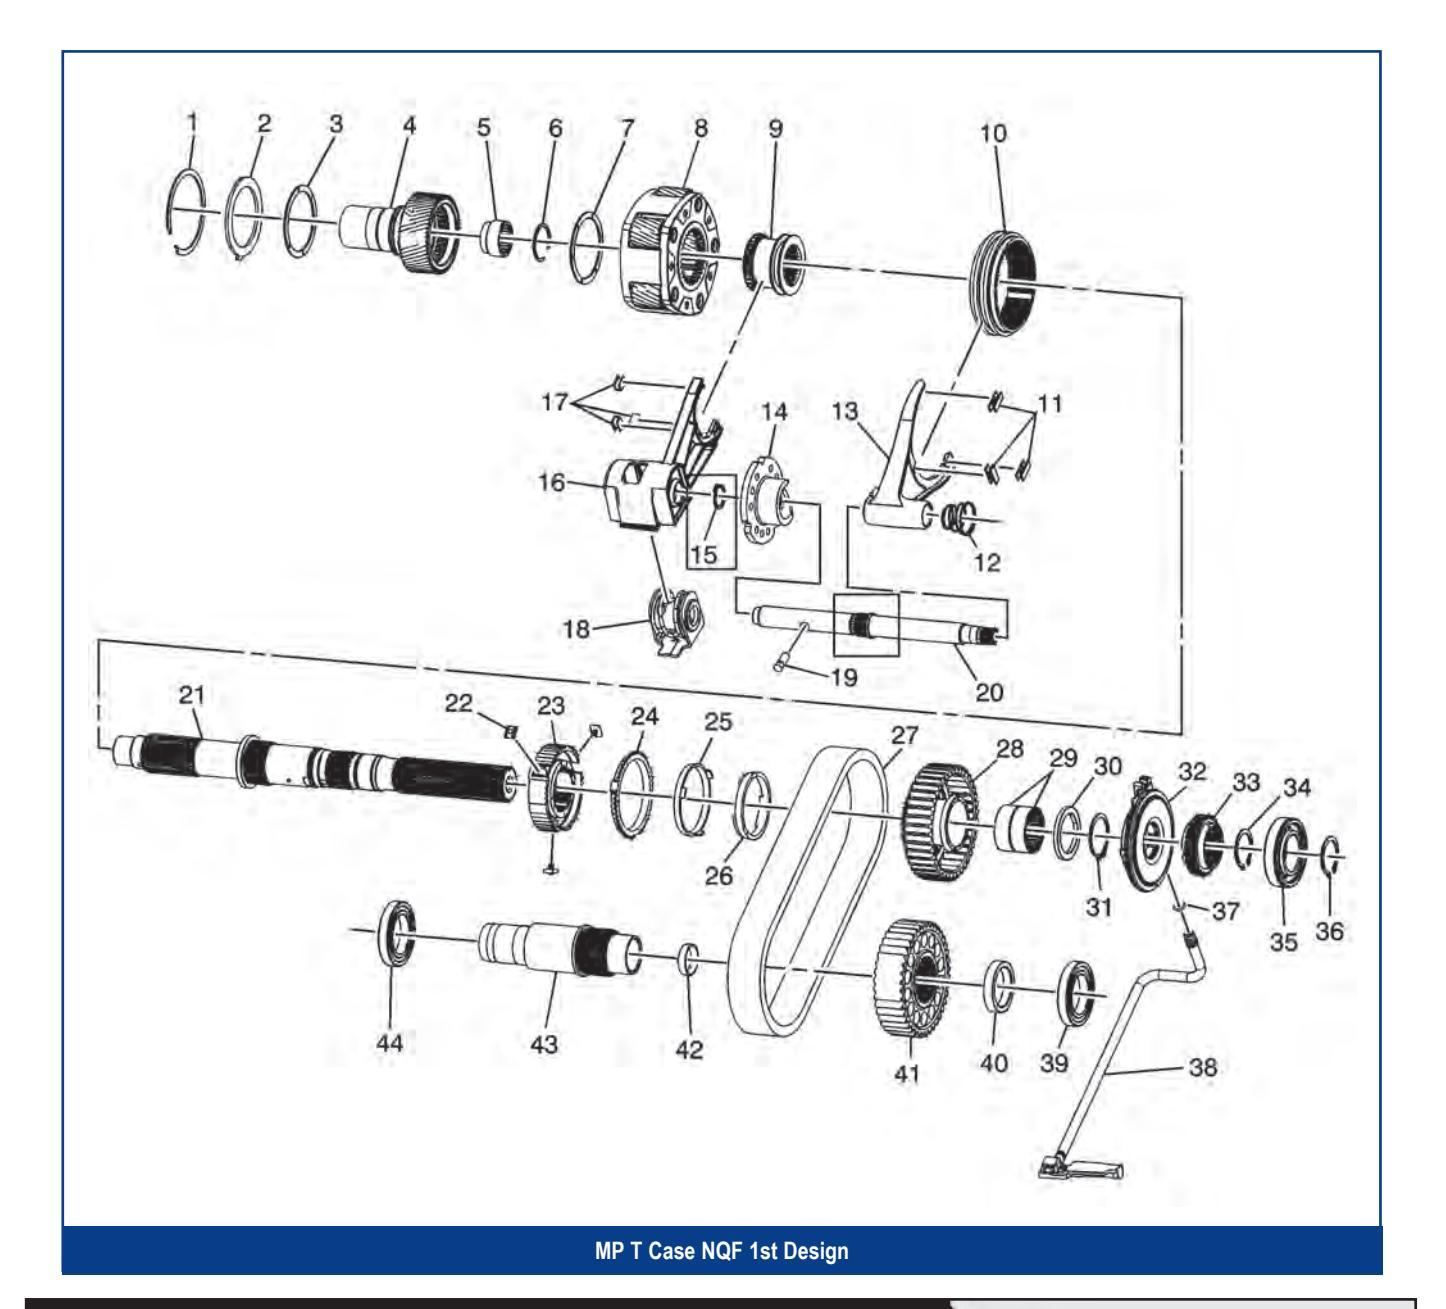
#### Transfer Case Chain Stretched

On applications that are used off road or on roads with standing water,

some customers may comment that they hear a popping noise, especially on turns, in 4WD or Auto mode.

Upon inspection you may find that the transfer case has taken on water. Water contamination will cause the chain to rust, leading to accelerated wear of the chain links and other transfer case components.
