**2000**

**TECHNICAL SEMINAR**

# ***Automatic Transmission Rebuilders Association***

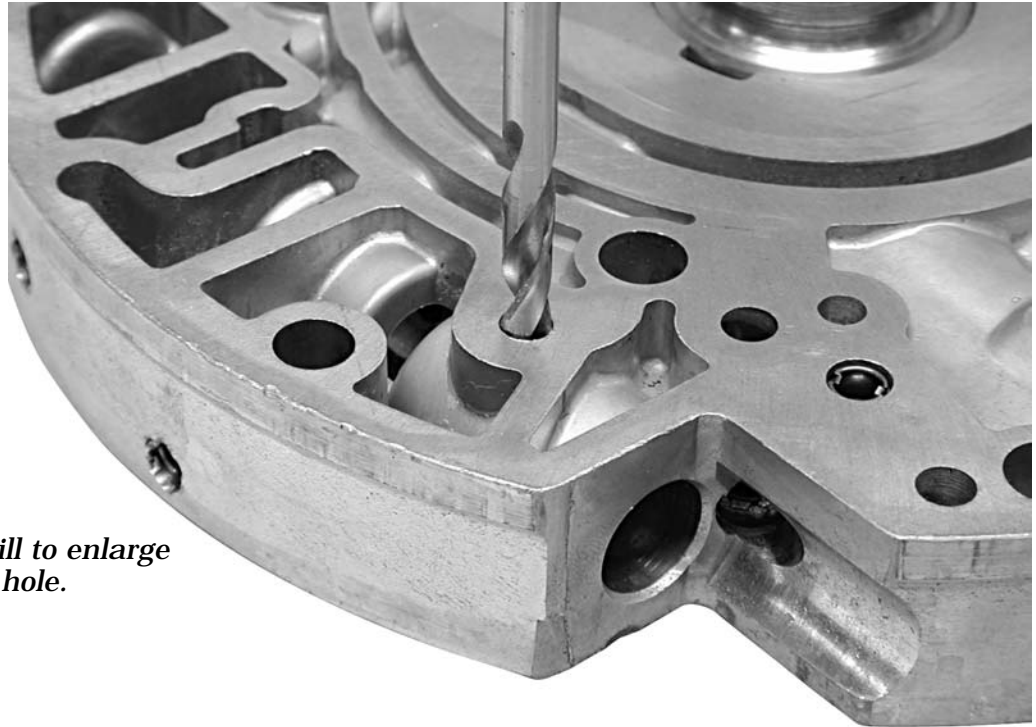
Under severe overheating conditions, the plastic insert can melt, clogging the orifice. Currently, the orifice isn't serviced separately, which gives you two choices:

*Use a 1/4" drill to enlarge the existing hole.*

*Use part number 8628864 for the new orifice.*

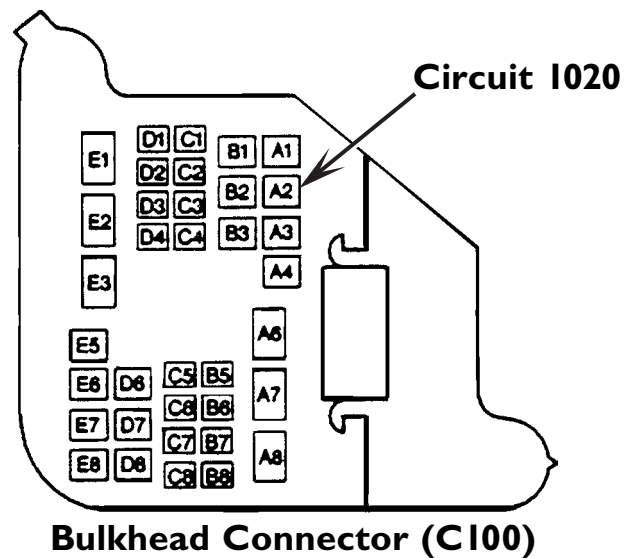
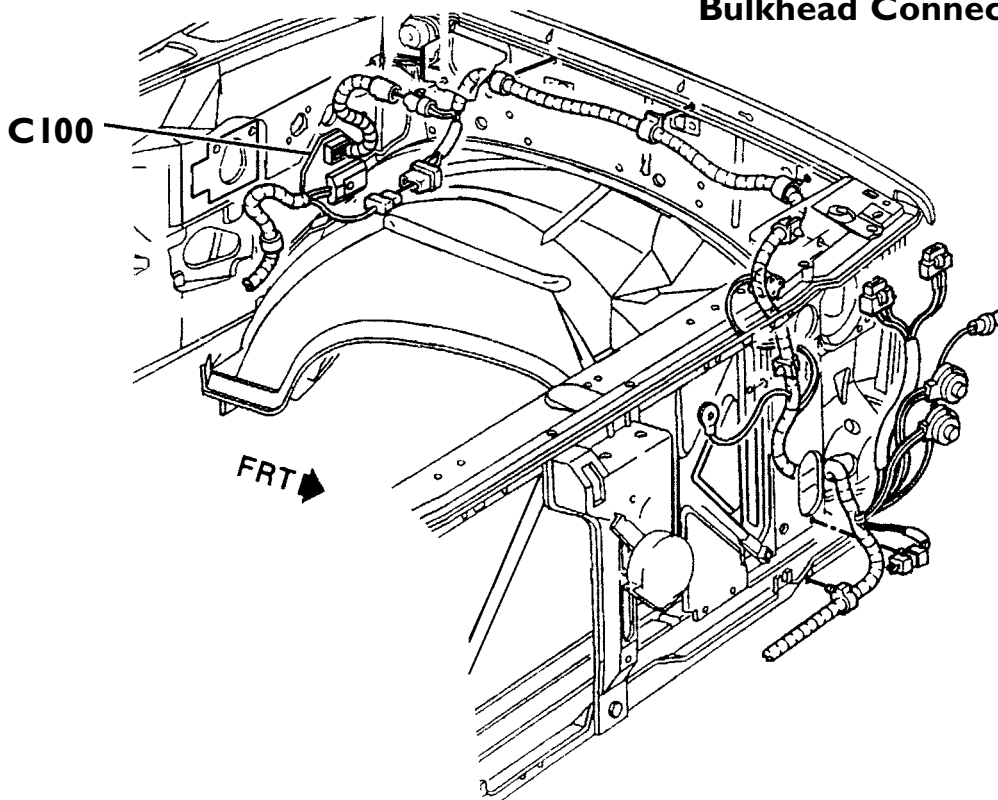
This problem is caused by a poor crimp on one of the terminals for circuit 1020.

Generally the crimp concern is cavity A2 at the bulkhead connector or (C100) on later model applications at connector C2, pins F2 or E2 of the UBEC (Underhood Bussed Electrical Center, used on many trucks).

To isolate this as a possible source of the problem, monitor pin voltage on circuit 1020 when the condition occurs. If the voltage drops below battery voltage, inspect the pins listed or the ignition switch for possible problems. If you find an open in the UBEC, you'll have to replace it, as it can't be disassembled and reassembled effectively.

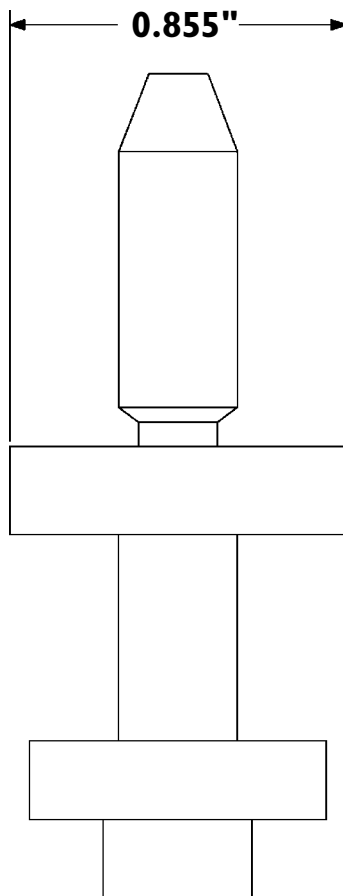
**Early Valve**

No reverse or a slip in reverse after a rebuild can be caused by installing a replacement boost valve bushing that doesn't match the original valve.

Some late-model pumps use a smaller boost valve than earlier models. Installing a smaller, late-model boost valve in a larger, early replacement bushing creates a large leak in the reverse apply circuit.

For now, the late-model valves and bushings aren't available separately, so if you have a smaller valve that needs replacement, you'll have to replace the valve-and-bushing assembly with the early set. These early design components are available separately.

Early Valve — 8680549

Early Bushing — 8682856

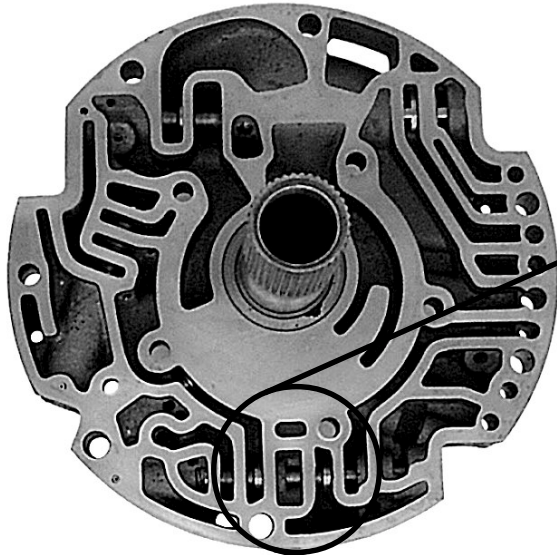
### 1991 – 96 Replacement Stator Support

*The bathtub in the replacement stator support isn't drilled. Never use this support in a 1997-or-later case.*

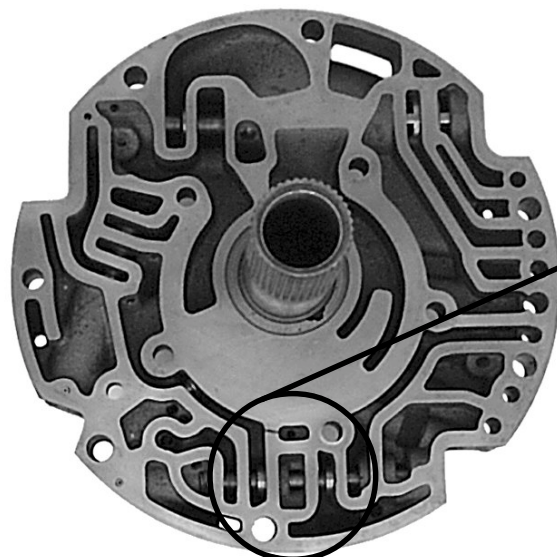
### 1997 – on (Late) Stator Support

*The bathtub in the late stator support is drilled. Never use this support in a 1991 – 96 case.*

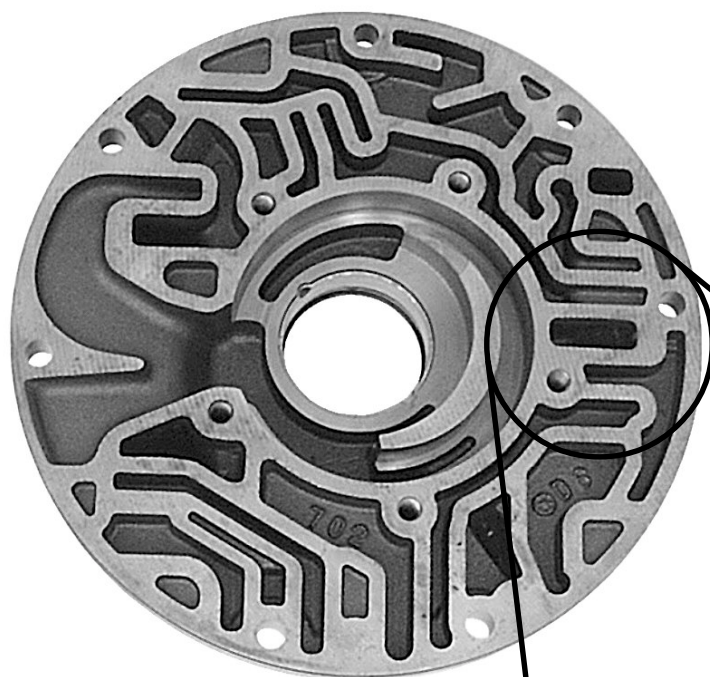
1991 – 96 Pump Body

*Never use this pump body  
with the late stator support  
and transmission case.*

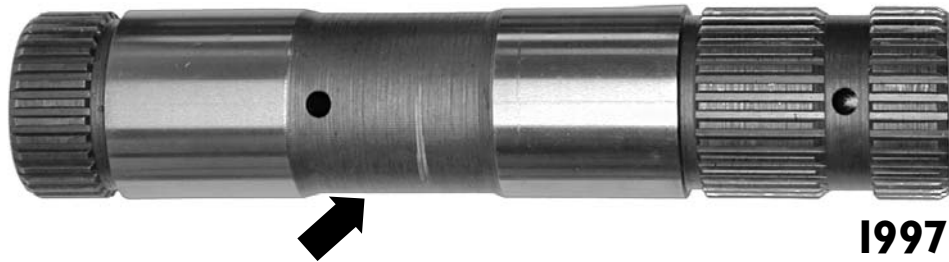
The early tube uses solid bushings; the late tube uses grooved bushings. Using solid bushings in the late tube will cut off lube oil to the forward clutch hub and the rear ring gear.

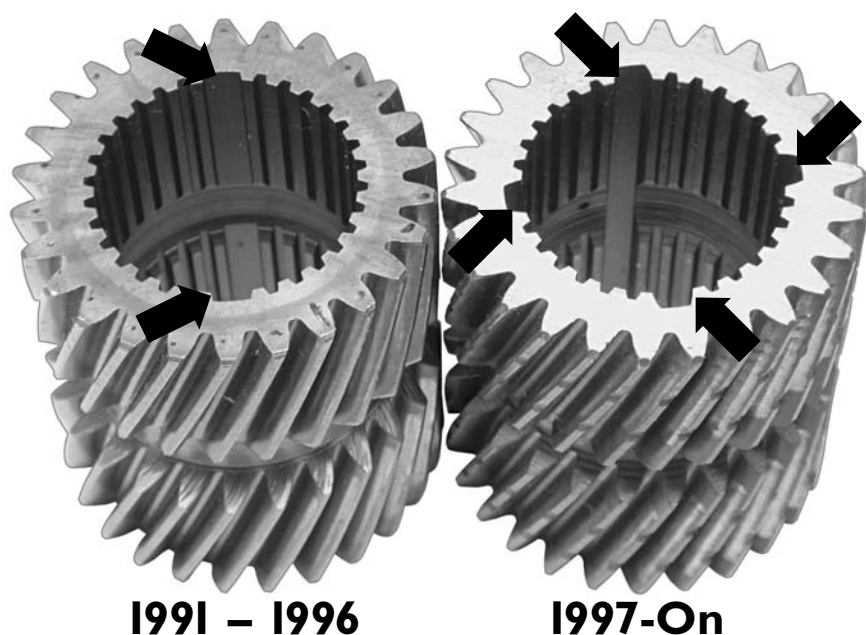
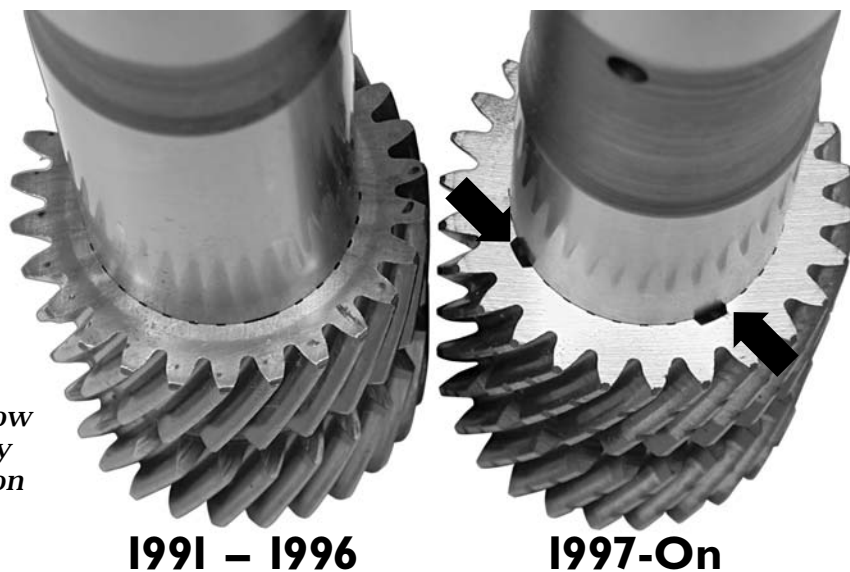
The late-design sun gear has four lube slots, versus the earlier gear, which had two. At first it seems as though this difference is negligible; however, when you compare how the two gears match up with the sun gear tube you can see that the tube completely cuts off oil flow between the tube and gear. These gears are not interchangeable.

*Notice the tube cuts off all flow through the slots on the early gear; the slots remain open on the late assembly.*

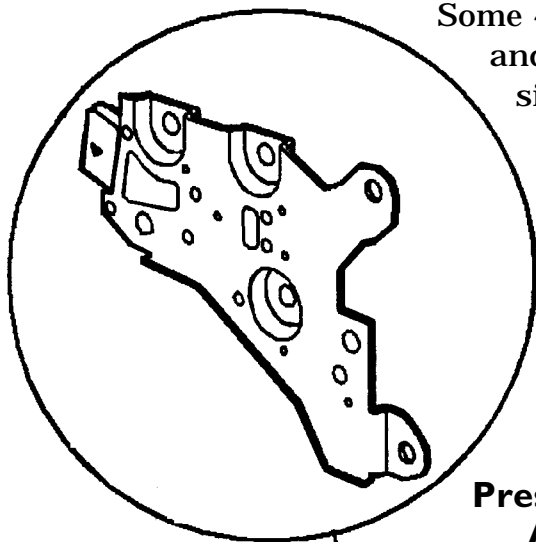
**Pressure Switch  
Assembly**

Some 4T40Es may lose TCC until you cycle the ignition off and on. This condition may also set DTC P1887. Diagnosis using the service manual may lead you to replacing the TCC release switch. The TCC release switch has created this problem, especially on early model units. The TCC release switch is part of the Pressure Switch Assembly (PSA) and is serviced by replacing the PSA.

The GM part number for the pressure switch assembly is 24200495.

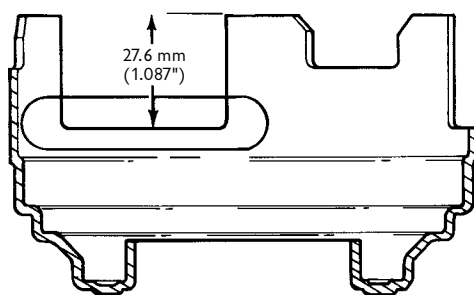
**Clutch Stacked Properly**

One of the more common causes is a mismatch between the type of input clutch piston and 3<sup>rd</sup> clutch piston used. If you use 10-plate 3<sup>rd</sup> clutch components with an input clutch piston designed for 8-clutch 3<sup>rd</sup> clutch components, the input clutch piston will interfere with the 3<sup>rd</sup> clutches, causing the 3<sup>rd</sup> clutch to apply anytime the input clutch is applied.

Use the illustrations below to identify the parts. Always make sure that the 3<sup>rd</sup> clutch rotates freely when you air check the input clutch.

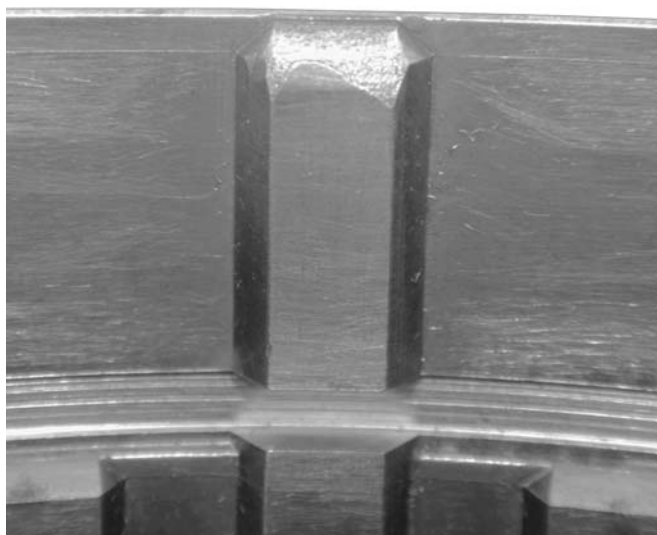
**Original Drum with 25° Splines**

The original 2<sup>nd</sup> clutch and reverse reaction drums had splines with 25° sides; these drums had a tendency to strip. GM has released new-design 2<sup>nd</sup> clutch and reverse reaction drums with 10° sides on the splines. A kit is available with both parts.

The GM part number for the kit is 24213402.

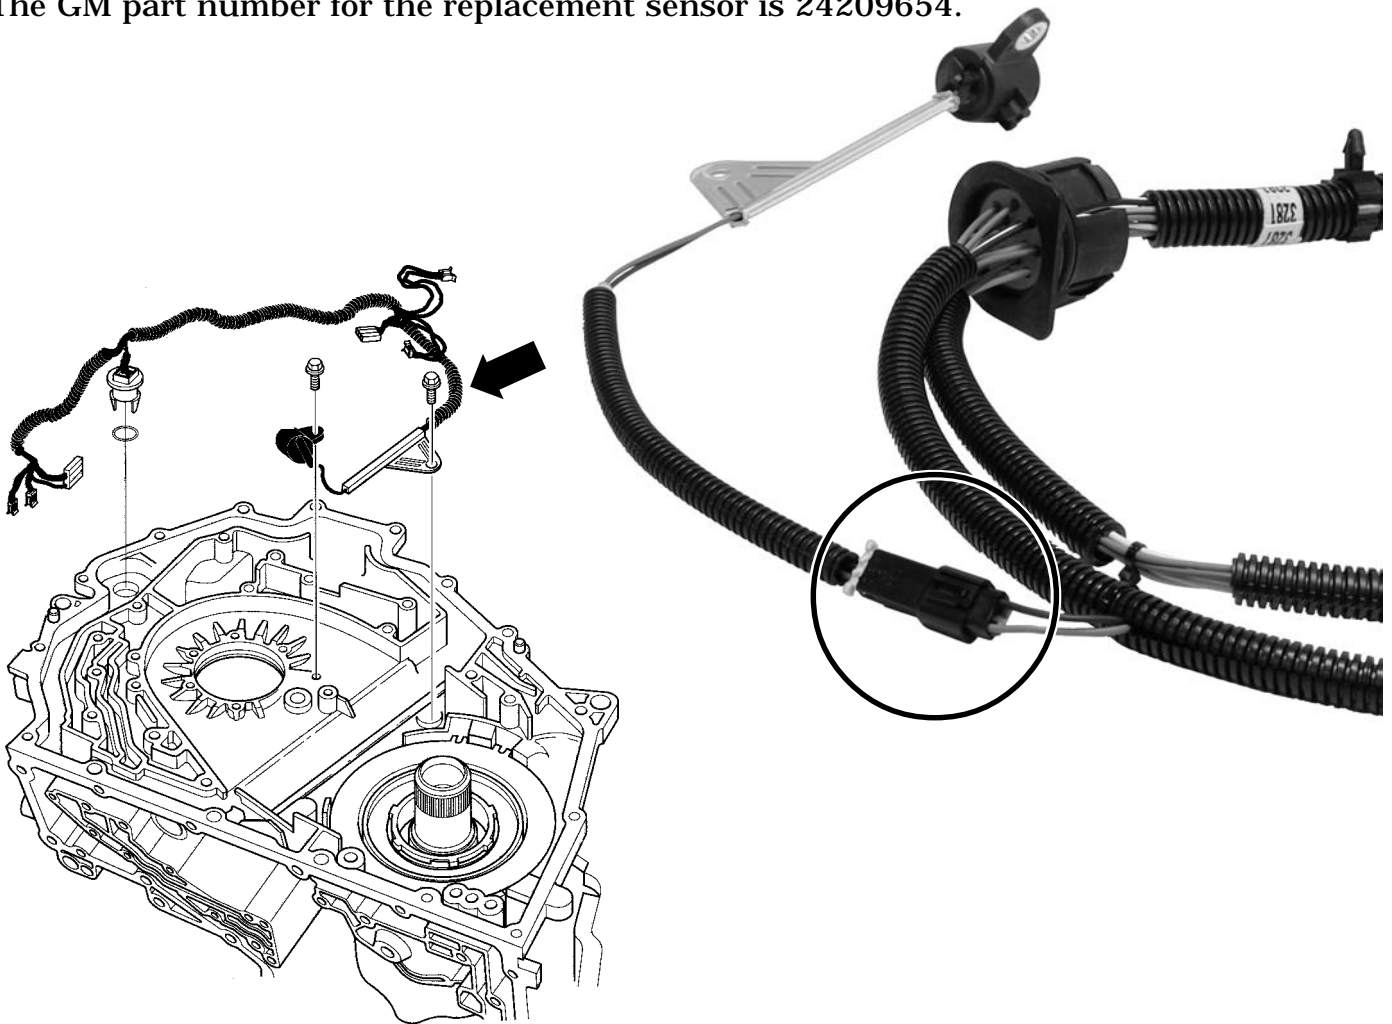
It's a good idea to replace the turbine speed sensor on every 4T80 rebuild. But don't be surprised to find the wires on the replacement sensor are out of position. Always check to make sure that the sensor wires are indexed into locations A and C.

The GM part number for the replacement sensor is 24209654.

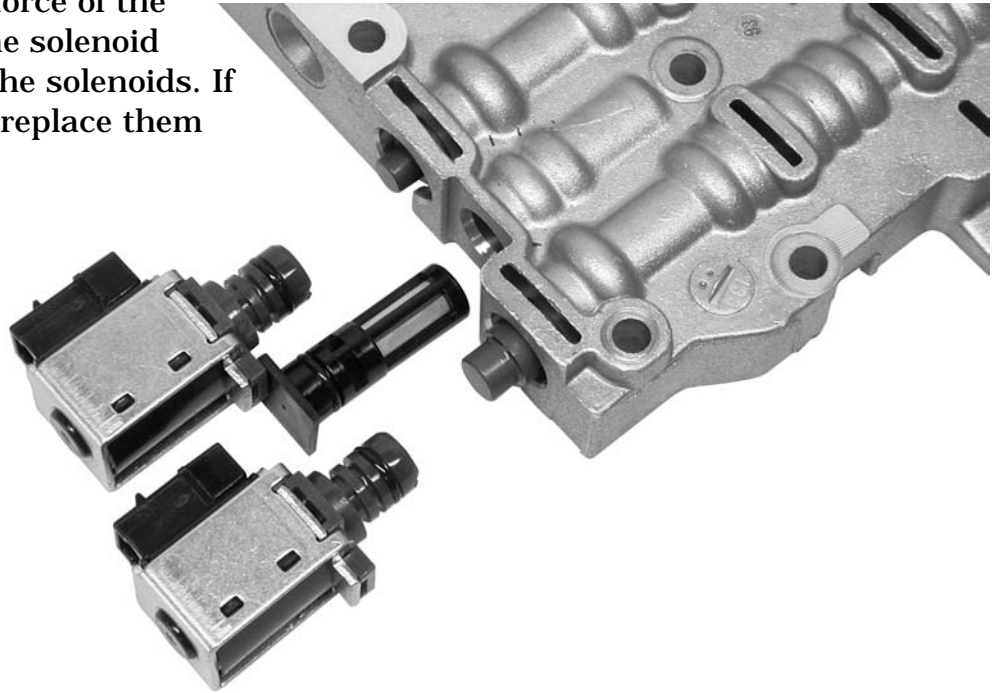
A second gear start (that usually goes away when you step on the gas) is often caused by poor pressure at shift solenoid A. This can be caused by a leaking shift solenoid, or poor feed to the solenoid. Early solenoids were designed to hold the pressure control solenoid feed screen in place. The force of the screen pushing against the solenoid had a tendency to break the solenoids. If you have the early setup, replace them with the upgrade kit.

The later solenoid setup used a separate bracket to hold the screen in place.

The GM part number for the solenoid update kit is 24211355.

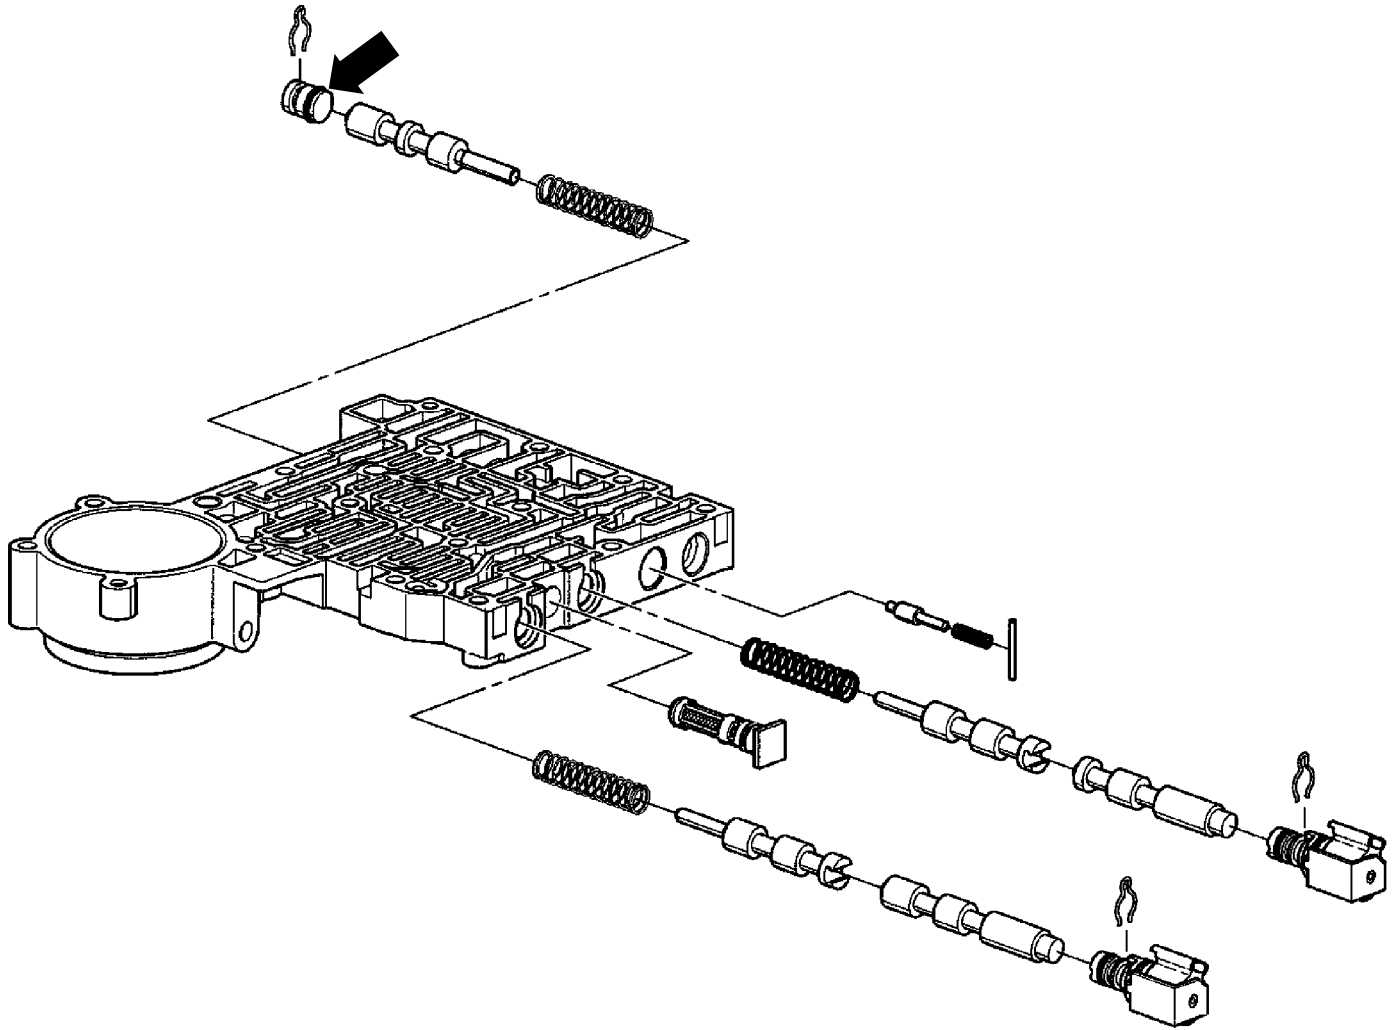
Another source for solenoid A leaks is the 3-4 shift valve plug. The 3-4 shift valve plug has an O-ring that seals solenoid A pressure. Replace this O-ring on every rebuild.

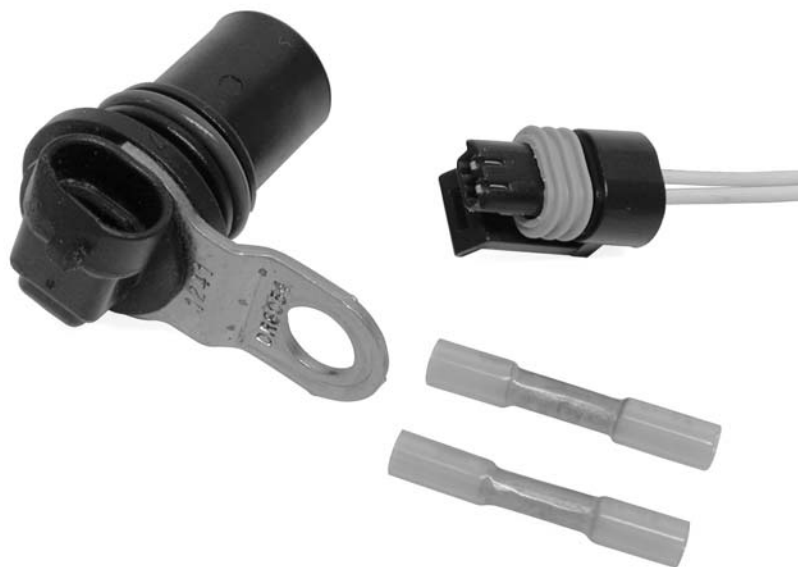
The VSS harness connector will often crack or break while disconnecting the harness during transmission removal. Never reuse a broken harness connector; replace it with a new harness connector.

The GM part number for the harness kit is 12101899.

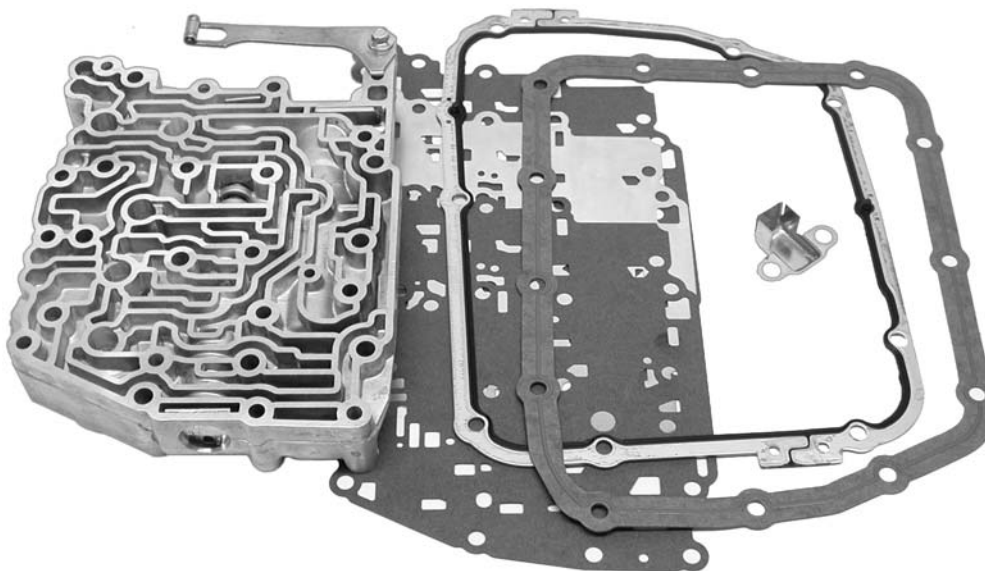
A harsh reverse condition is often caused by a worn out pressure regulator bore. Saturn offers a kit that includes the valve body half (with regulator valve) and gaskets.

When the pressure regulator bore wears out, line pressure will go higher than commanded. To verify line pressure, follow the procedures on page 62.

The Saturn part number for the kit is 21005813.

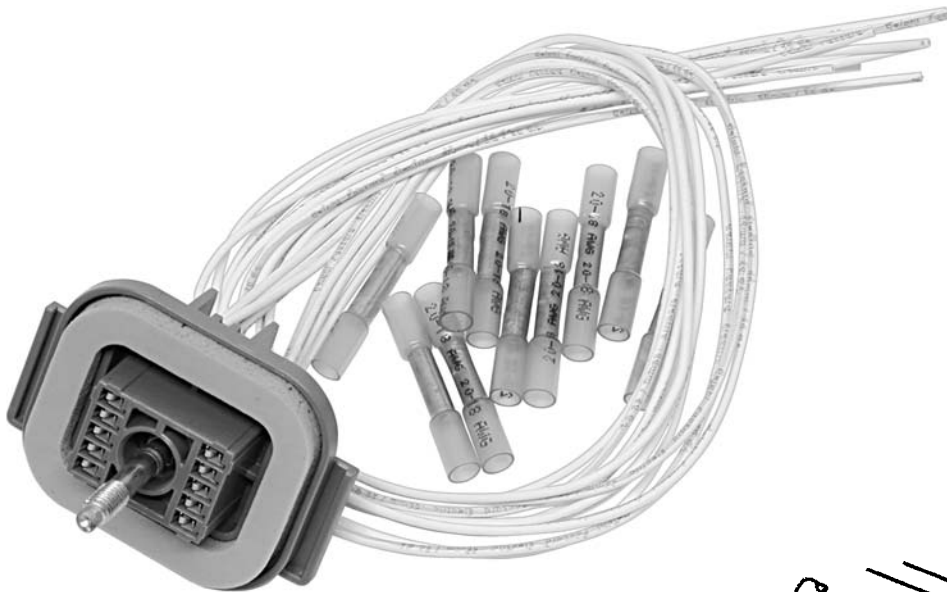
Poor connections at the solenoid harness connector can cause many problems including wrong gear starts and harsh shifts. In some cases no DTCs will set.

Saturn offers a solenoid harness connector repair kit for replacing this connector. The Saturn part number for the kit is 12116563.

Always stagger the splices about  $\frac{1}{2}$ " apart, beginning with the first splice, which you should start about 1" from the connector.
