TECHNICAL SEMINAR

# *Automatic Transmission Rebuilders Association*

# *Program Contents*

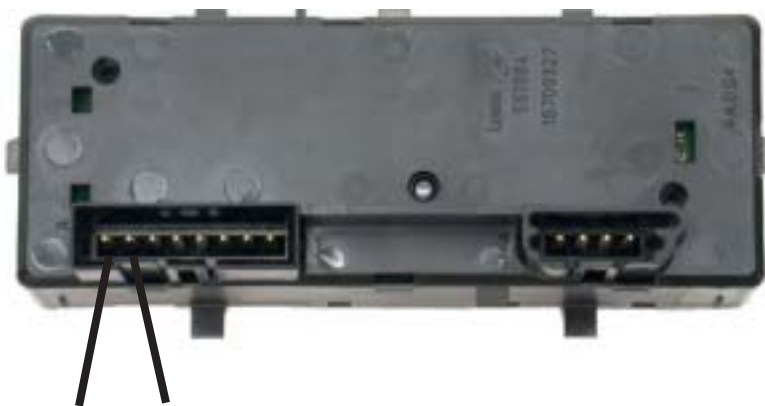
**NOTE:** When following the service manual diagnostic procedure, you may be lead to replace components that are not faulty. The switch resistance values listed in the service manual maybe incorrect.

The correct control switch resistance values are as follows:

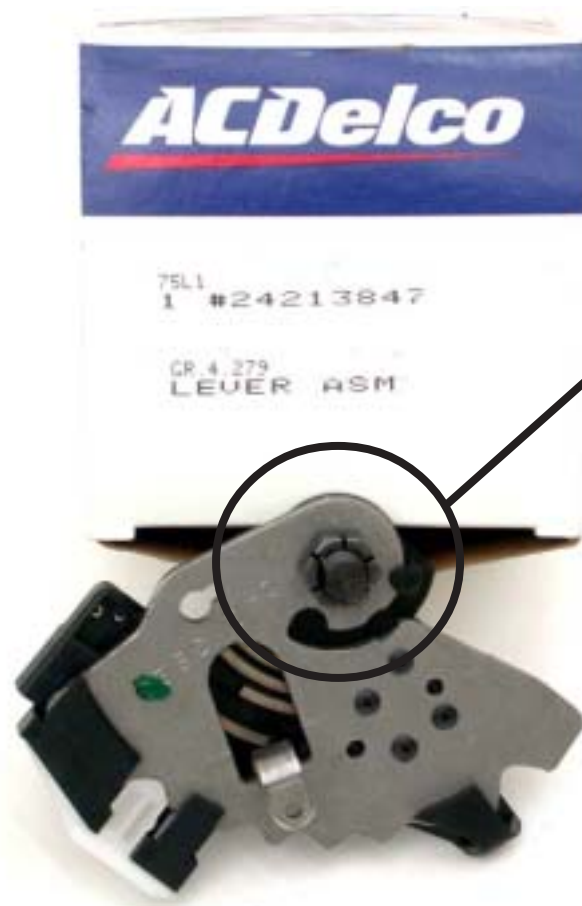
An IMS (Internal Mode Switch) was added to all 4T65Es. A new design replaced the previous design that used a nut to hold the design together. The update was done as a cost savings.

**Fastening Nut  
was removed on  
the new switch**

The new design will back service the 99 and later model 4T65Es that utilized an IMS. As with the previous design, make sure the IMS is properly positioned on the rooster comb before installing the transmission in the vehicle!! The IMS part number is 24213847

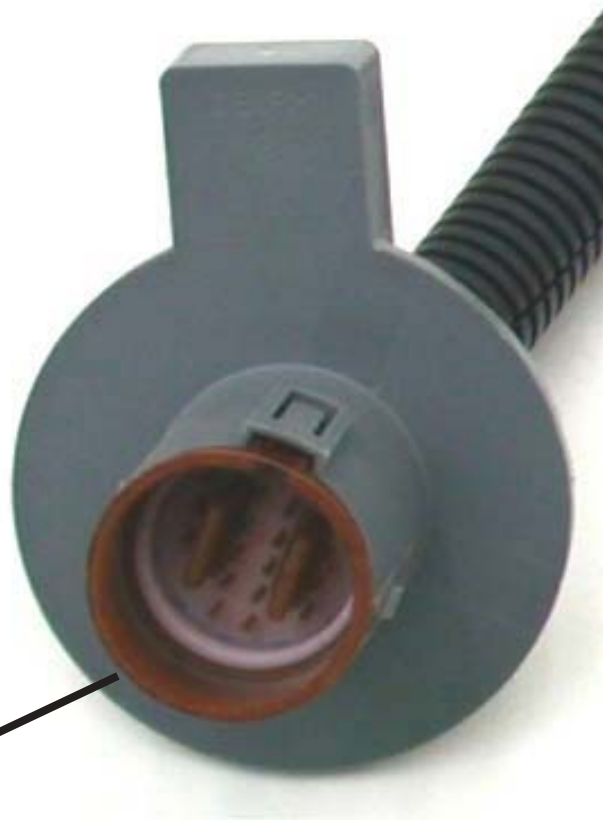
Mid year change included a 2<sup>ND</sup> lock ramp was added to the pass through connector. This design prevents the connector from side loading.

**Make sure your new  
harness has the new clip**

This change has no effect on service as the harness was only updated for the new 2003 harness applications.

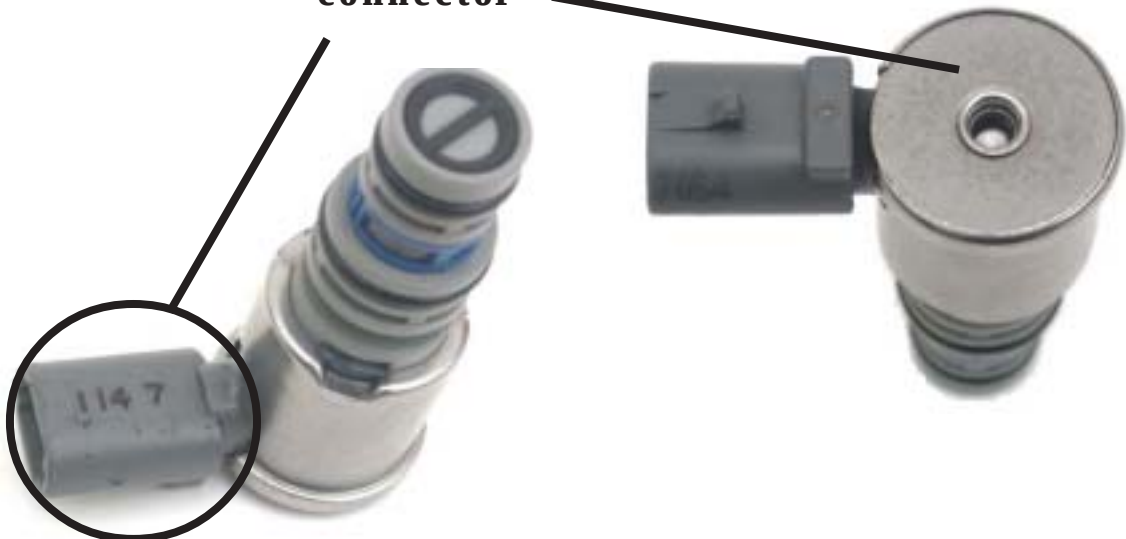
When encountering a TCC concern with a 4T80E transaxle, make sure you have the correct TCC PWM solenoid installed. To verify the correct solenoid check the Julian date. This date may be located in a number of different places including, top cover, connector top / bottom, or body assembly. To ensure you have the correct solenoid make sure the Julian dates are NOT within 1137-1171. If you have a solenoid between these numbers you will need to replace the solenoid assembly. Part # 24212690

***Do Not Use Solenoids With The Numbers Between 1137 and 1171***

**Part numbers may  
be on the top hat or  
on the back side of the  
connector**

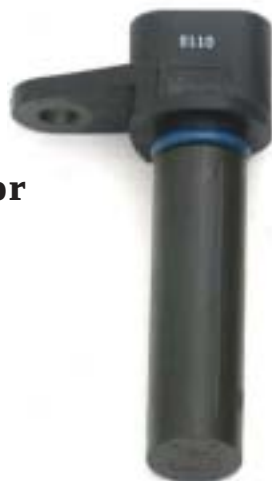
**Crank Sensor**

The Northstar engine applications utilize two crank sensors and one cam sensor. The crank sensors are different part numbers and are also different colors (Grey and Black plastic). If one of the crank sensors fail or if a loss of signal occurs the PCM will raise line pressure resulting in harsh shift concerns. If the Cam sensor fails, DTCs may set and drivability concerns may be present, but shift feel will remain normal.

Inspect the sensor connector pin tension and the terminal crimp. If pin tension is good replace the suspect sensor.

NOTE: If a crank sensor is replaced the “RELEARN PROCEDURE” for the crank sensor must be performed using a scan tool. Failure to relearn the crank sensor value will result in a DTC being set and possible drivability concerns

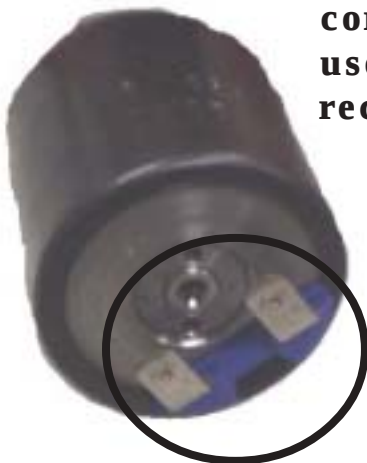
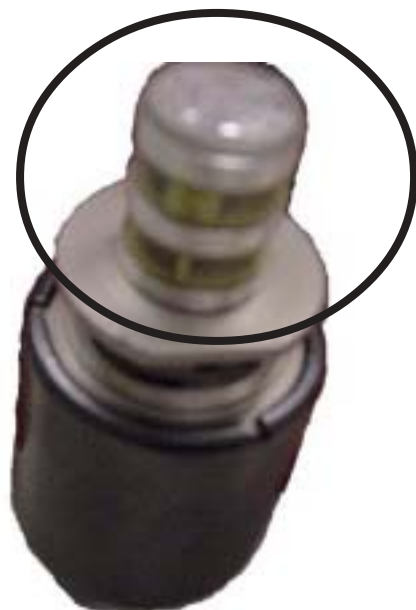
The 1<sup>st</sup> design solenoid went into production at SOP (Start of Production) 2003 while the 2<sup>nd</sup> design was introduced in December 2002 as a running change for the 2003 model year. The part number for the 1<sup>st</sup> design solenoid is 24219308 while the 2<sup>nd</sup> design part number is 24224905. The harness was updated to prevent someone from interchanging the Borg Warner solenoid with the previous Delphi solenoid. The updated harness part number is 24222891.

**Make sure the  
correct solenoid is  
used for the cor-  
rect vehicle**

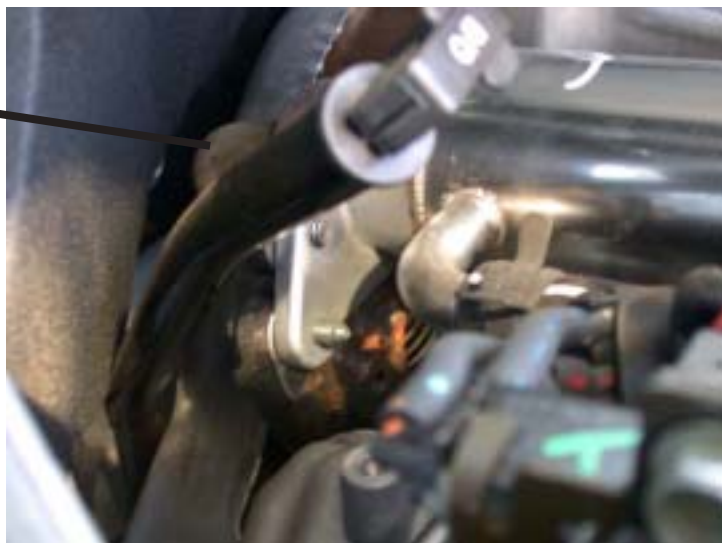
**The EGR is located  
behind the dipstick**

On L56 (EGR equipped 6.5L Diesel) applications, if the timing is correct and the problem is eliminated when the EGR is disconnected, replace the EGR with part number 12530288.

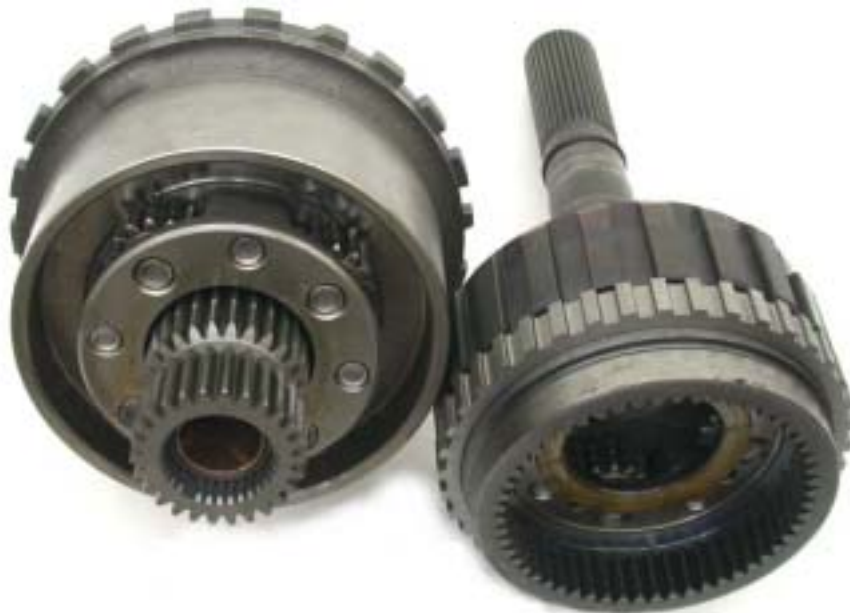
Some 4L80E transmissions may exhibit excessive planetary gear noise when operating in 1<sup>st</sup> and 2<sup>nd</sup> gears. This noise will resemble the noise developed from HD 4L80E applications which use straight-cut gears. Upon inspection, you will notice some irregular wear lines on the reaction planetary carrier pinion teeth and possibly on the sun and ring gear teeth. These wear lines run parallel to the transmission center line. The wear may look like dark lines on the gear teeth, grooves in the gear teeth or bronze lines on the gear teeth.

This concern can be caused by either:

Â A reduction in the volume of lube oil feeding the planetary. This problem is typically caused by pump cavitation, a restricted filter or damaged oil pan, or a cooler flow rate problems.

Â Output shaft misalignment. This concern is the most common cause of the noise on 97 and later applications. Misalignment of the output shaft will cause side loading of the planetary. This problem generally leads to the technician replacing the planetaries only to have a repeat failure within 5-20 thousand miles.

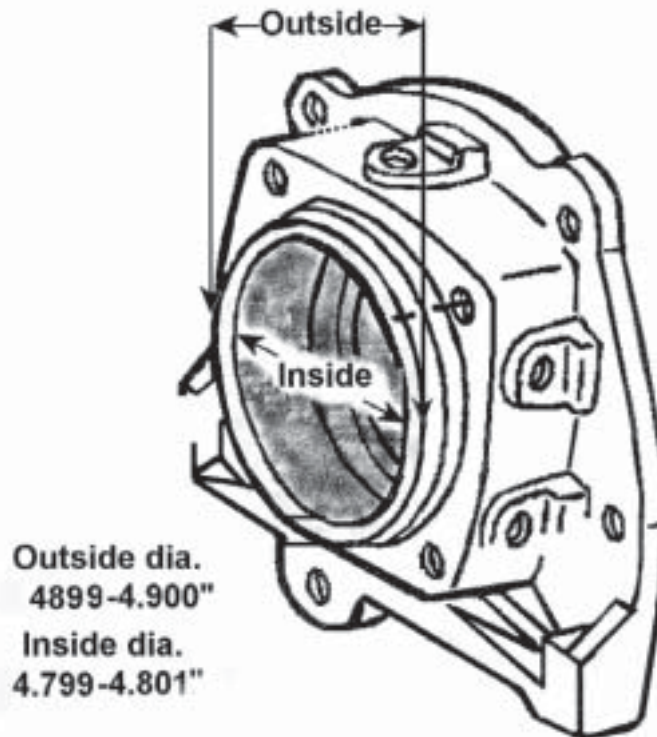
### *Planetary gear noise in 1<sup>st</sup> and 2<sup>nd</sup> gears only*

If shaft alignment is suspected on a 4wd application, inspect the 4wd adapter. We have measured brand new adapters that have had excessive offset! To inspect the transfer case adapter measure the transfer case pilot inside and outside diameter. The outside diameter specification is 4.799"-4.801" while the inside diameter specification is 4.899"-4.900".

If the measurements are not correct, replace the adapter. On 2wd applications a common cause of the concern is the position of the output shaft bushing. If the bushing or bore was machined off center, side loading of the shaft will occur. On 2wd applications, you will typically be able to see that the bushing is worn off center. Replace the bushing or the case as necessary.

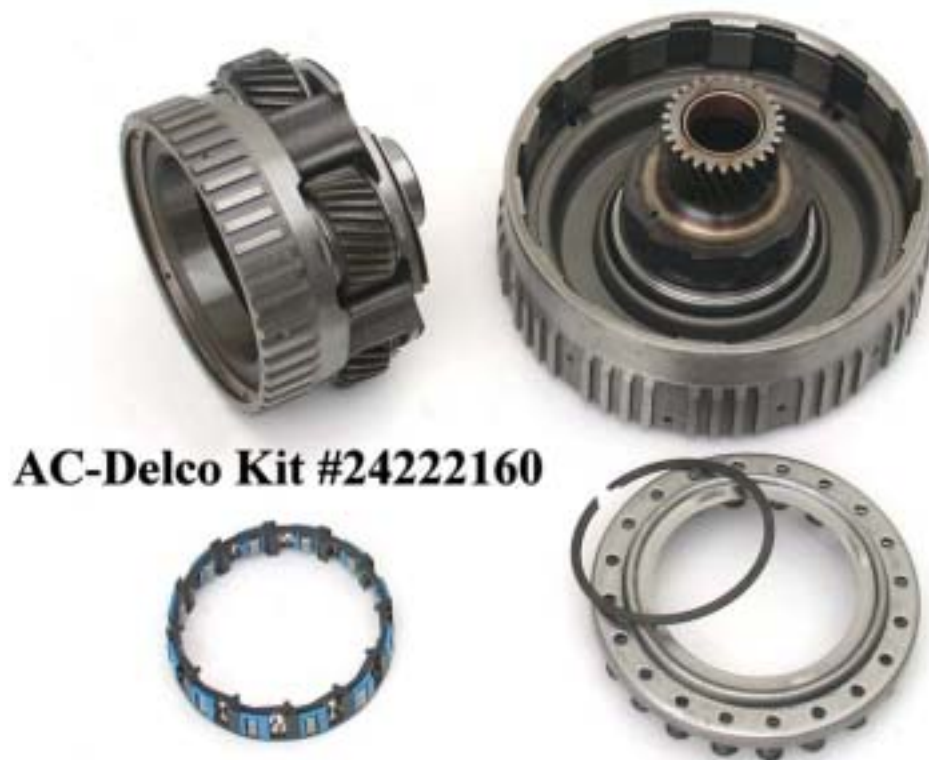
**AC-Delco Kit #24222160**

Some of the components are only available by ordering an upgrade kit part number 24222160

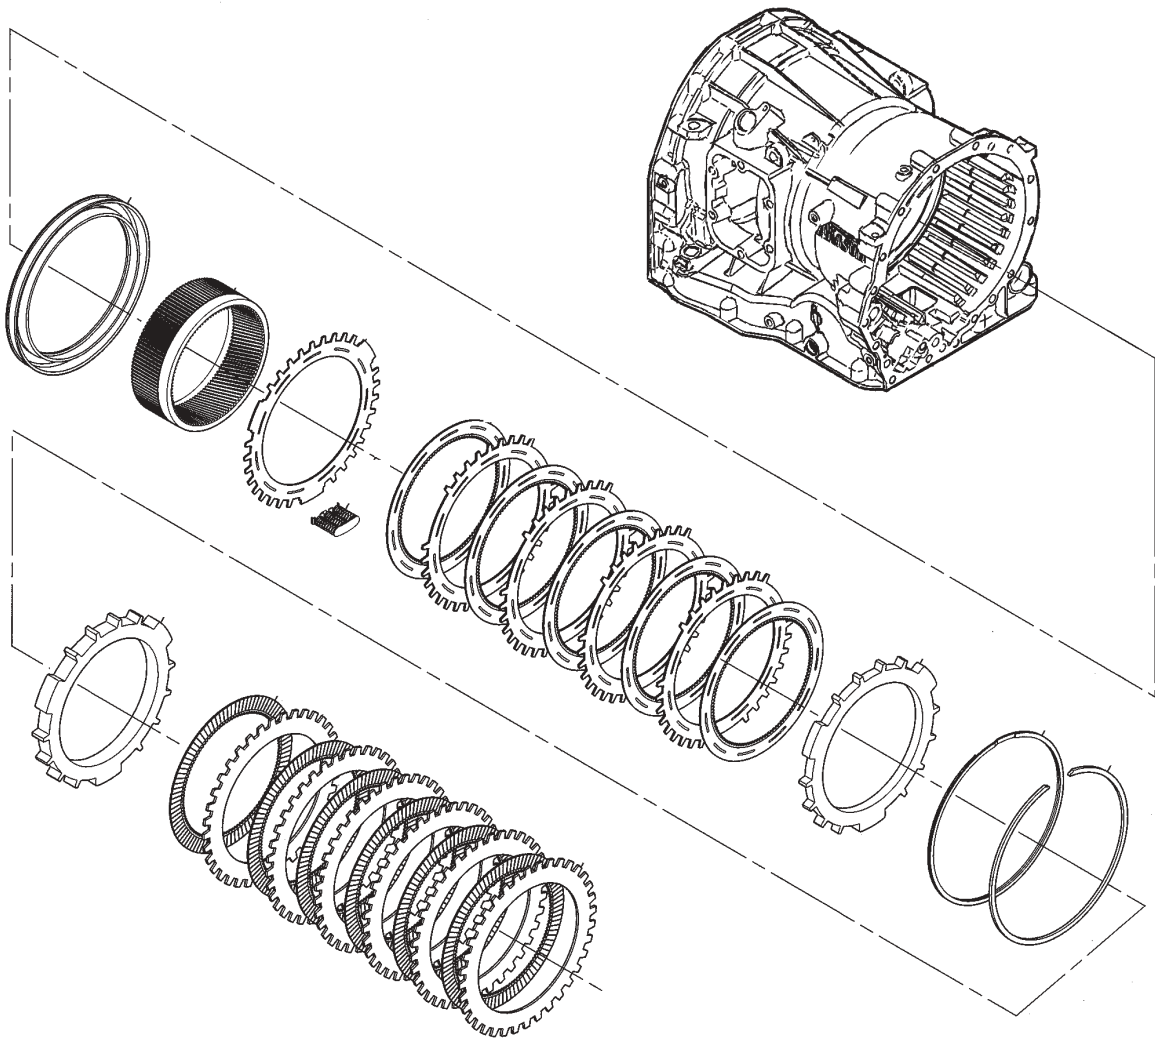
### **C-5 Clutch Assembly**

LCT 1000 applications may experience a condition described as a “flare” or “neutral” condition when coming to a stop or accelerating from a stop. A harsh engagement may occur as the unit reengages 1<sup>st</sup> gear. Many times, when the condition is present, input speed will be present even though the transmission is being commanded to 1<sup>st</sup> gear with TP and VSS values at 0.

- Â Leakage in the C5 clutch or its circuit: If you perform a clutch test using your scanner, you will generally notice the condition when the 2-1 downshift is commanded. This will be indicated by a delay in line pressure response when the C5 Clutch is commanded to apply.
- Â Sticking valves: Most of the sticking-valve-related concerns have proven to be temperature related with this transmission.
- Â TCM calibration: An updated calibration has been released aimed at improving this condition. The updated calibration was released in March 2002. Check the GM web site to see if your vehicle has been updated with the new calibration.  
<http://calid.gm.com/vci/>

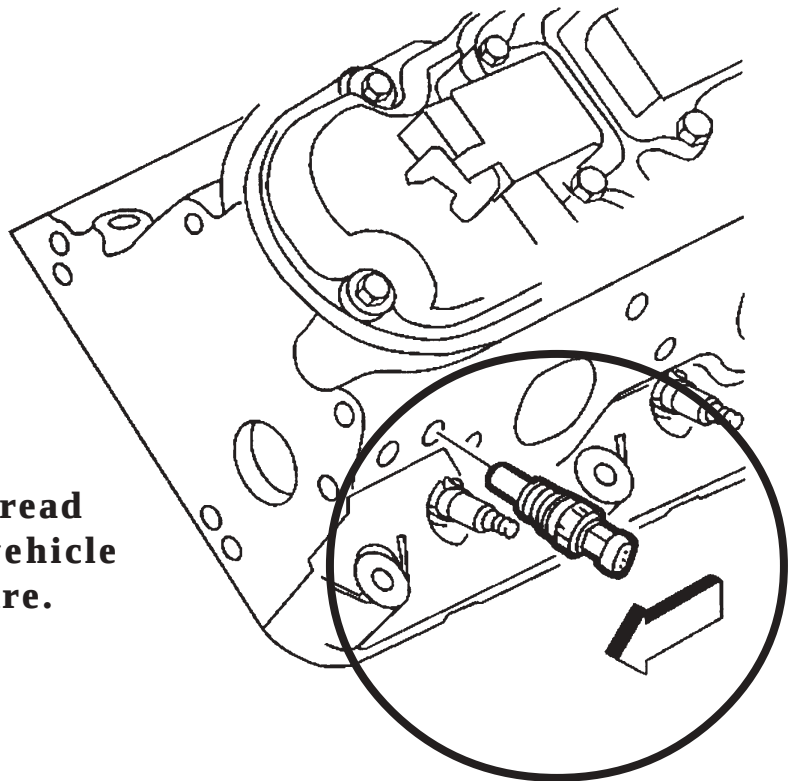
The most common cause of this problem is related to the coolant temperature sensor reading. Generally, ECT DTC's will not be set.

**Generally the ECT will read about 60°F (15c) with the vehicle at full operating temperature.**

Replace the ECT sensor
