2010

**TECHNICAL
SEMINAR**

This manual has been developed by the Automatic Transmission Rebuilders Association (ATRA) Technical Department to be used by qualified transmission technicians in conjunction with ATRA's technical seminars. Since the circumstances of its use are beyond ATRA's control, ATRA assumes no liability for the use of such information or any damages incurred through its use and application. Nothing contained in this manual is to be considered contractual or providing some form of warranty on the part of ATRA. No part of this program should be construed as recommending any procedure which is contrary to any vehicle manufacturer's recommendations. ATRA recommends only qualified transmission technicians perform the procedures in this manual.

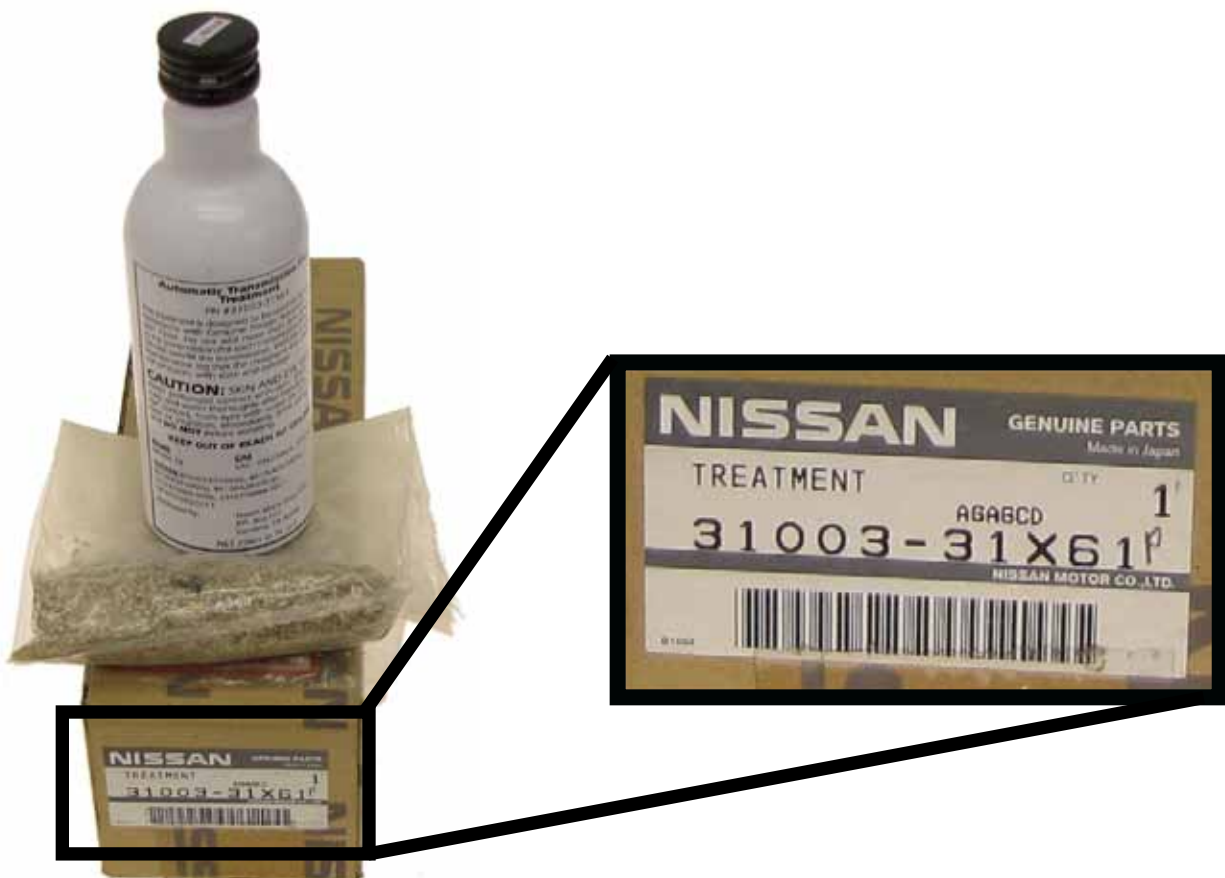
1999-2000 Nissan Quest or Altima with a RE4F04A transmission may experience a chirp type noise coming from the transmission during the 2-3 shift at light throttle.

This chirp noise may be coming from the high clutch assembly. Adding two (200cc each) bottles of ATF Treatment to the transmission fluid will correct this problem. Nissan's ATF treatment part number is 31003-31X61P.

Caution! This is a metallic container and it is packed in oil absorbent material. Be sure to wipe the bottle clean to prevent ATF contamination.

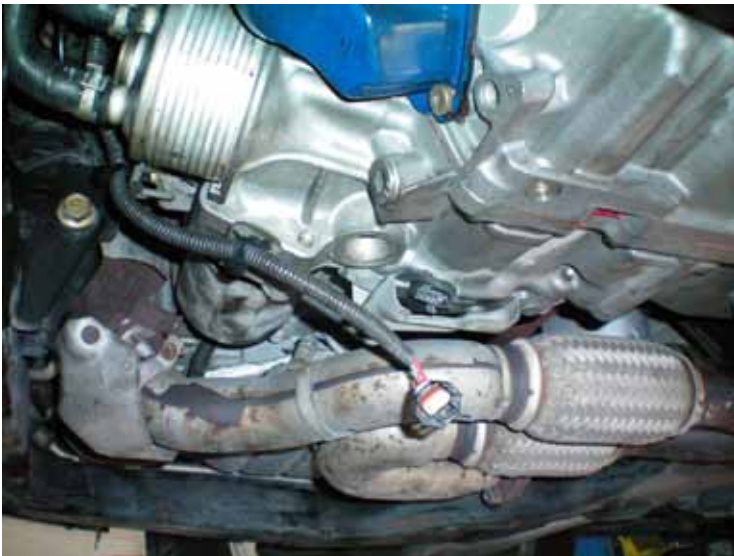
2004 & up Nissan Maximas with the RE5F22A transmission may be experiencing codes for the Crank and/or Cam sensor causing the transmission to go into failsafe. There will be no communication or codes set in the transmission module. The problem is usually a broken wire at the sensor. To correct the problem repair the wiring at the connector or replace the sensor.

The Crank Sensor is located under the vehicle between the transmission and engine, attached to the bottom of the bellhousing.

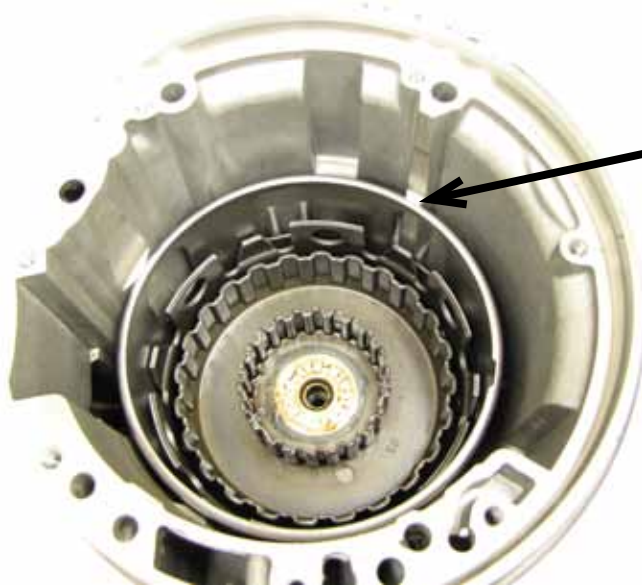
RIGHT!

The support is indexed correctly. A mark can be made on the case to easily identify the correct depth in the case.

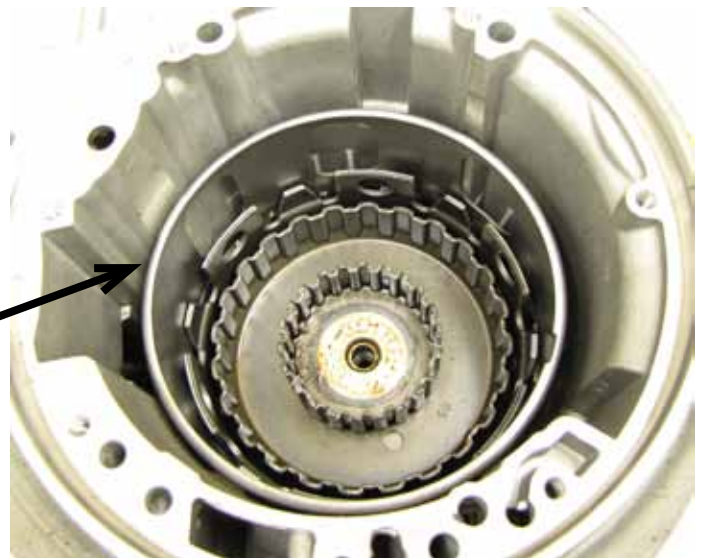
WRONG!

The B2 clutch support is NOT indexed correctly note the index mark is not visible.

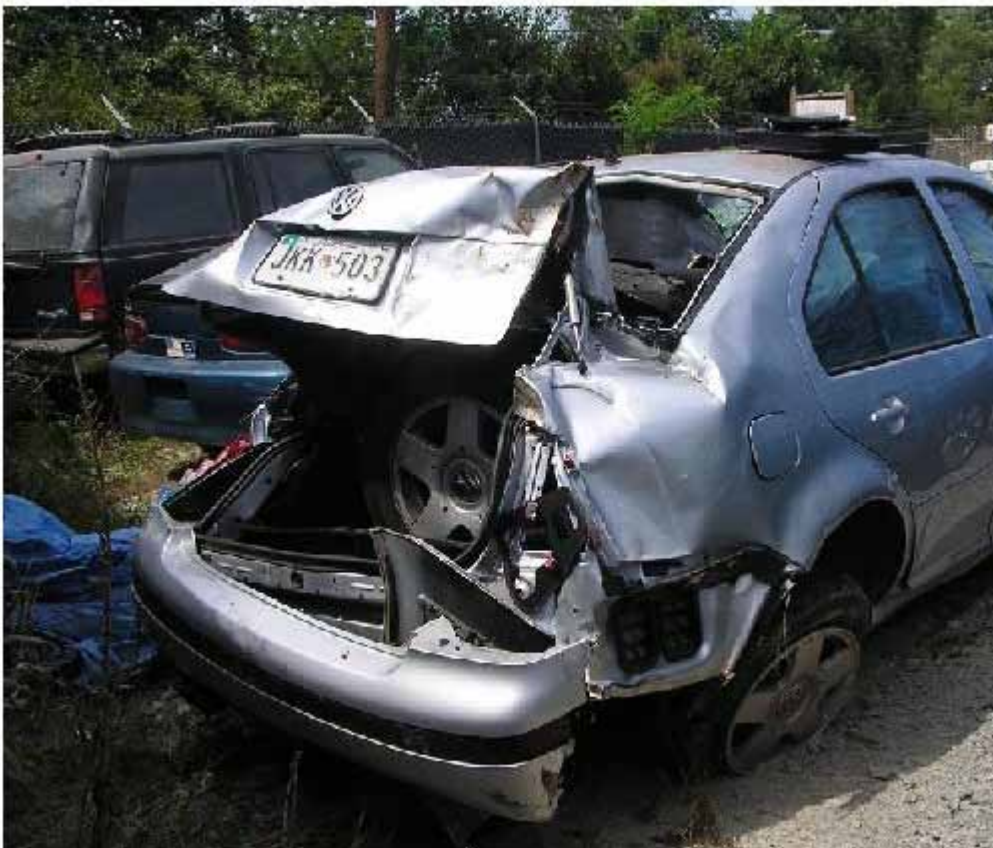
A staying in Neutral (TCM commanded) problem with no codes that could effect 2001-2003 VW Jetta vehicles may be caused by the brake light bulbs or the brake switch. The brake light system is directly related to TCM function. Make sure to check the brake lights prior to diagnosing this concern. Replace the bulbs or brake switch if necessary.

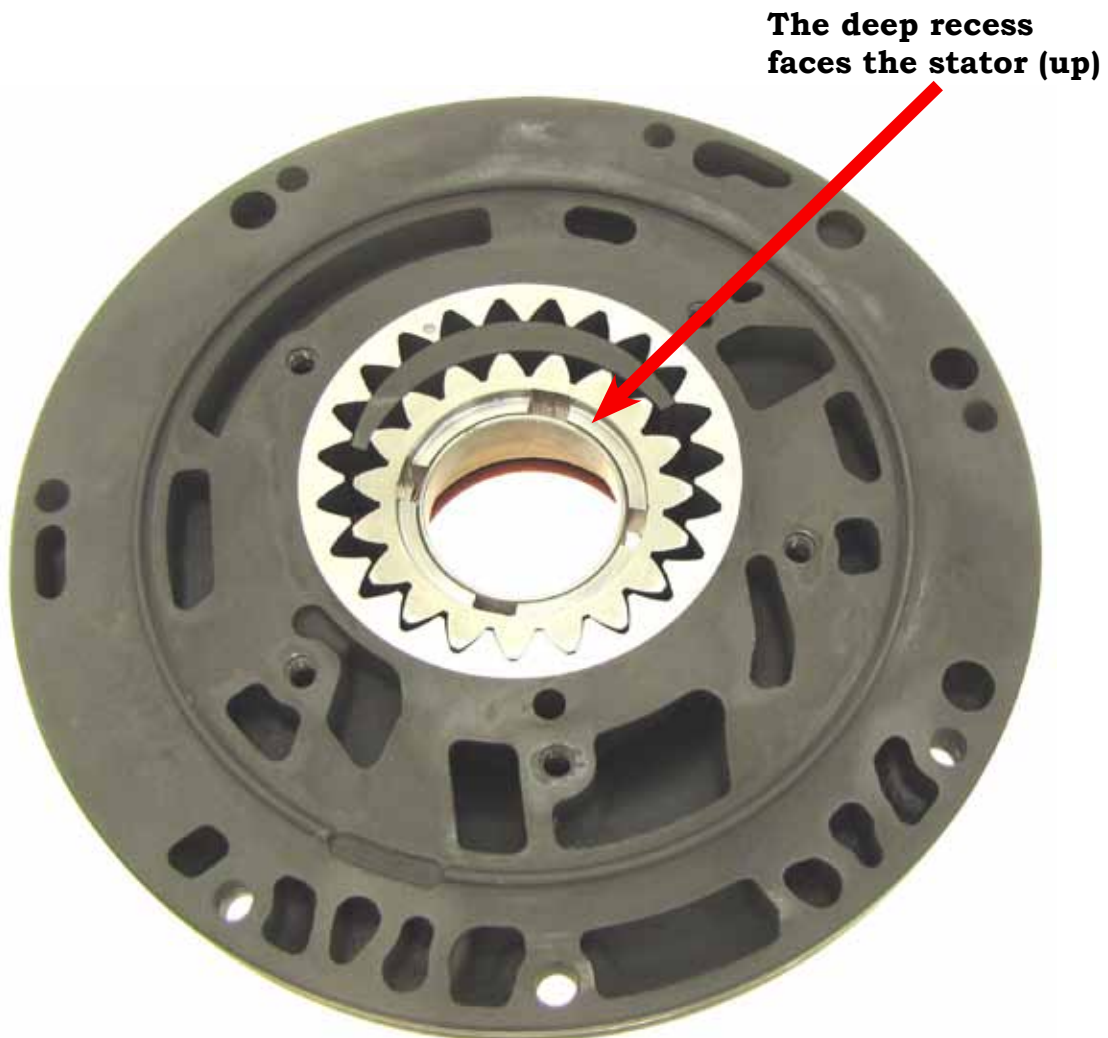
Code 1192 may be caused by installing the inner pump gear incorrectly. The correct way to install the inner gear is to have the deep recess facing the stator support.

Also make sure the correct torque converter is used. Some vehicles built after 2000 used a needle bearing located in the support converter shell to support the input shaft. The other design did not have a needle bearing on the converter support. Refer to ATRA Bulletin #1090.

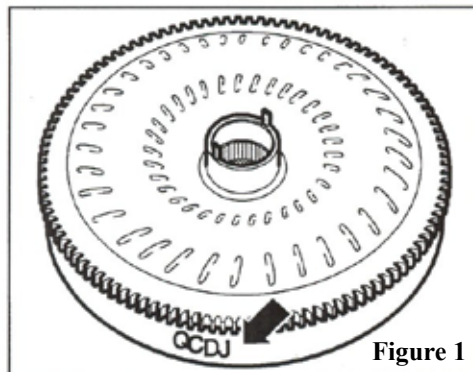
Figure 1

Starting in the model year 2000, some 01M transmissions started using a converter with a needle bearing between the turbine shaft and converter. The converters which include the needle bearing can be identified with D, H or J in the 4th digit of the converter code. See Figure 1.

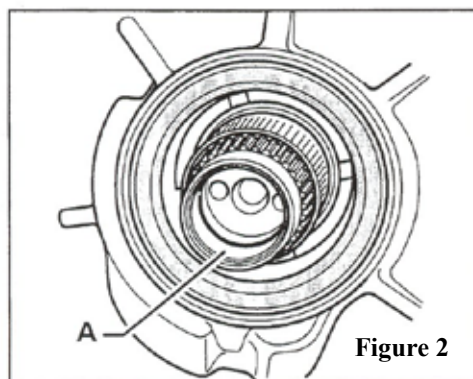
Figure 2

When a converter that includes a needle bearing is used, the bushing at the end of the turbine shaft MUST be removed

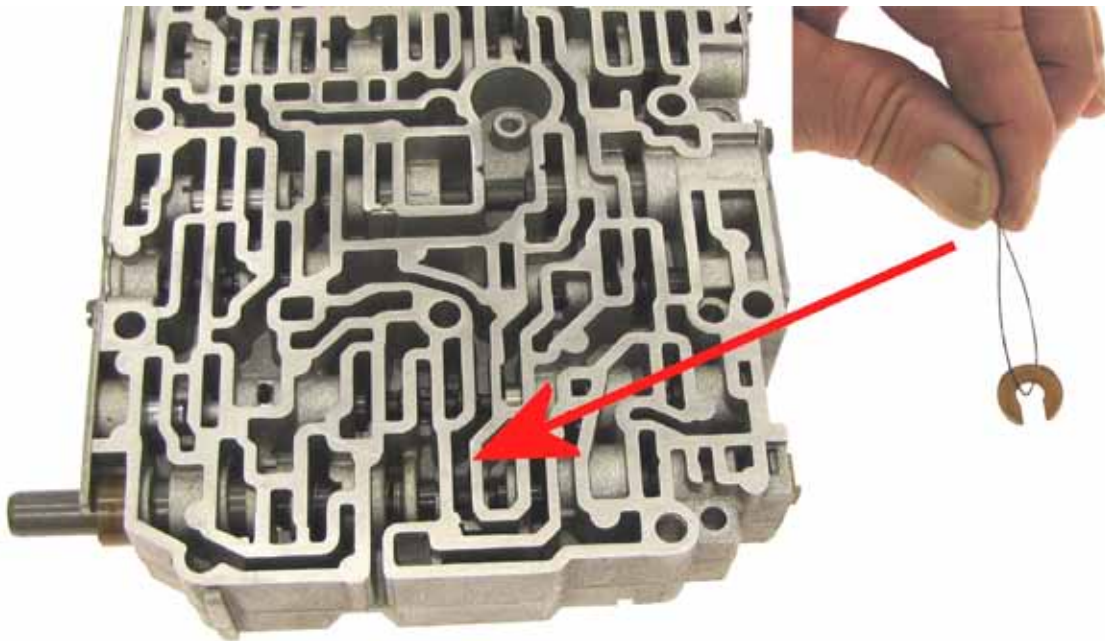
Most late shifts problems on the Mercedes 722.3/4/5 are caused by a sticking throttle valve in the main valve body. It may seem free if you're checking the valve while still in the valve body with a scribe or small screw driver.

You must remove the throttle plunger and throttle valve to verify the valve's movement. You won't be able to see the area where the throttle valve doesn't return to its correct location in the bore. You must remove the plastic throttle valve "E" clip, to gain access to the throttle valve.

The availability of this clip is almost impossible to locate. Luckily there is an easier way to remove the plastic "E" clip without breaking it with the use of fishing line. Thread the line under the clip, then simply pull up on both ends of the fishing line and remove the "E" clip.

Work the loop under the clip and pull the clip straight up and out of the valve body.

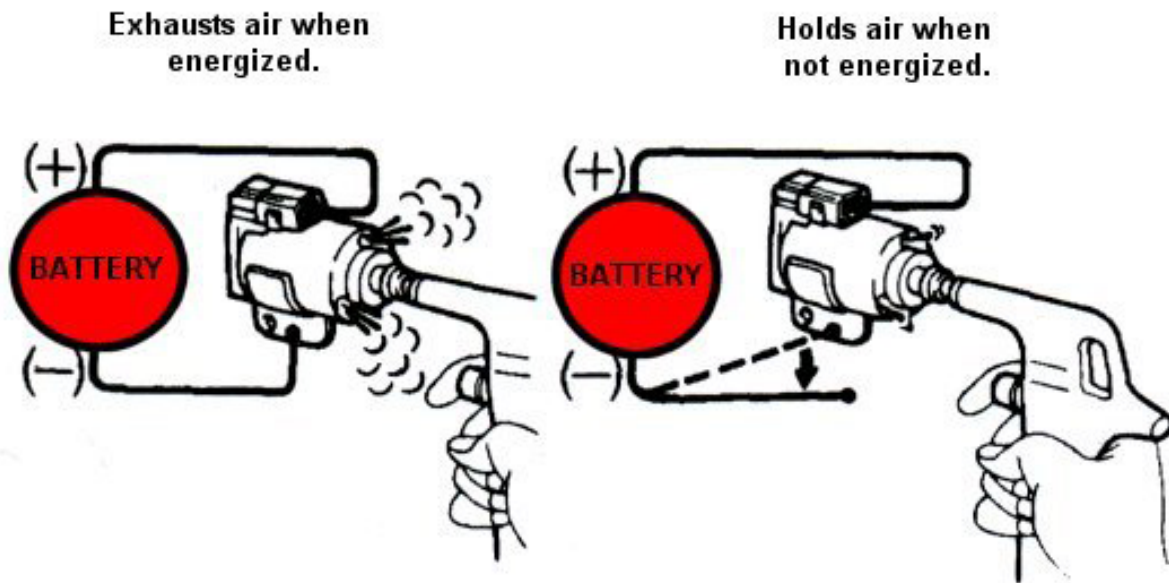
Code P0770 is a Shift Solenoid SL (TCC) malfunction and/or stuck off. Toyota has done a good job with keeping the lockup system simplified in most of their units. Even though P0770 mentions the TCC solenoid in the definition, rarely is it the problem.

The solenoid is a simple on/off type solenoid that can be tested on the bench by blowing air into the snout of the solenoid while turning the solenoid on and off with voltage. The valve bodies rarely have any issues with bore wear because the TCC valving is a simple on/off, switch valve type system. If the valve moves freely in the bore, then the issue is not likely in the valve body.

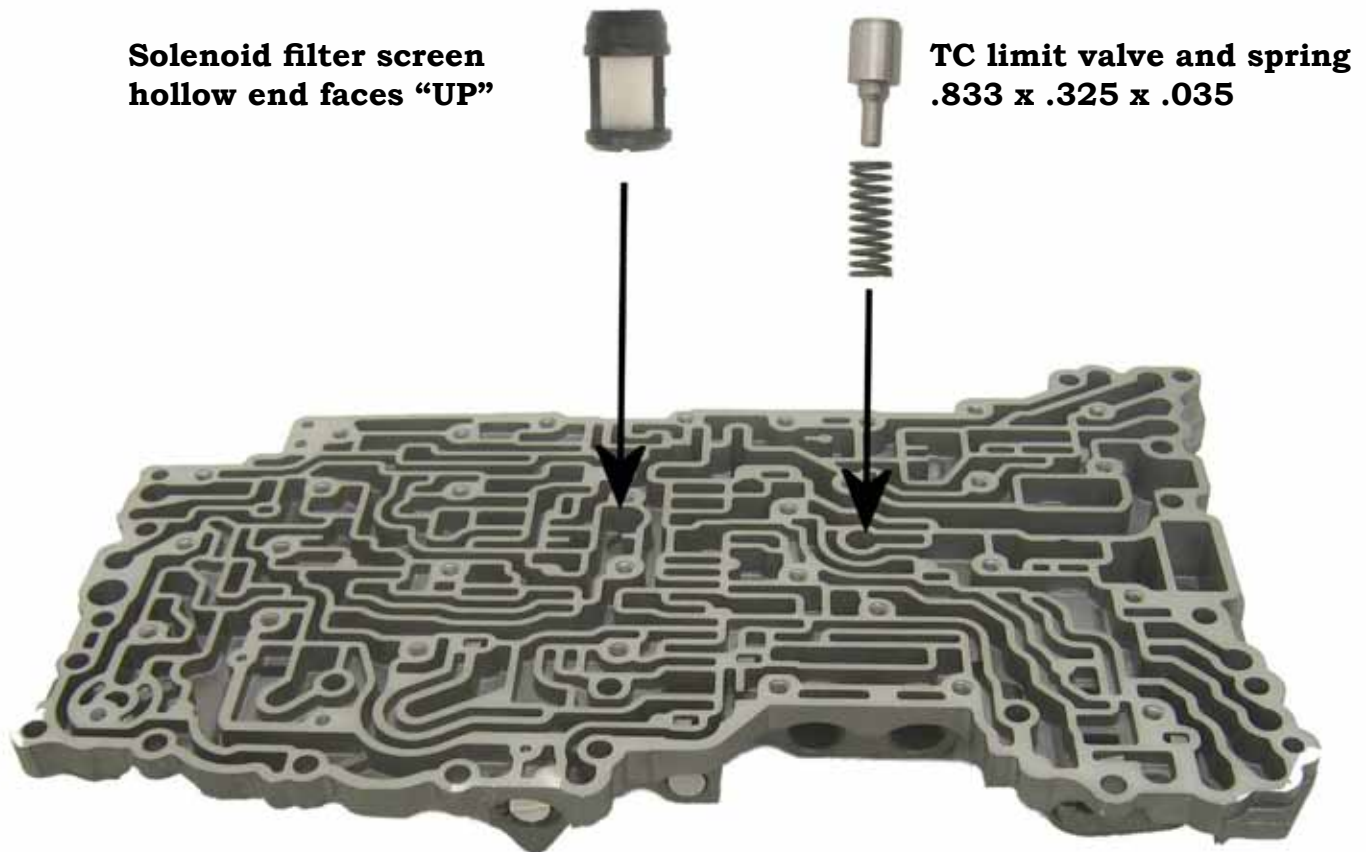
The solenoid filter screen must be installed open end "UP". When properly installed the screen will snap into the separator plate. The torque converter check valve must be installed as shown.

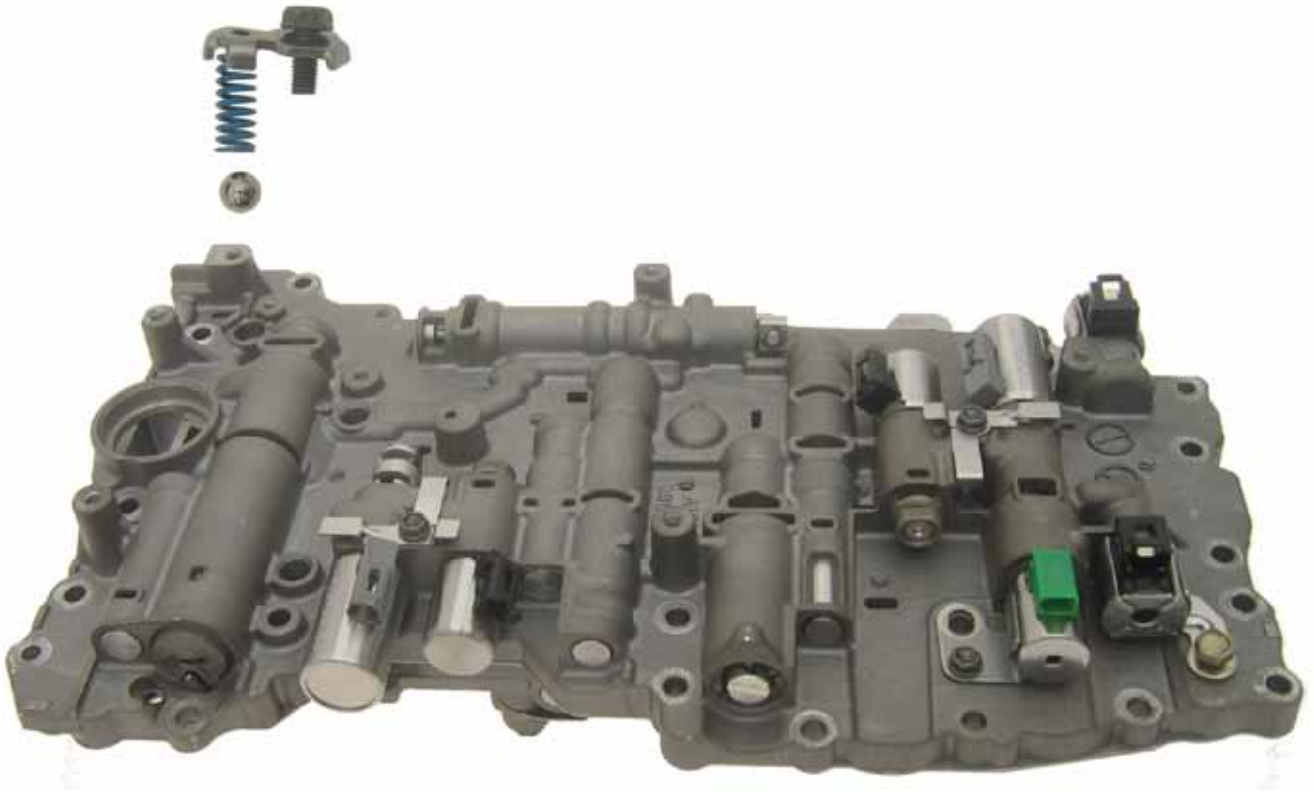
The pressure limit check ball is used for exhaust purposes due to extremely high pressure. The limit check ball will blow off at approximately 300 psi.

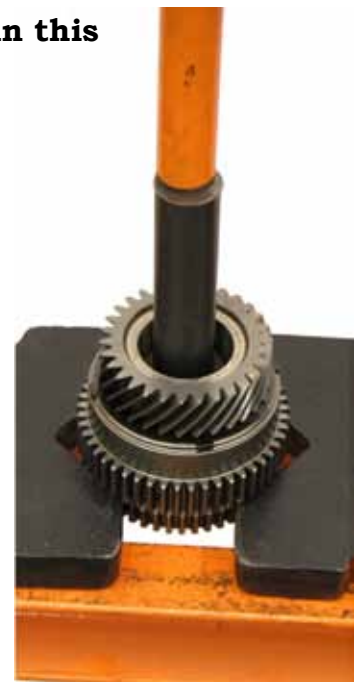
**First Hold Clutch
Hub**

Failure usually occurs in the low one way clutch (sprag) and/or inner sprag race (part of 1st gear). The outer sprag race (low clutch hub) in most cases may not need replacement.

Inner race inspection: The 1st hold clutch hub must be pressed out from 1st gear with 1st gear facing up. After the components are disassembled, 1st gear (inner race) can be inspected. Excessive wear on the 1st gear inner race will require replacement.

Check for wear here

Replace components as needed. If both races are fine then only the sprag element needs to be replaced.

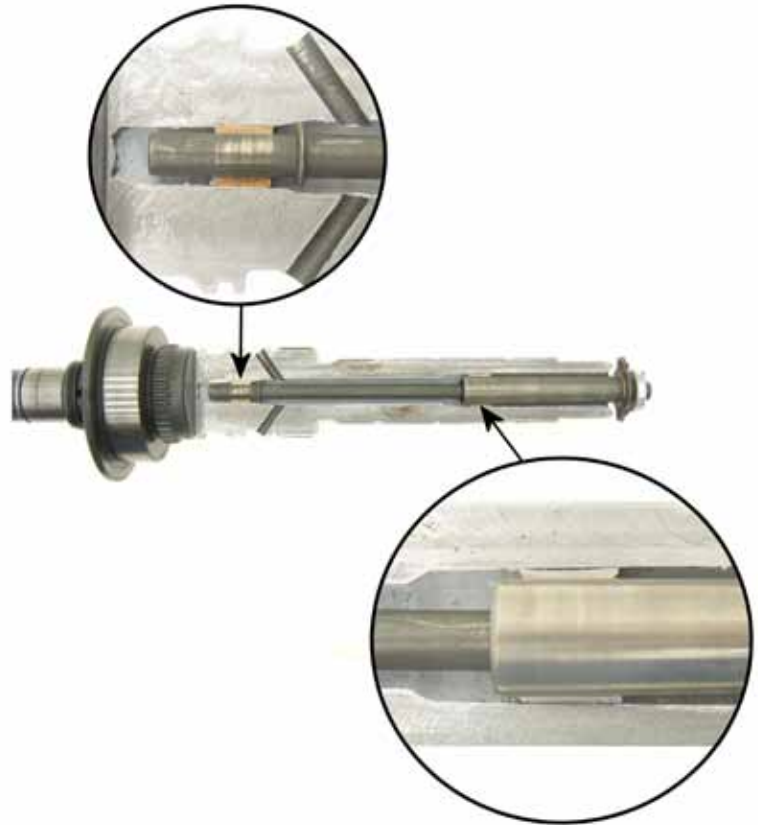
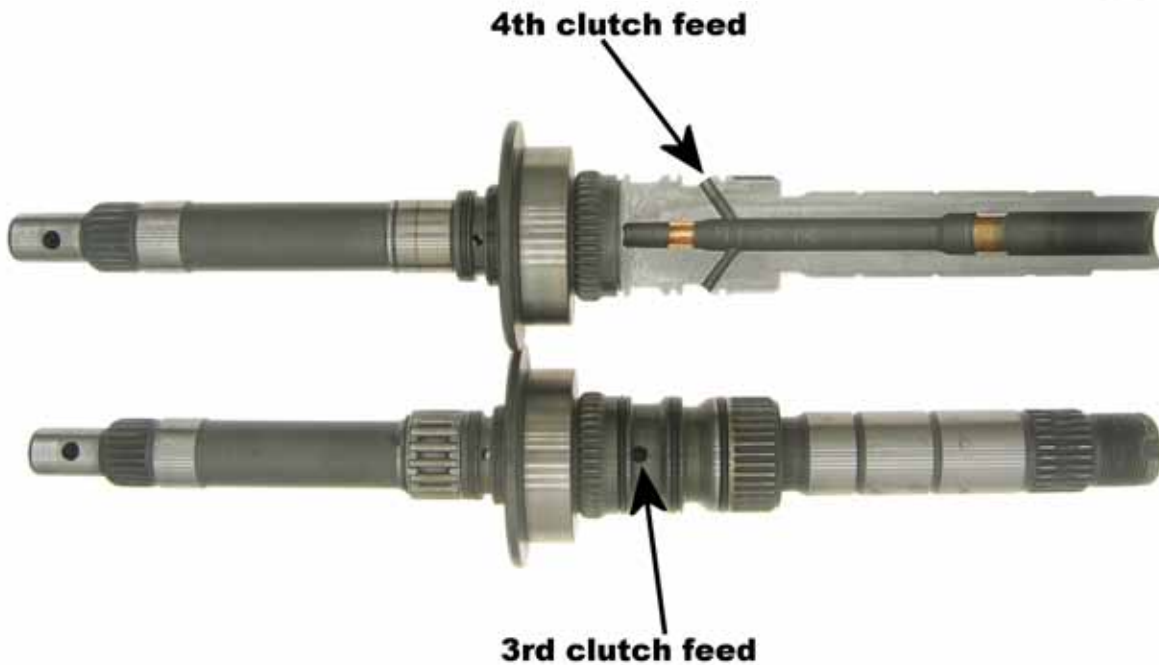
**BAXA/MAXA
Example**

Shaft Bushing Wear

Sealing bushings must be replaced if there is any failure with the shaft's bearings.

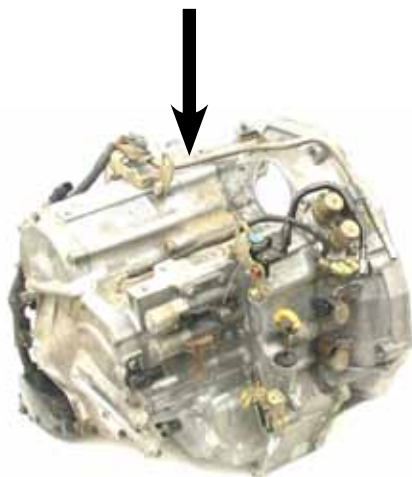
**2nd Clutch Pressure
Switch 4Cyl Unit**

The second clutch pressure switch is a critical input to the TCM/PCM for clutch timing control and clutch overlap during the 1-2 shift. A faulty second clutch pressure switch can cause one or more of the following symptoms:

There are several different switch calibrations used on the different transaxle/vehicle combinations. The switches have different closing pressures, and are identified by the color of the plastic connector. It is recommended that the switches only be replaced with the correct color. If you are not certain of the switch application it is recommended to order the switches from the dealer using the vehicle information to ensure getting the correct switch.

NOTE: The second and third clutch pressure switches are very sensitive to moisture and chemicals. Do not wash them with a parts washer or solvents.

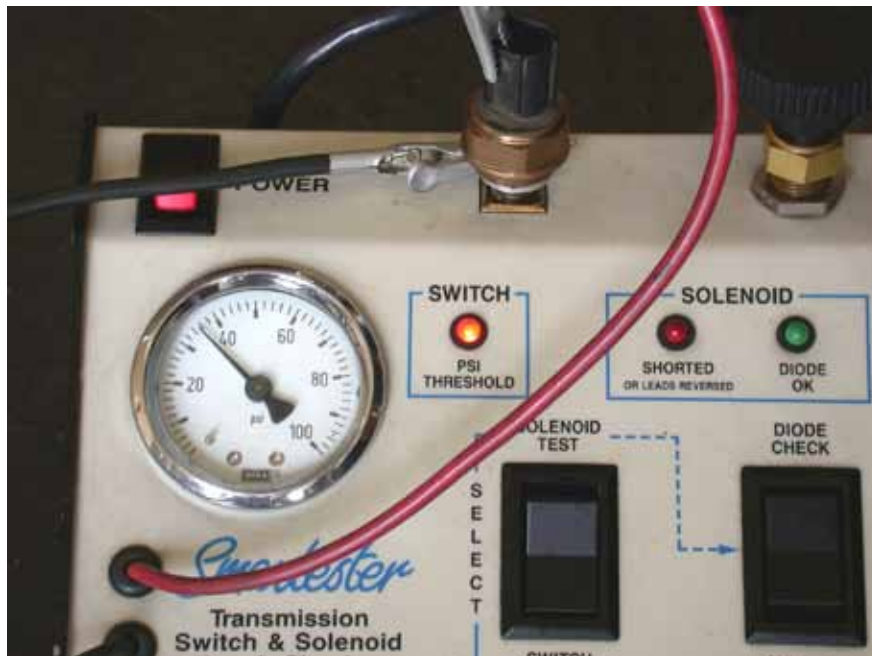
Switch “CLOSES” at 36 psi or greater

Do not allow electronic parts to soak in solvent; this can create after overhaul problems. If the valves in the linear solenoids show signs of scratching or galling, they should be replaced.

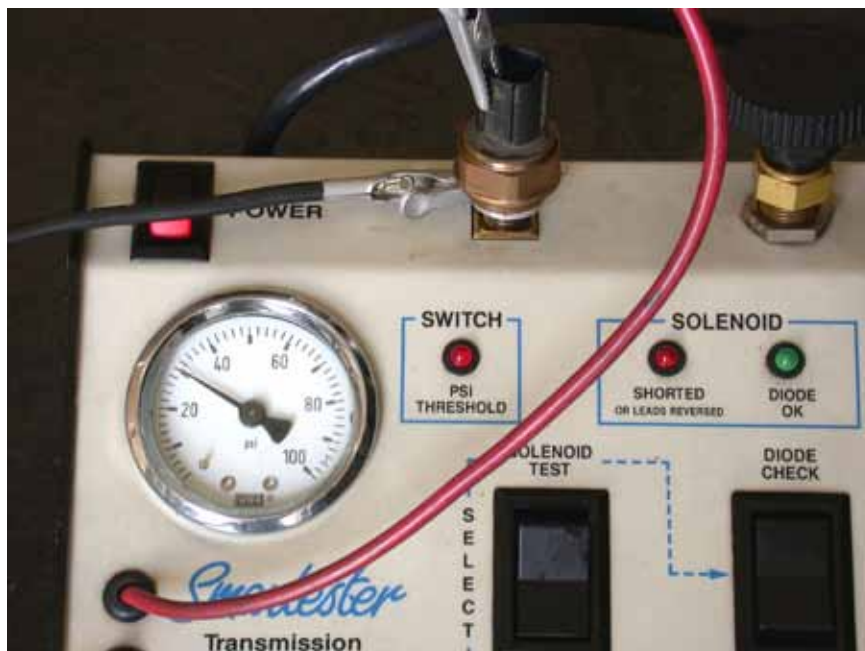
Switch “OPENS” at 35 psi or lower

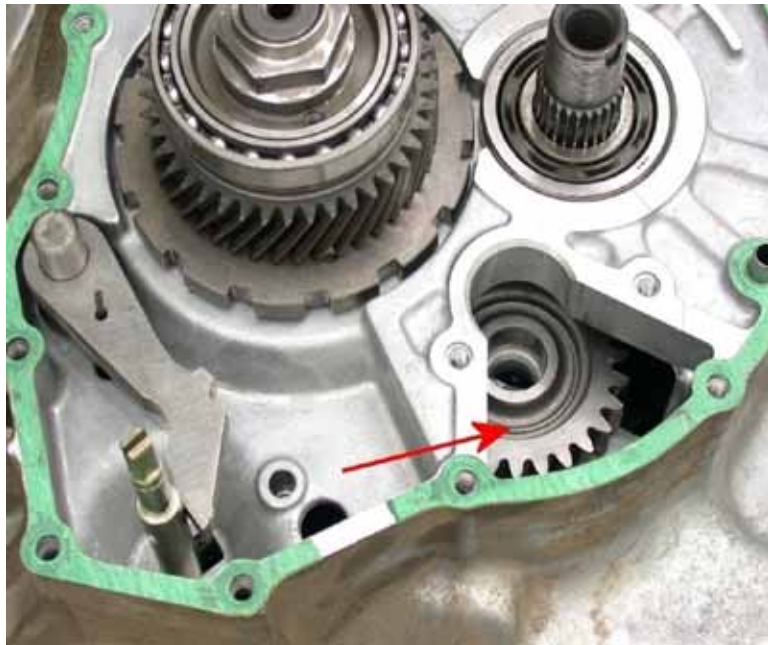
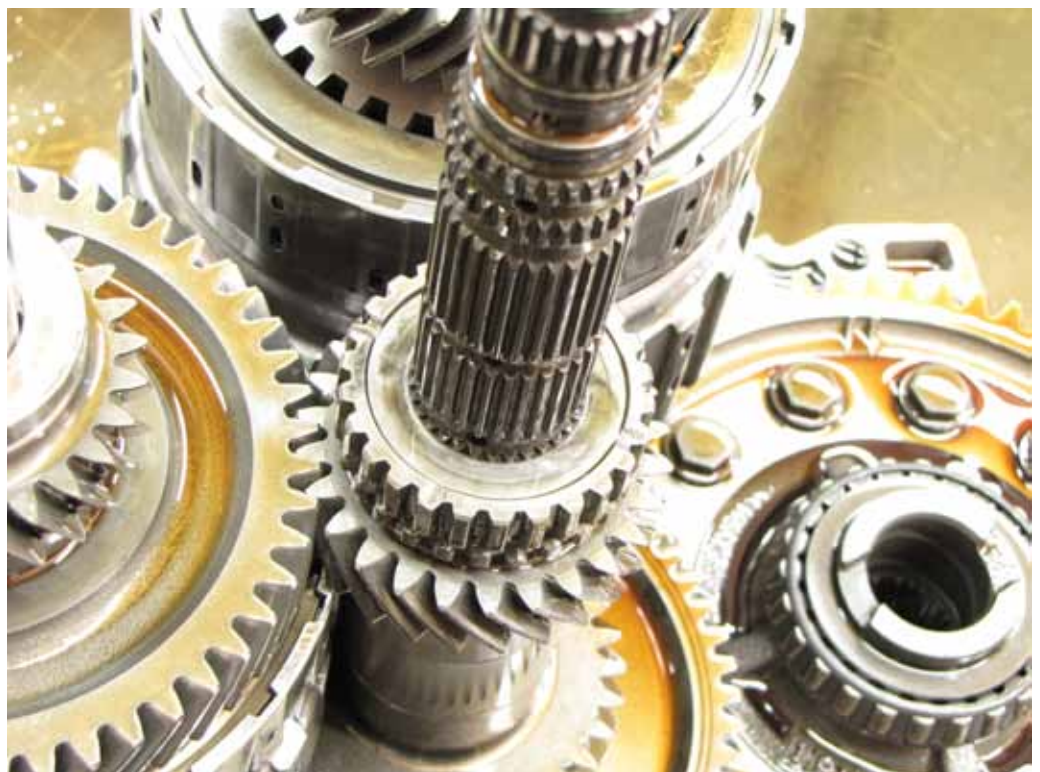
Assembly Tips

Note the position of parts on paper. Some units will allow the reverse idler to be installed upside down. This will create a noise or grinding complaints.

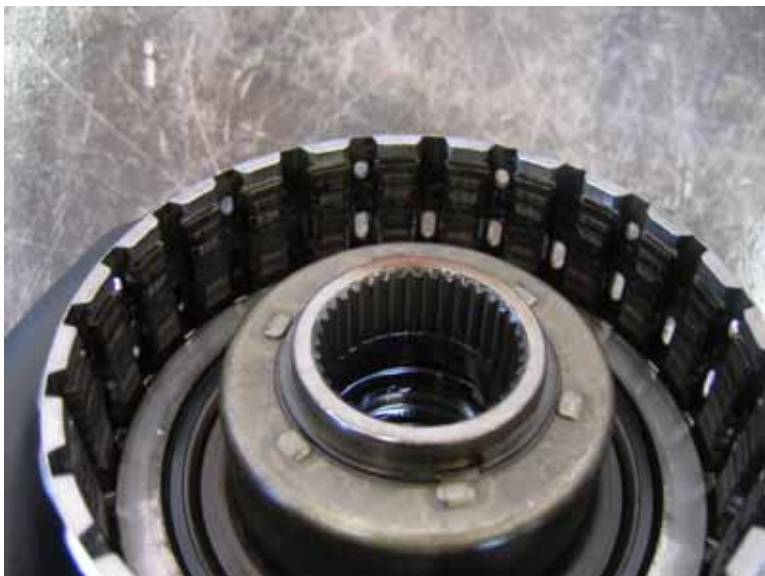
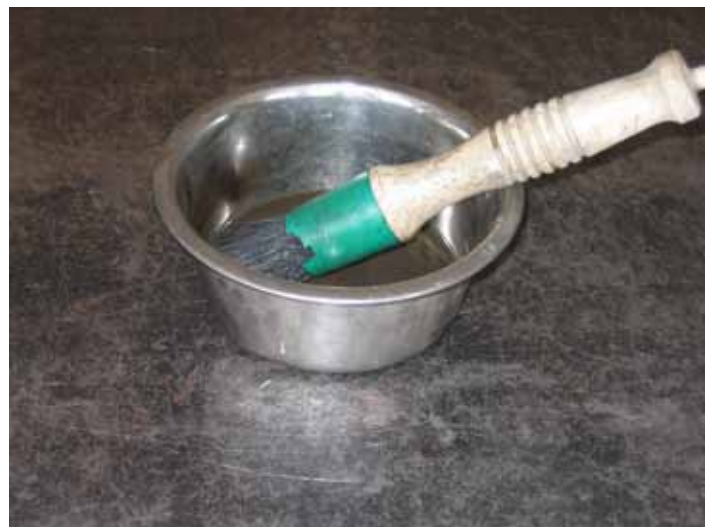
Cleaning and Inspecting (continued)

Debris can build up and stick to the sides of the drum, using solvent to loosen the material before placing the drum in the hot tank will help clean the debris out while in the washer. Skipping this step will cause the debris to come loose while you're blowing them dry with compressed air, or even worse, when the clean, fresh transmission fluid starts circulating through the unit on the test drive.

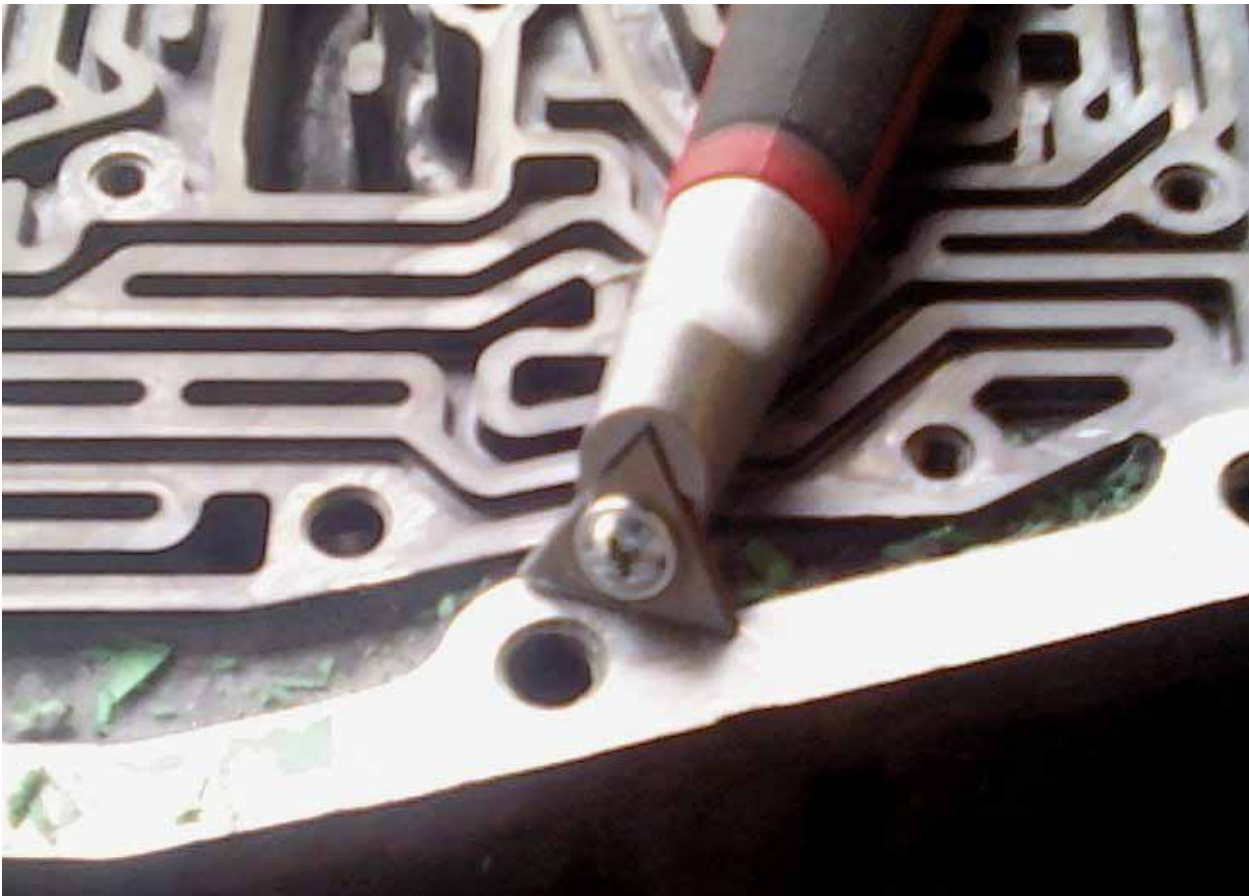
Honda case gaskets are extremely difficult to clean off of the case. Fight the urge to clean them off the easy way with angle grinders and abrasive pads. The channel casting for the valve body is too close to the gasket surface and can easily be damaged using any power tools.

Power tools will start to grind on the aluminum once past the gasket and cause excess debris to contaminate the case and your work area. Take the time and care to remove the bulk of the gasket with a razor blade and then use a carbide tipped scraper like the one shown below to get those stubborn pieces off.
