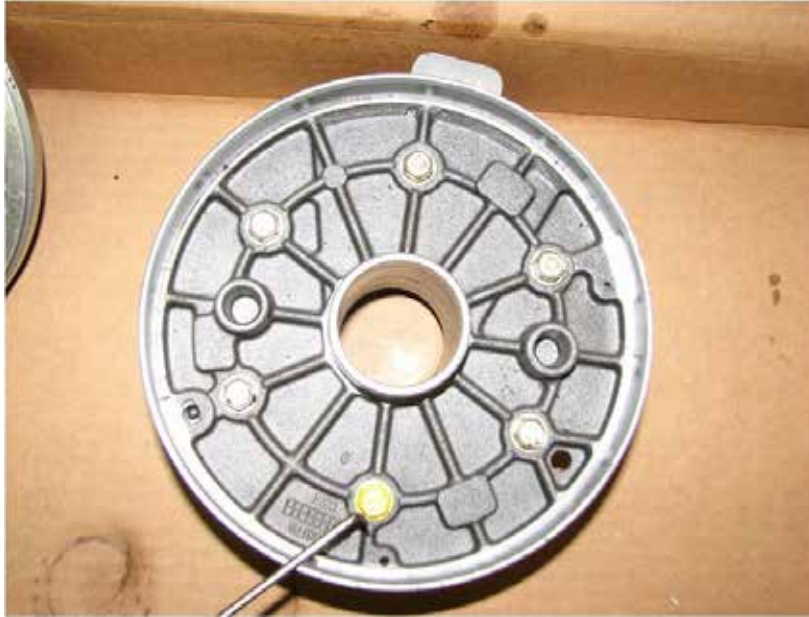
Burnt overdrive clutches can be caused by a bad piston casting. Check the piston for proper machined area. If the area has not been machined follow these simple steps.

Mark the head of the bolt with paint or a marker that will transfer to the piston surface.

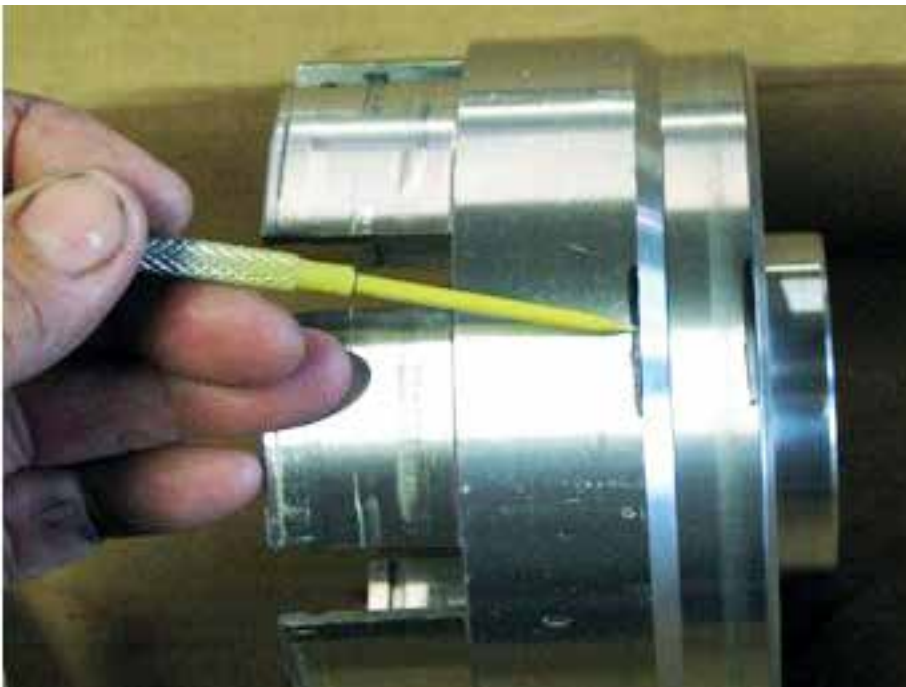
A no forward movement condition can be caused by the underdrive molded piston seal being ripped. You might even see the input drum full of burnt clutches from the underdrive drum assembly. The underdrive piston assembly fits into the drum very tightly. There are cases of this piston being torn in brand new vehicles.

Make two marks on the old drum, the marks shown are approximate. Use a micrometer and depth gauge to accurately measure your cutting area. Cut the drum where the marks are located. This will leave you with the bottom half of the drum only.

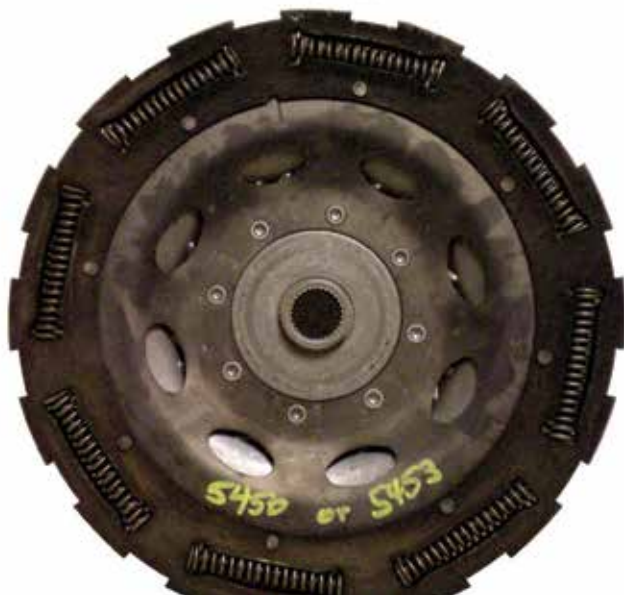
Medium Or Early Type Low Stall

After overhaul on a 2006 or later Dodge truck with a Multi Displacement 5.7L Hemi engine may have a complaint of TCC shudder during lockup apply. This may be caused by installing the wrong converter.

The Multi Displacement engine is designed to drop from 8 cylinders down to 4 cylinders in approximately 40 milliseconds during highway driving with no load. Some rebuilders use either damper style with the grooved clutch lining on either 5.7L Hemi type engine with the correct stall. The smooth clutch lining will cause a shudder during partial lockup (shown on next page).

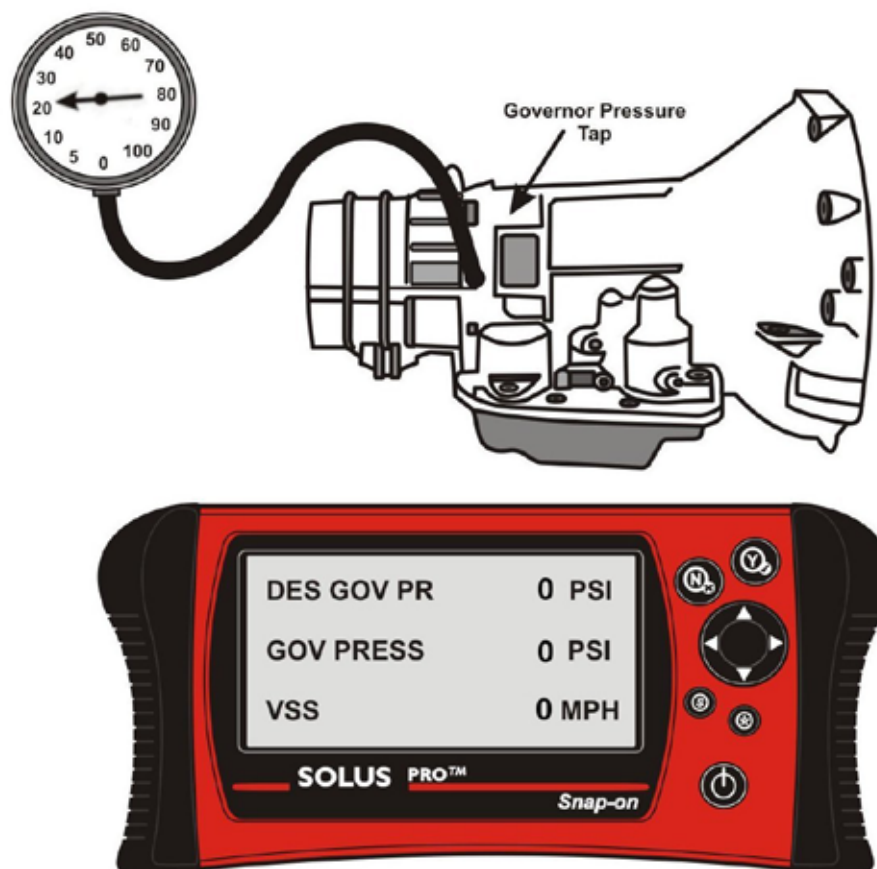
So you measure the voltage at the governor solenoid and sure enough the computer is sending 4.2 volts to the governor solenoid when it should be closer to 4.6 or so. Since the computer is sending the erroneous signal, you might suspect the computer — or even replace it.

What really happened though? The computer knows the truck is stationary so it wants to deliver zero PSI of governor pressure. It even says so on the scan tool. It will increase voltage to the governor solenoid until the transducer reports zero PSI. In this case the transducer reported zero PSI when it was actually at 22 PSI.

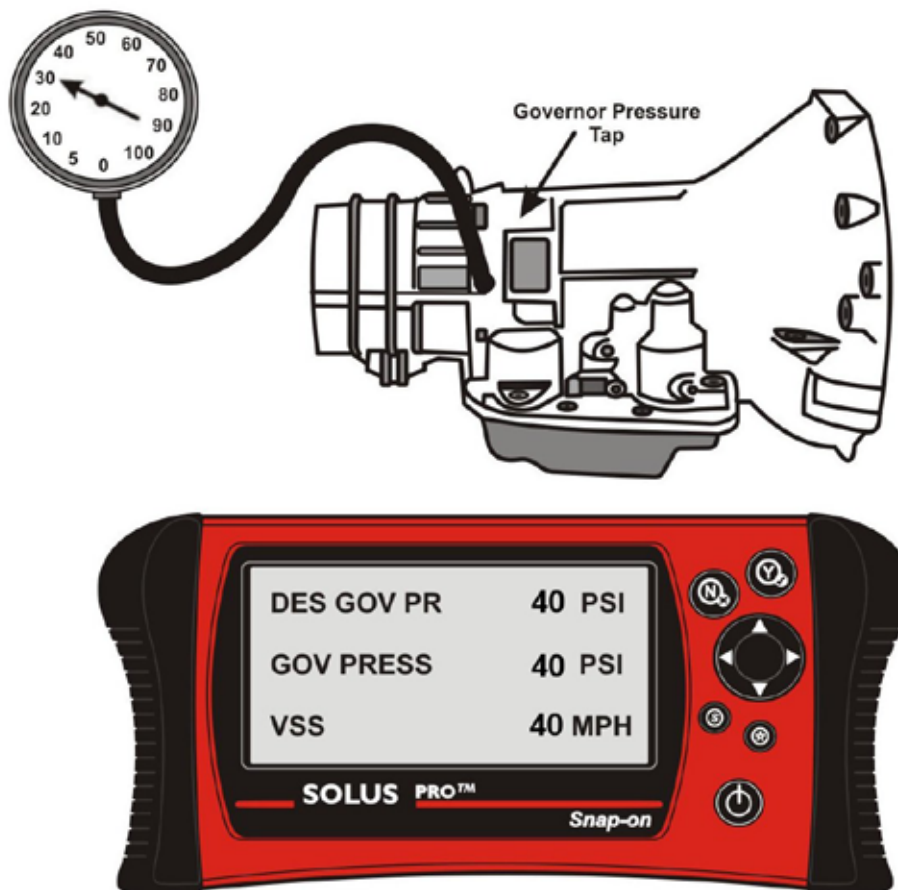
Scan tool data was correct: both desired and actual governor pressure moved with road speed and both were reporting the same value. But actual governor pressure, the reading on the gauge, was lower than the scan tool displayed. For example, when the scan tool readings showed 20 PSI, the gauge showed only 16 PSI. At 40 PSI on the scan tool it really had only 31 PSI on the gauge.

The transducer reported a higher pressure than actual. Remember, the computer will deliver whatever voltage to the governor solenoid necessary for the transducer to read correctly. If the computer wants 20 PSI and the transducer reports 20 PSI when it's only 16, so be it. Replacing the valve body fixed the problem because you replaced the transducer along with it.
