2013 TECHNICAL SEMINAR

**2013 TECHNICAL
SEMINAR**

The
Automatic Transmission
Rebuilders Association

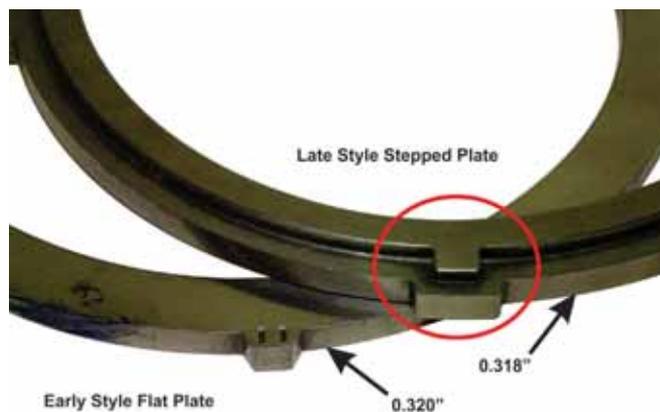
The transmission may exhibit an unusual bind in Reverse, Drive 3, and Manual Low; Drive 2 is working fine. The transmission may feel like it's taking off in a higher gear than 1st in the O/D position.

In 2006-and-later model 5R110W, the O/D pressure plate has a raised, stepped area on one side with an extended tab toward one lug. These plates are found mostly in the 5R110W with the PTO setup. These plates are "NOT" interchangeable!

After taking a close look at the transmission clutch apply chart, the one common denominator for a bind in all these ranges would be if the overdrive clutches were staying on all the time. The coast clutch is on in Reverse, Manual 3 and Manual 1, causing the bind. But it's not on in Manual 2 or the Drive range so it'll move, even though feels like it's in a higher gear.

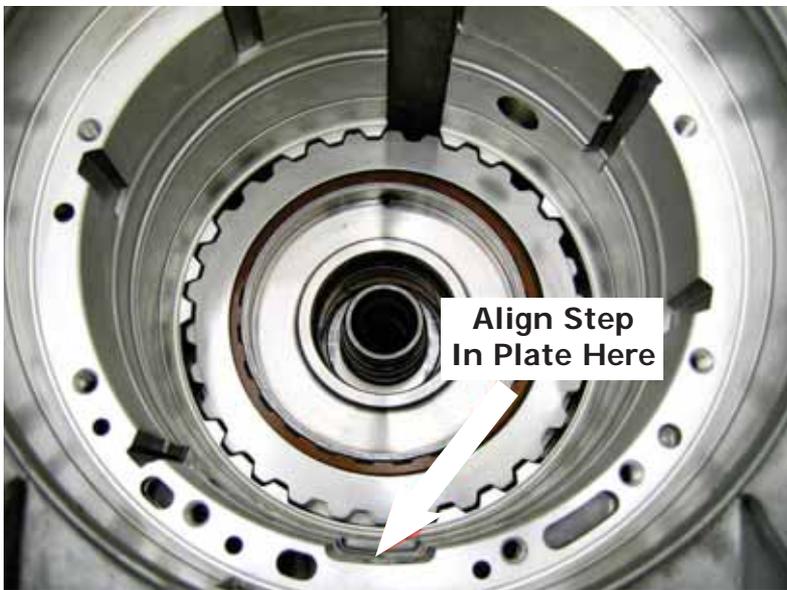
When you install the plate in the case, the extended tab is supposed to face the valve body, or the 6 o'clock position with the flat side up. If you don't place the snap ring opening in the proper location during a rebuild (incorrect installation shown below), the O/D clutches will mechanically lock when you bolt the pump to the case. If you make this mistake, you'll have no choice but to remove the transmission from the vehicle and correct it.

**Incorrect Snap Ring Location
This Area Must Be Kept Open**

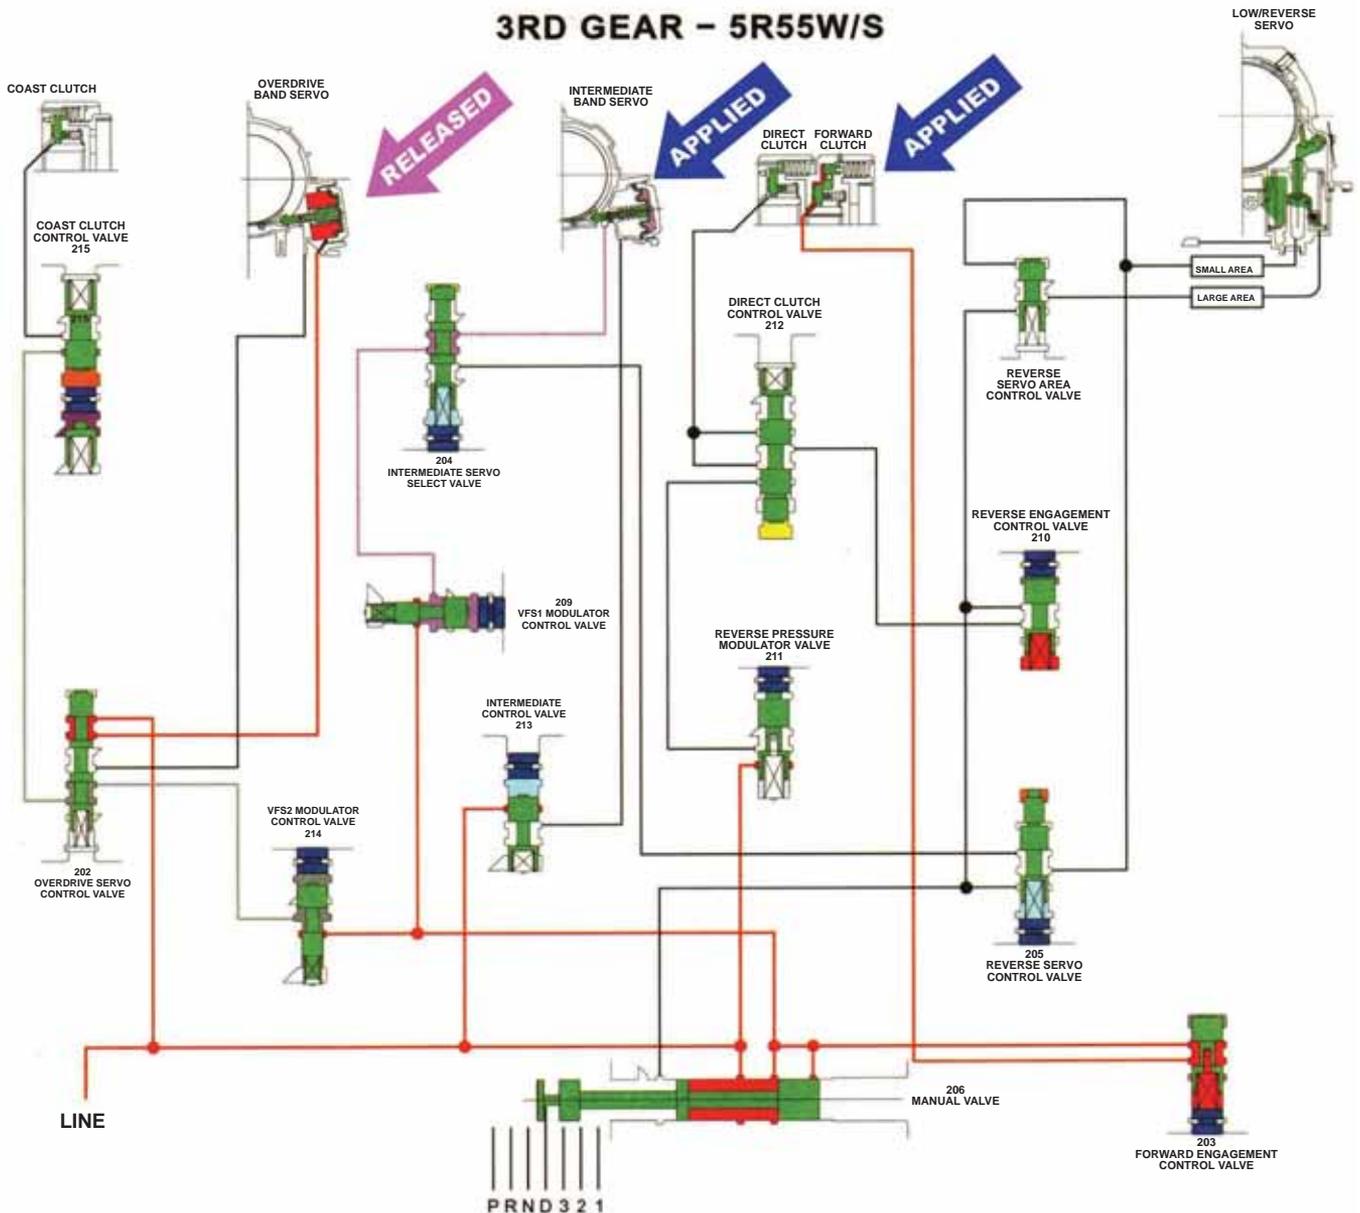
5R55W/S

After many tests and countless hours reading hydraulic schematics, measuring valves, and applying the math. We discovered; there's a slight difference, but a difference nonetheless in solenoid output. When we tested the PCA solenoids from the different solenoid packs, we found that at 0.6 amps, there was a 4 psi difference.

That doesn't sound like much but it becomes a big deal when it comes to overall pressure in the system. The 4 psi difference equates to about 30 psi of mainline pressure, enough to cause the problems we've been encountering. In nearly every case, replacing the solenoid pack corrects the problem.

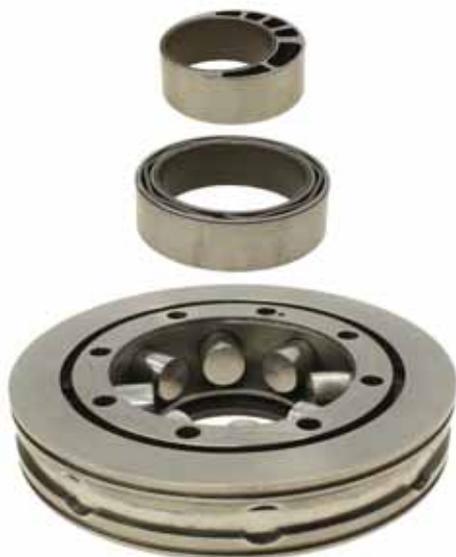
Remove the eccentric then pry out the contact ring.

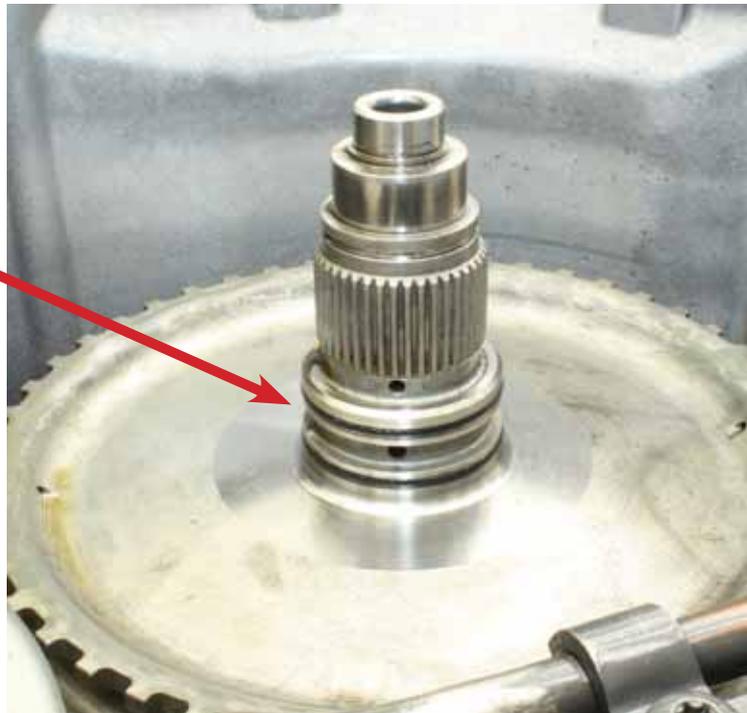
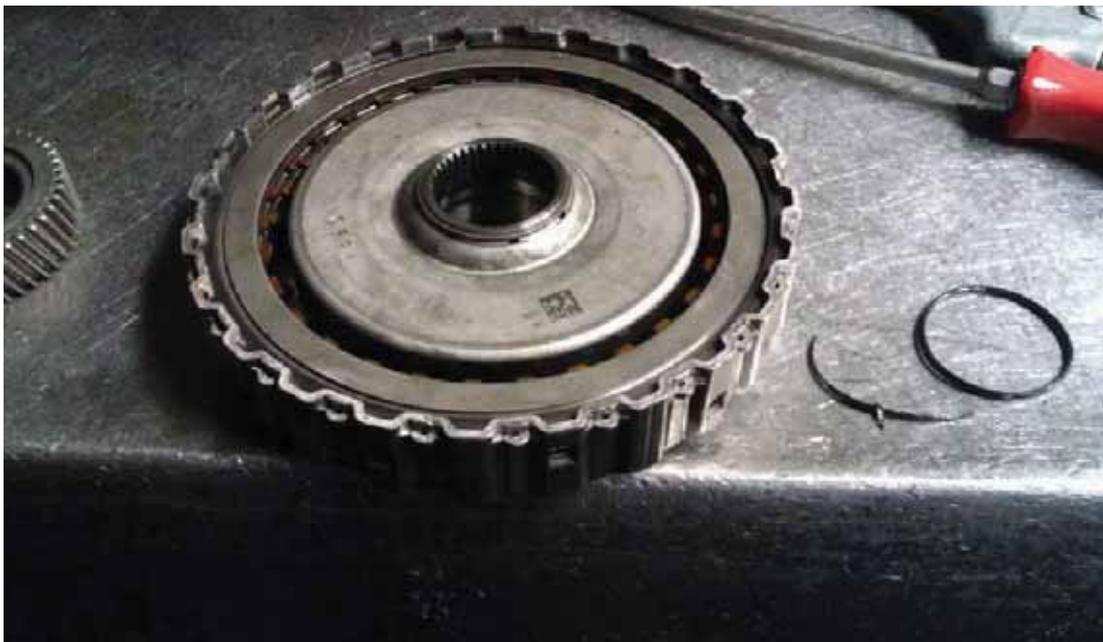
CFT 30

After disassembling the unit we found the forward clutch drum O-rings were cut and damaged. There are aftermarket companies offering seal kits and replacement parts for this unit. Replacing the seals fixed this unit, and resealing the transmission was simple with no hassles.

Always inspect the
forward clutch sealing
rings for damage.

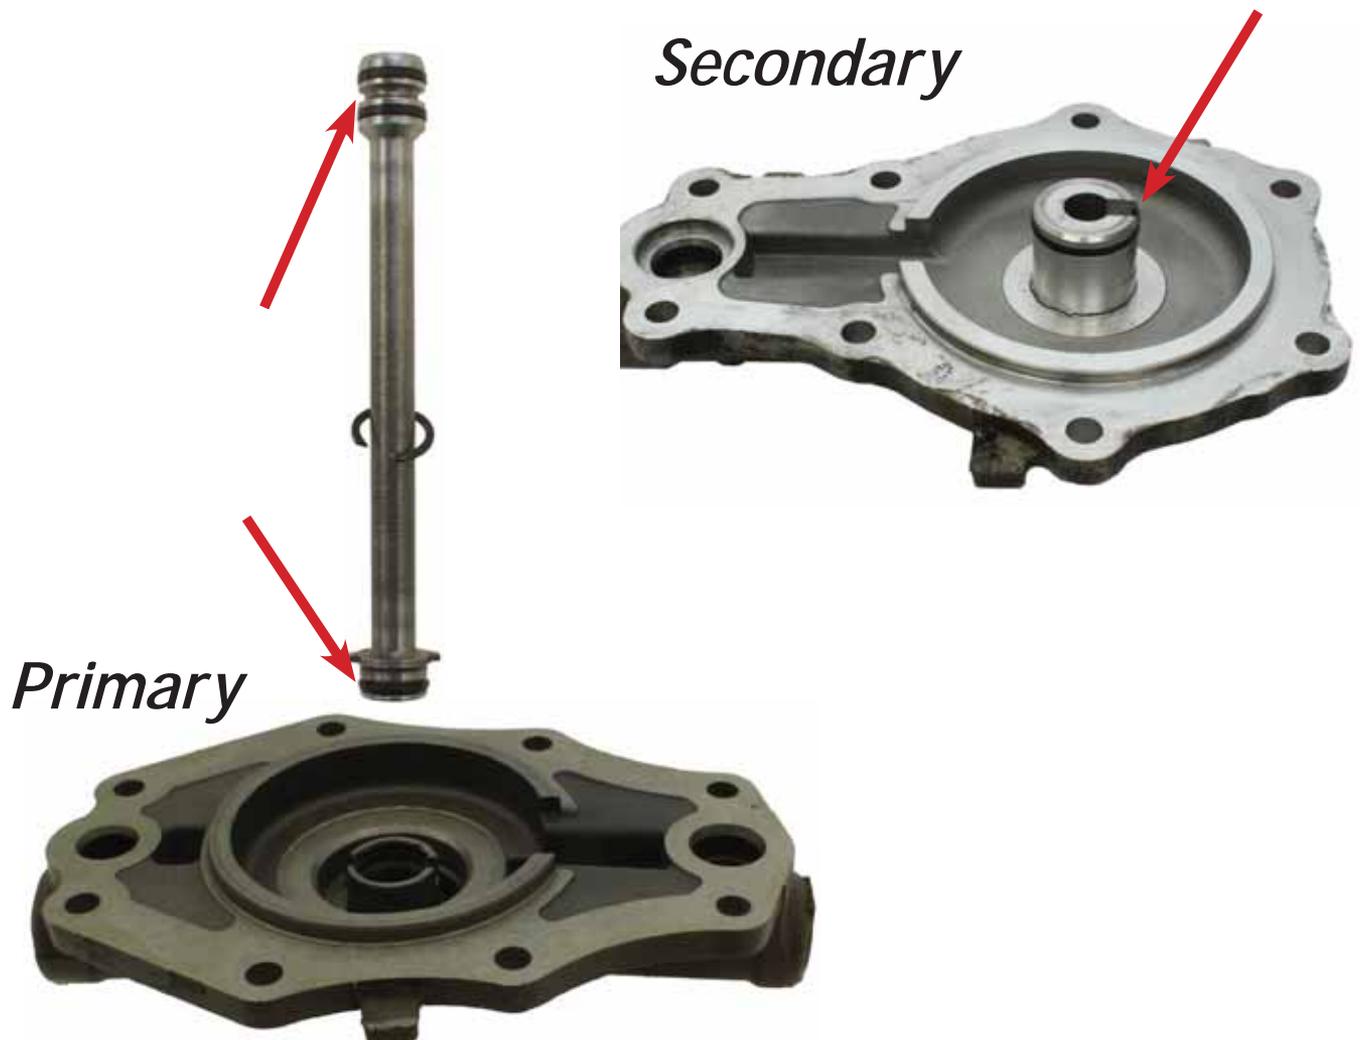
There are other pressure issues that are associated with pressure codes. One common problem we're starting to see is variator tube failure.

You can replace the feed tube seals and sealing rings without taking the variators and belt out of the case.

Always replace the tube seals
