# Welcome To Today's Presentation 6L80/6L90

Steve Garrett  
ATRA Service  
Engineer

6L80 6L90 Webinar ©2017 ATRA. All Rights Reserved.

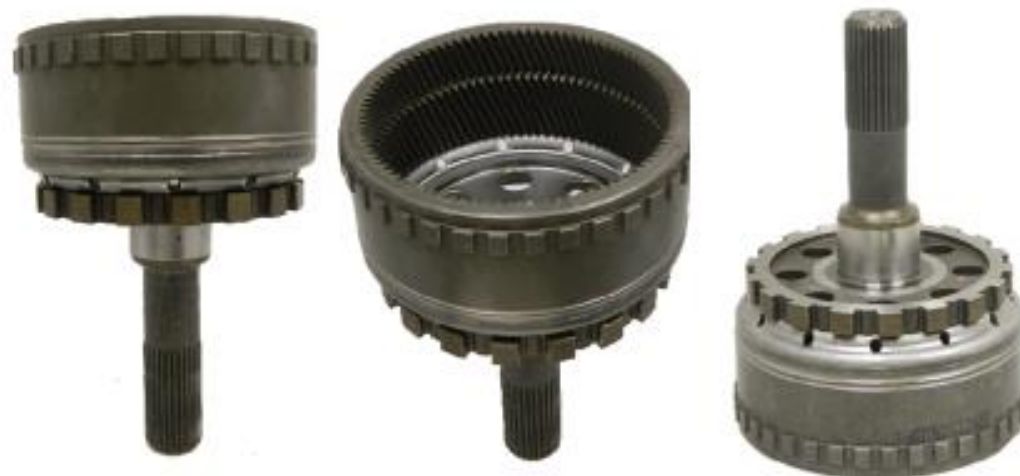
# Uni-Gear Update

An update occurred to all 6L80/6L90 applications starting in mid 2012. An updated output shaft and ring gear assembly was implemented. The update was a mid year production running change that was not fully implemented in all models until late 2014. 2012/2014 model year units may be equipped with either design output shaft. The updated design uses a different ISS/OSS assembly. The updated design can be interchanged with the earlier design as long as the speed sensor is the correct design for the output shaft assembly being used.

24265535 Previous Design Input & Output Speed Sensor Kit (6L80 and 6L90, All Models)

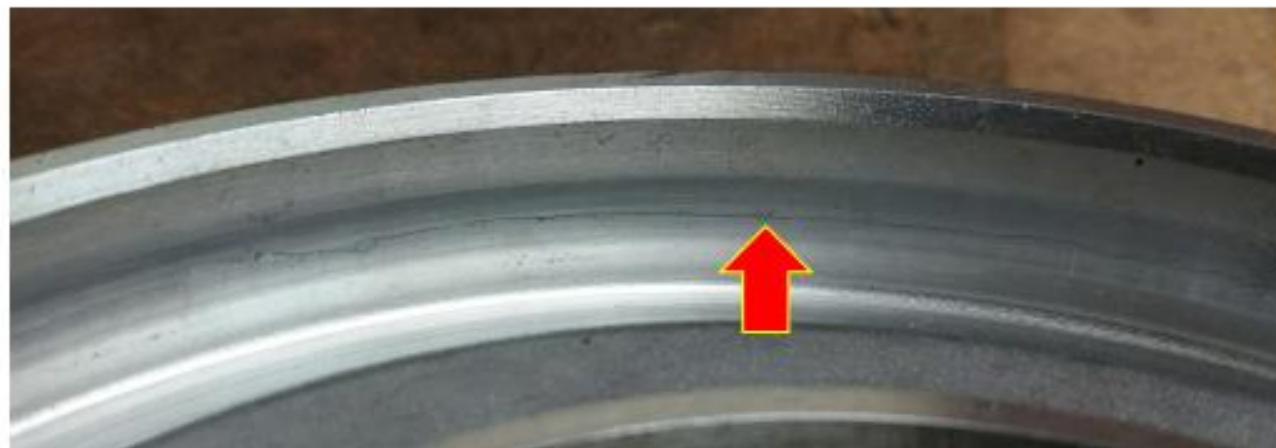
# 1234 Piston

2011 models received an updated 1234 piston. The update was due to cracks developing in the piston leading to leakage and failure. (No movement forward/slips going forward, DTC's set) The updated design has the ribbing redesigned to address piston breakage issues. The updated piston has part number 24238700 cast into the piston. The updated design will back service 'most but not all' models and years. NOTE: The updated piston is also cracking, just in a different area, so you may want to consider using the aftermarket billet design piston.

A broken or cracked 1234 clutch piston is a common failure leading to burnt 1234 clutches and a slipping or no movement in 1<sup>st</sup> gear. GM redesigned the piston for this issue. The updated piston is still cracking with one exception, rather than a crack in the piston cavity, the updated design may crack where the piston contacts the plates or it can be cracked in both locations.

**Always inspect the 1234 piston  
for cracks no matter which  
version piston you have**

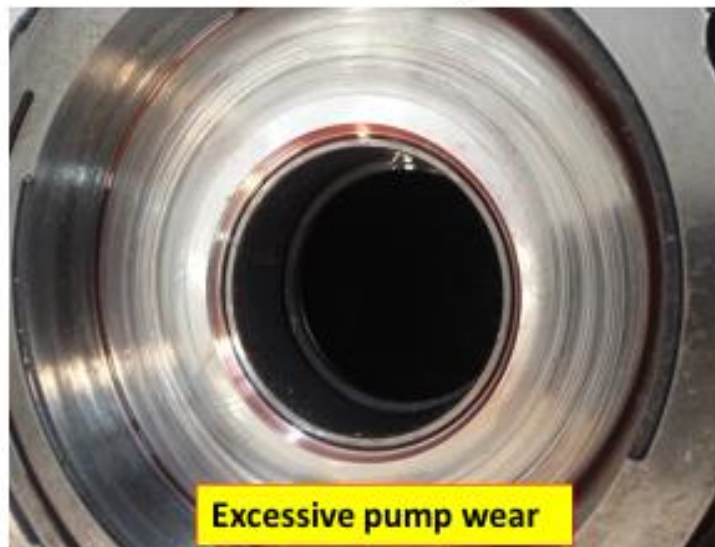
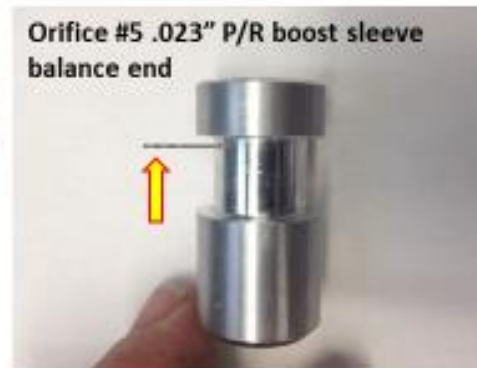
# Pump Wear Issues, 6L80/90 Slip, Low Line Pressure, Damaged Clutches

## Restricted Orifices are an Issue on the 6L Family of Transmissions

Converter damage can lead to restricted orifices.  
Always check and clean ALL pump orifices

**Note:**  
All new 6L pump components are coated with a corrosion inhibitor. This inhibitor needs to be removed with brake clean. Valve sticking or orifice restriction issues may occur if not removed.

Always inspect the passages in your new pump half for restrictions due to machining issues. We have seen several instances where there is no boost after pump half replacement.

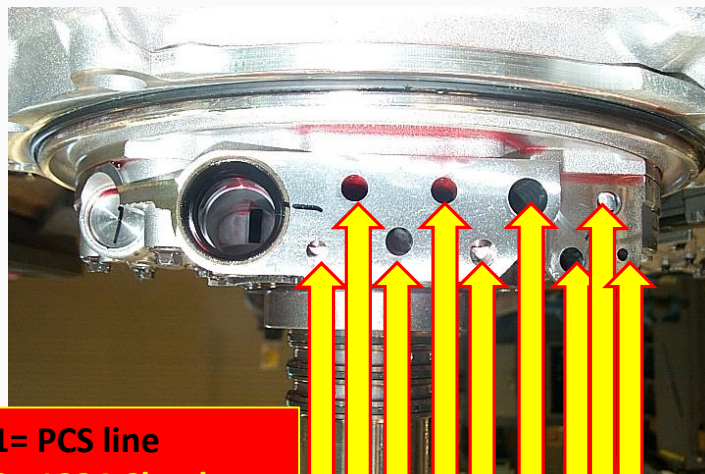
# 6L80/6L90 Delayed Engagement, Slip, Shudder, Clutch Damage

**Cause/Correction:** One of the more likely causes for any of the above concerns is a leak between the pump stator support and the pump cover. The stator to pump cover component mating surface areas are sealed with a gasket. To test for a leak in the gasket, use shop air or vacuum. Apply the air or vacuum to the valve body feed passages on the pump.

- 1= PCS line
- 2= 1234 Clutch
- 3=Compensator
- 4= 35R Clutch
- 5=Regulator apply
- 6=Line
- 7=456 Clutch
- 8=Center Lube
- 9= PCS TCC

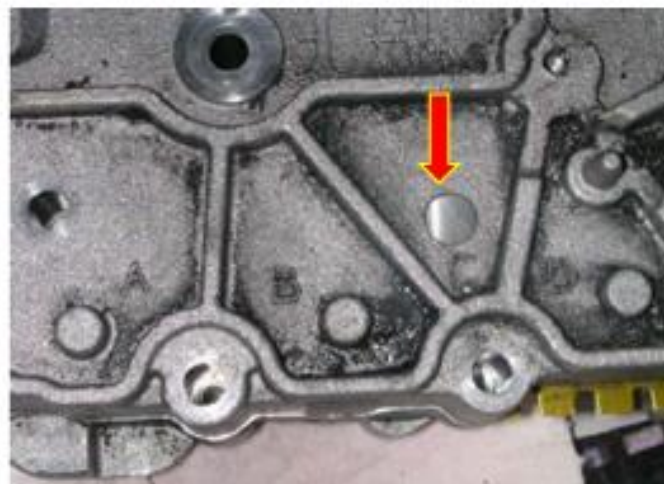
# 6L45/6L50/6L80/6L90 Valve Body Id

Machined boss on upper VB casting IDs transmission

- A = MYA / 6L45
- B = MYB / 6L50
- C = MYC / 6L80
- D = MYD / 6L90
- E = MYC / 6L80 (2010)
