# ATRA WEBINAR

## 6T70 Product Issues and Updates

Presented by:  
Steve Garrett  
ATRA

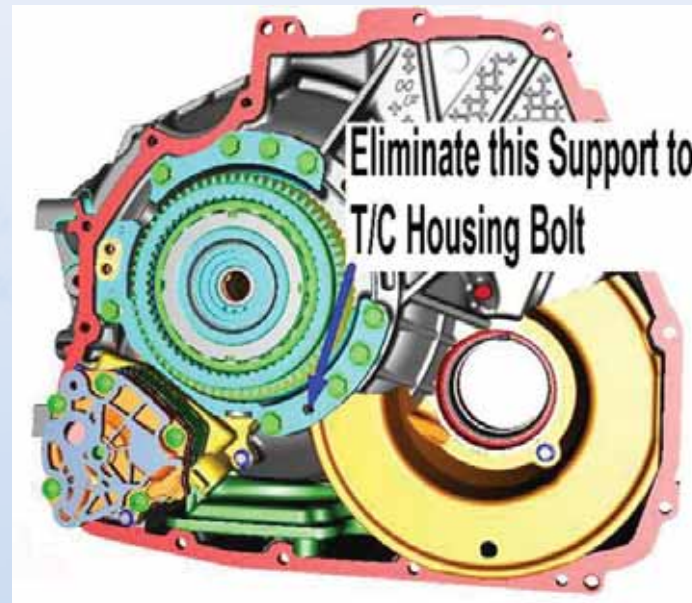
# Updated Support 2007 and Later

- \* 2007 and later models have eliminated one bolt from the torque converter housing area. The updated transaxle will utilize a 9 bolt support. The updated converter housing is not tapped for the bolt so it is not necessary for you to do any modifications to assist you with interchange of the parts. The updated support will backservice previous models as you will simply eliminate the bolt. When installing the updated support on an earlier application, simply follow the torque sequence for the 9 bolt system

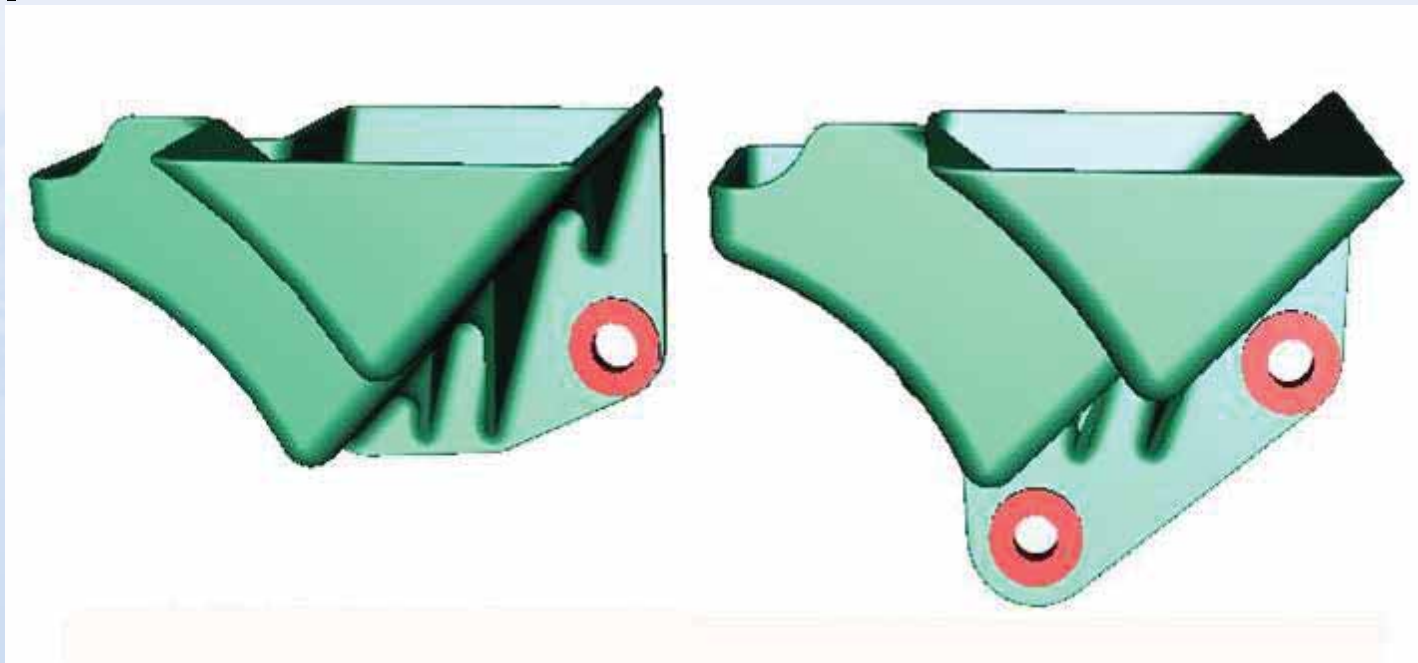
# Lube Trough Update

**\* The lube trough design was updated on 2008 applications. The updated design uses only one bolt to retain the trough in the case. In later case designs only one bolt hole is drilled in the case. The updated trough will backservice previous design applications.**

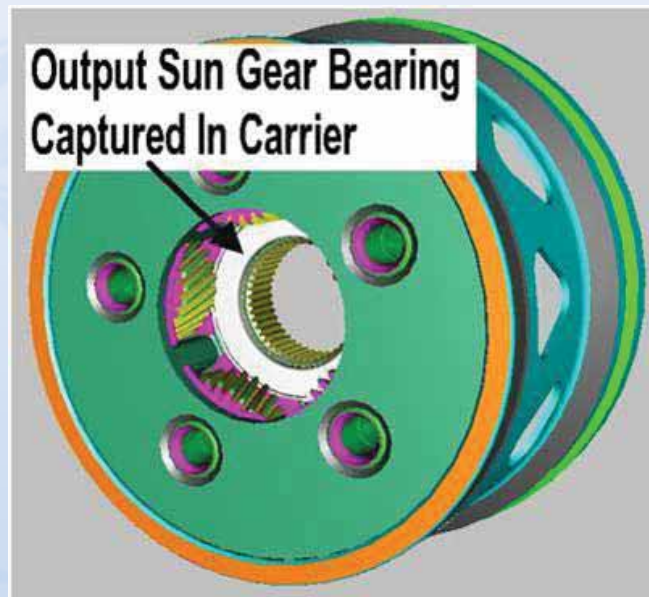
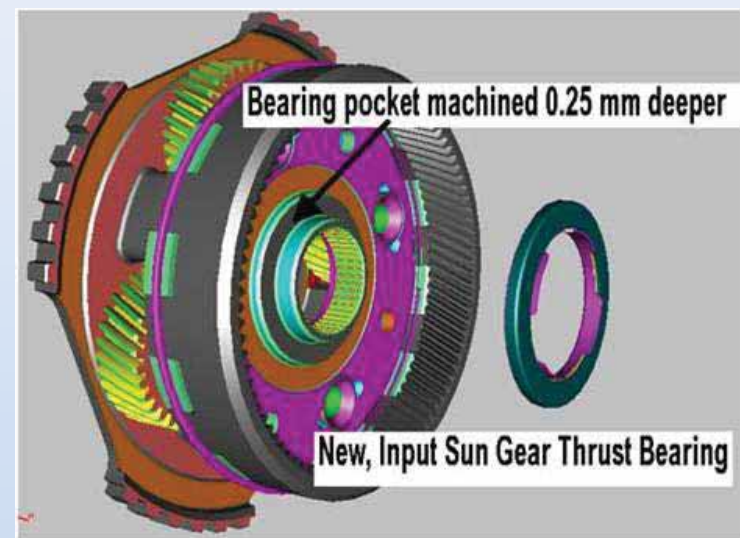
# Carrier Updates

- An update to the design of the Output and Reaction carriers occurred for the 2009 model year. The Output carrier bearing pocket has been machined .01" (.3mm) deeper to accept a thicker sun gear bearing design. The Reaction carrier sun gear bearing has also been modified. The bearing pocket on the updated carrier has been machined .009" (.25mm) deeper to allow for a more robust bearing design. The updated carriers will backservice if the updated bearings are used.

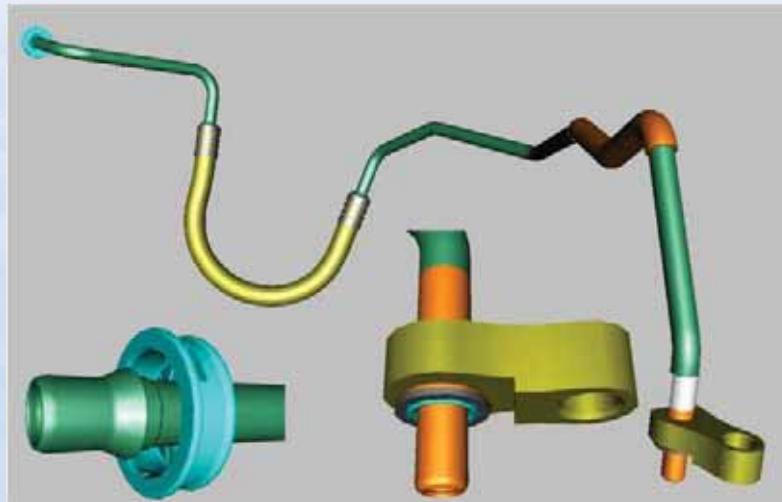
# Cooler Line Updates

**A updated cooler line was developed to reduce the chance of leakage from the cooler circuit. The updated lines have longer snouts and the cooler line holes in the case were modified to accept the longer snouts. This update was designed for 2008 and later applications and it will NOT backservice into the previous design cases.**

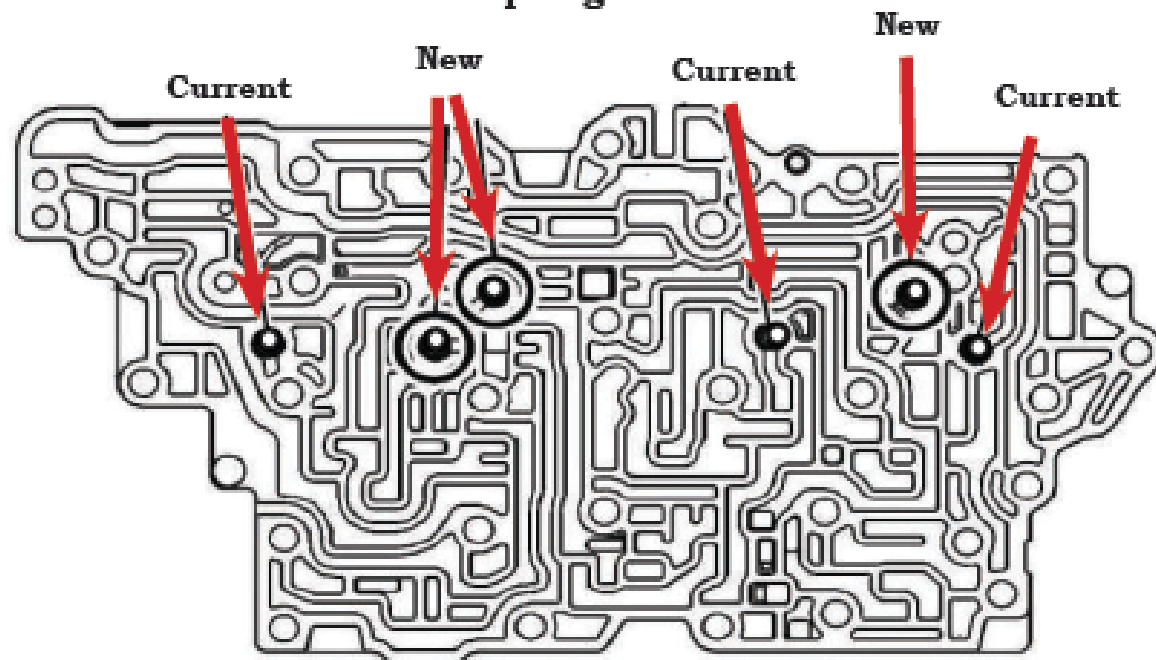
## VB Accumulator Pistons Update

**Control Valve Channel Plate New Design**

**3 New Actuator Feed  
Accumulator Pistons  
& Springs**

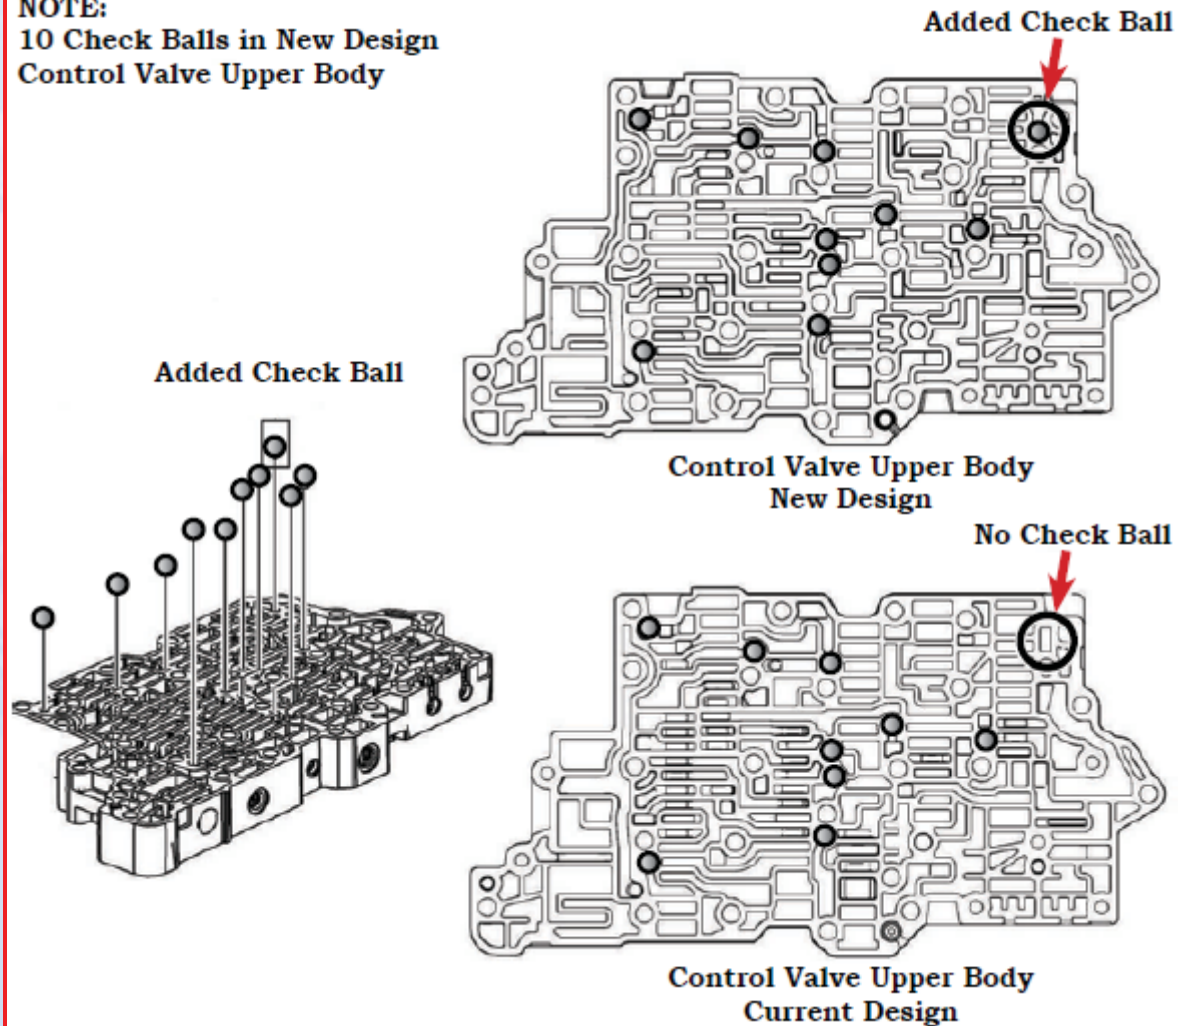
# 6T70-75 2013 Gen II Check Ball Update

**NOTE:**  
10 Check Balls in New Design  
Control Valve Upper Body

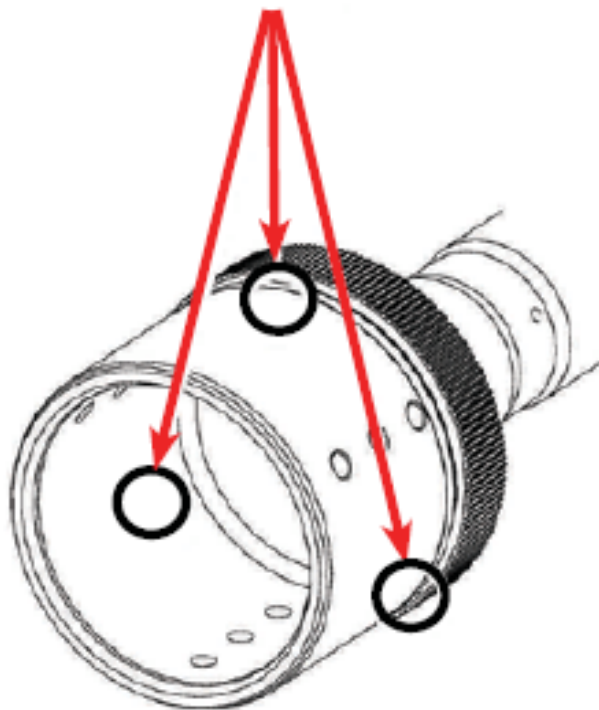
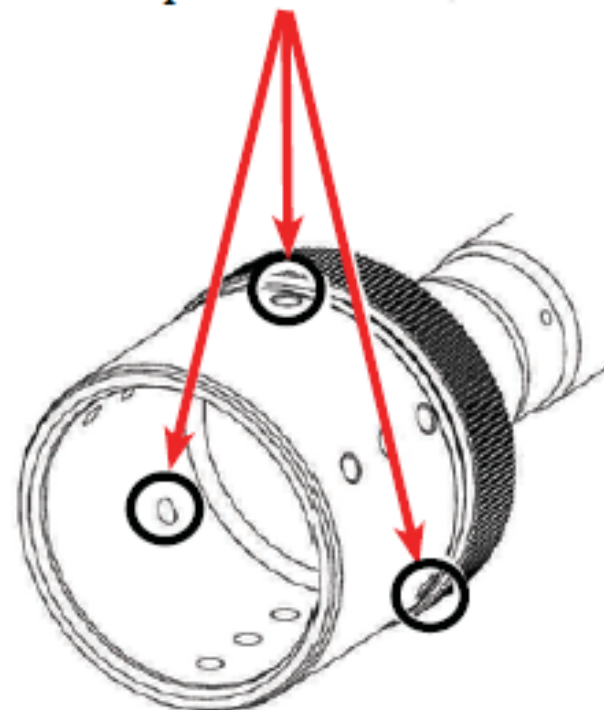
**No Holes**

**Turbine Shaft  
Current Design**

**3 Added Holes To Improve  
Compensator Feed oil**

**Turbine Shaft  
New Design**

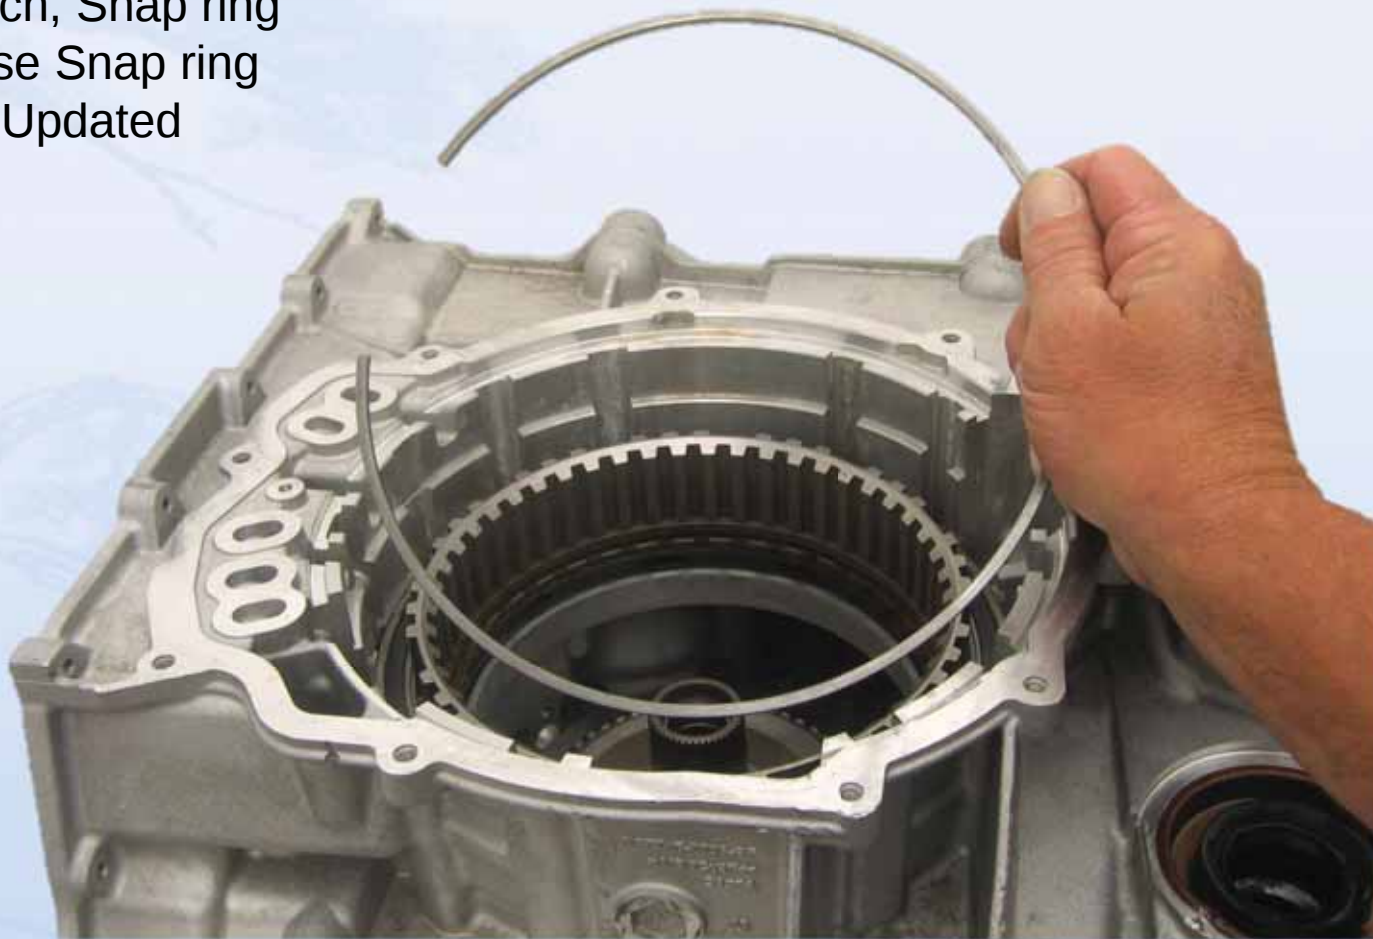
2-6 Clutch, Snap ring  
And Case Snap ring  
Groove Updated
