Troubleshooting the 604 (41TE)

by Dave Skora

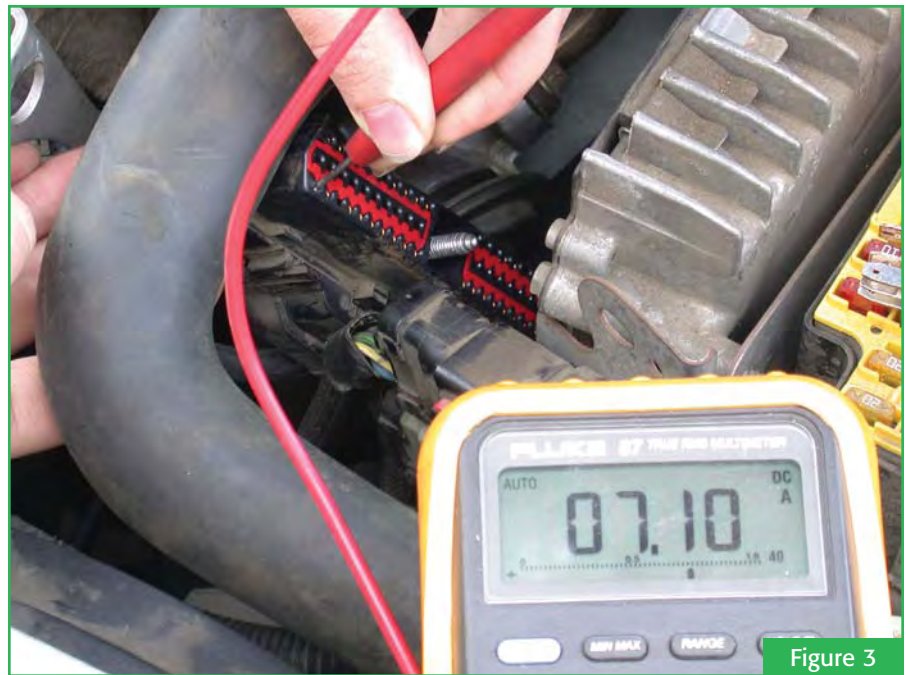
Figure 3

- Make sure the battery is fully charged with a minimum rest voltage of 12.45 volts.
- Disconnect the TCM.
- Connect a jumper wire between terminals 56 and 15. This should energize the ETAX relay and supply battery voltage to the solenoid circuits. On some models you may have to turn the ignition switch on. You now have control over the entire solenoid circuit (minus the TCM).
- Make sure terminal 20 at the TCM connector has battery voltage.
- Ground the L/R solenoid circuit at terminal 20 through an ammeter, lab scope or jumper wire with an inductive current clamp to monitor current (figure 3).

As soon as you measure the current flow, remove the jumper wire; you should have 6.5–7.5 amps. If it's too high or low, look for a problem in the circuit. If the current is correct, suspect a bad TCM.

To verify the circuit, repeat the current flow test for the other three solenoids circuits at terminals 19, 59 and 60. As a final test, cycle the suspect circuits on for one second and then off, about 10–12 times. This will heat up the

solenoid windings. If the solenoid circuit still reads 6.5–7.5 amps, the circuit and solenoid are good, so the TCM is likely the problem. Reconnect the TCM when finished.
