AF 33-5 part 1

by Steve Garrett

Available in the Opel, Saturn Vue and Chevrolet Equinox, the Aisin Warner AF 33-5 is a fully automatic 5 speed transmission and is available in both a front wheel and AWD versions (Figure 1).

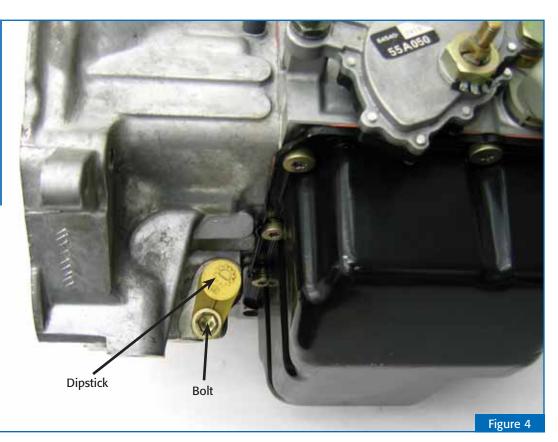
The bolt and dipstick are located on the "INBOARD" side of the transaxle.

FLUID LEVEL CHECKING PROCEDURE (figure 4):

Like several other GM transmissions, the factory fill is designed for an "extended service interval". As you know, many GM transmissions no longer use a dipstick, but instead use a sight plug. Although the AF33-5 does not have a dipstick tube, it does have a dipstick. The plastic dipstick is positioned in a location that one would not expect. It's in the case and held by a bolt that must be removed to check the fluid level. The bolt and dipstick are located on the "INBOARD" side of the transaxle.

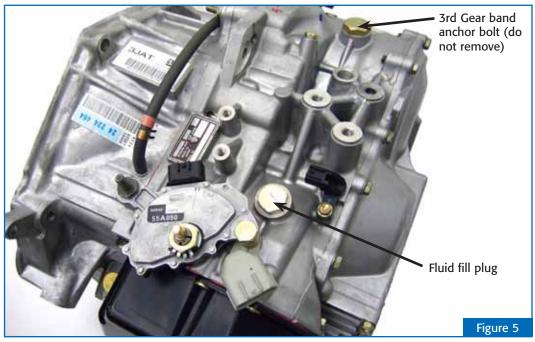
To fill the transmission with fluid you must remove the fluid fill plug. The fluid fill plug is located next to the P/N PRNDL switch on the top of the transmission.

FILLING THE TRANSMISSION WITH FLUID (figure 5):

The fluid used in the AF-33-5 is TYPE T IV synthetic (GM part # #88900925). To fill the transmission with fluid you must remove the fluid

fill plug. The fluid fill plug is located next to the P/N PRNDL switch on the top of the transmission. The fluid fill plug is a hex head style plug. It is important not to confuse the fluid fill plug with the third gear band anchor bolt. The third gear band anchor bolt is located within a few inches of the fluid fill plug. If the third gear anchor bolt is removed the band will fall out of position resulting in a "NO 3RD gear" condition even if the bolt is reinstalled. If the third gear anchor bolt has been removed you will need to remove the transmission and disassemble it to reposition the band and its anchor correctly.
