Technical Bulletin #1610

Transmission: 41TE/42LE/42RLE
Subject: Check Ball Locations
Application: Chrysler
Issue Date: May, 2014

41TE/42LE/42RLE Check Ball Locations

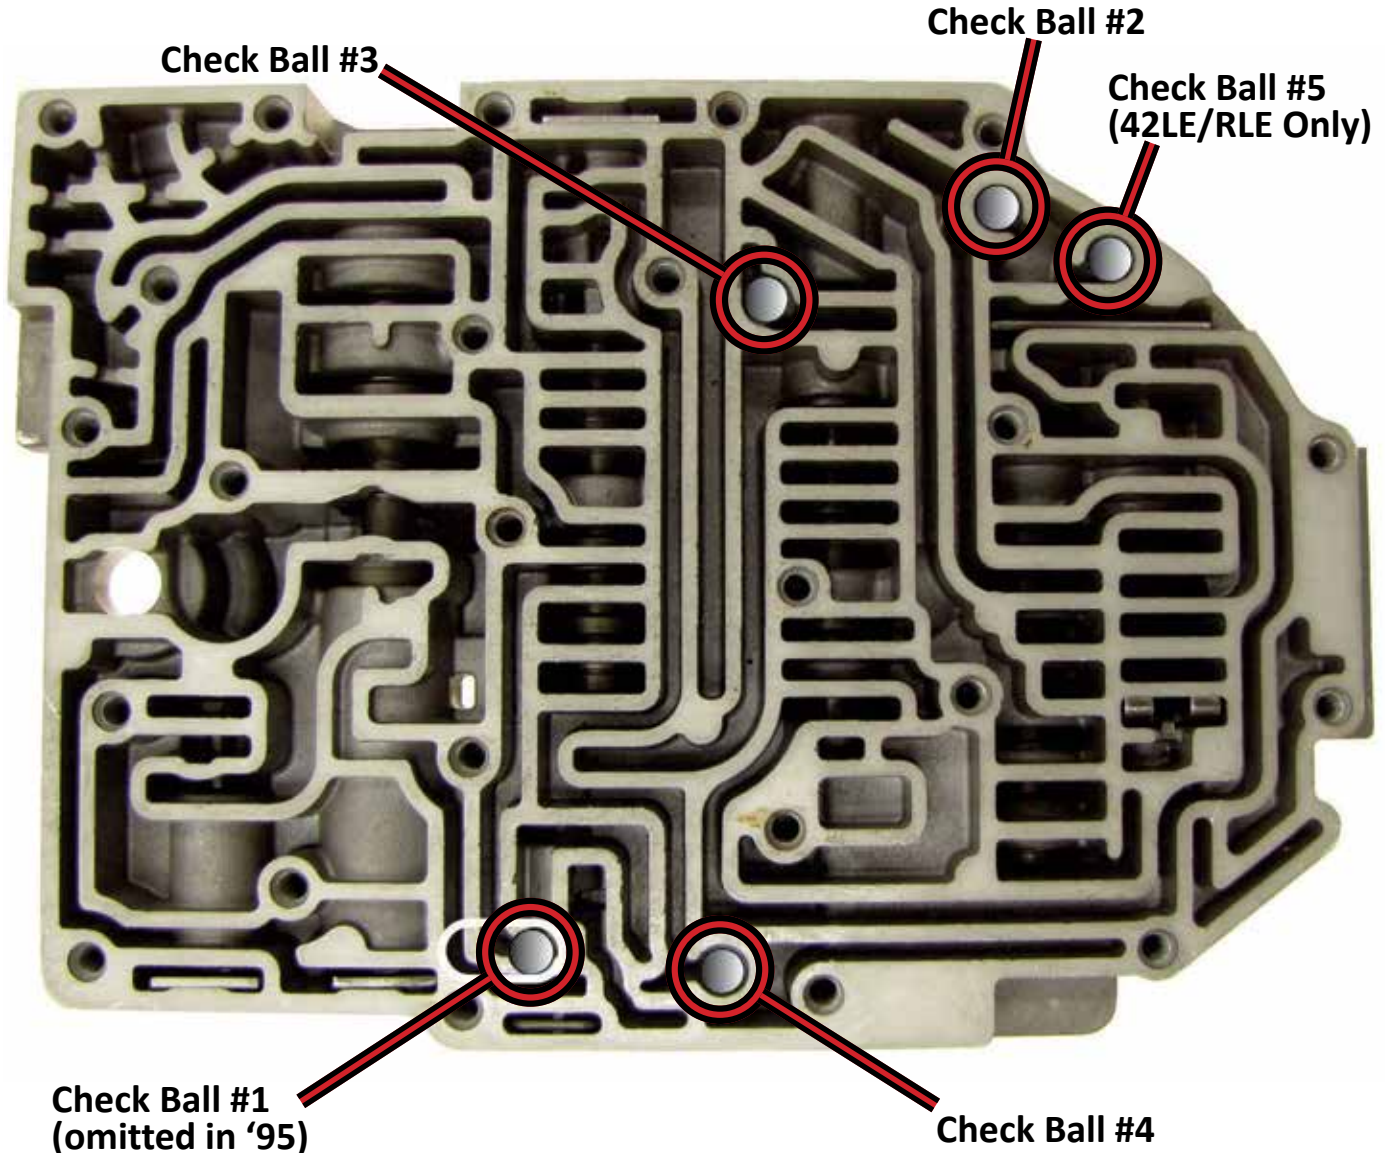
Check Ball #2 Was Eliminated in 2009 on the 41TE and 42RLE
(No Hole in that Location)

Late Valve Body Shown
(Earlier 41TE/42LE Valve Body has a #1 Check Ball Located in Bathtub)

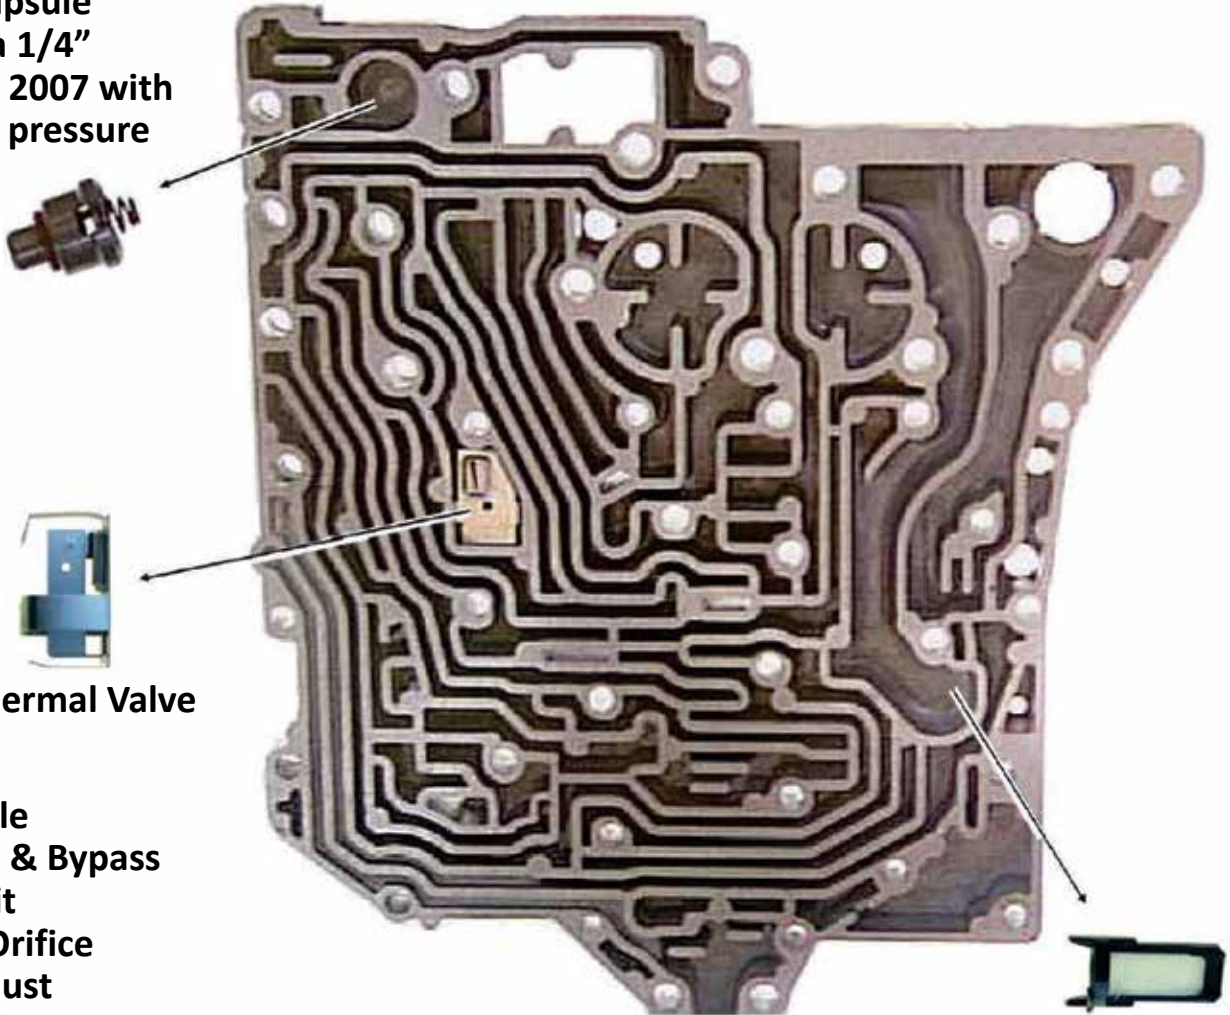
41TE/42LE/42RLE Check Ball Locations

Check Ball #5 Capsule (41TE)

Note: The capsule
changed to a 1/4"
check ball in 2007 with
variable line pressure
control.

Channel Plate (Early Models)

Deleted in
2009

Thermal Valve

- #1 L/R Shuttle
- #2 U/D Feed & Bypass
- #3 L/R Circuit
- #4 Reverse Orifice
- #5 O/D Exhaust
